## AC Inspection as Found

Draslovka  
2571 Fite Road  
Millington, TN 38057

### AC Inspection - Rev. 2

Description: 250 Hp Reliance

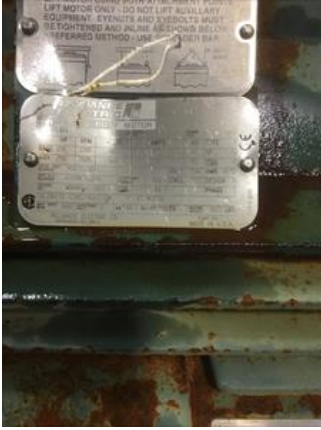
P2

2. Nameplate Picture

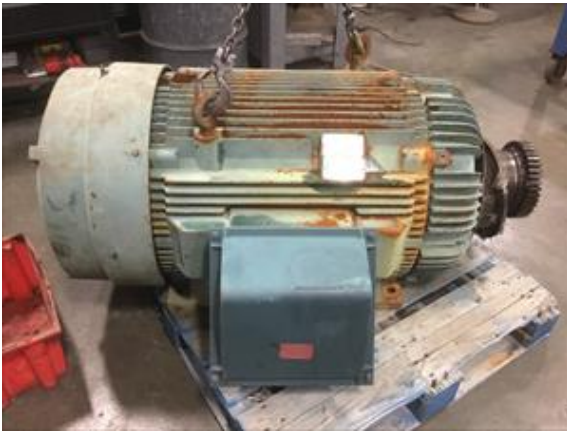
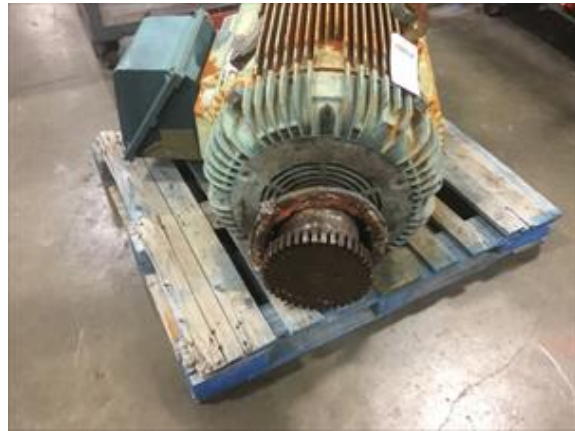
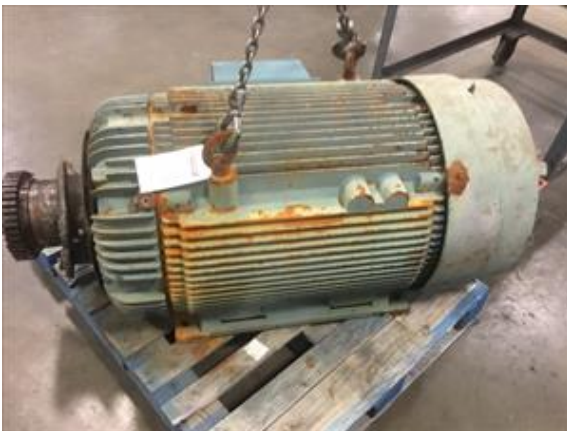
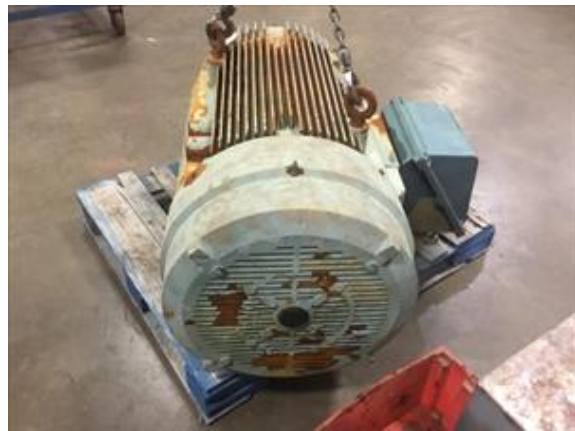
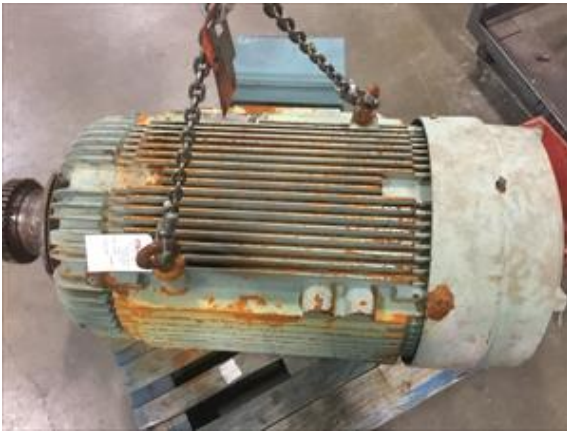
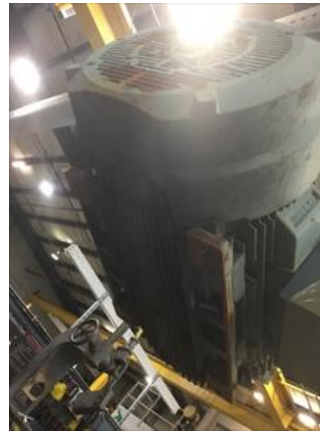
P3

3. Photos of all six sides of the machine.

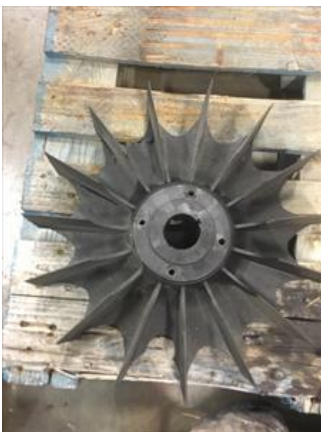
4.	Describe the Overall Condition of the Equipment as Received		
	<i>Good</i>		
5.	Distance from the end of the shaft to the Coupling/Sheave	0 inches	
6.	Report Date [COPY]		
Initial Mechanical/Electrical			<input type="checkbox"/>
7.	Does Shaft Turn Freely?	(Y) Yes	
8.	Does the shaft require T.I.R in Lathe to identify additional repairs?	(No) No	
9.	Does Shaft Have Visible Damage?	(No) No	
10.	Assembled Shaft Runout	Inches	
11.	Assembled Shaft End Play		
12.	Air Gap Variation <10%		
13.	Lead Condition	(P) Pass	
14.	Lead Length	28 Inches	
15.	Does it have Lugs?, If so what is the Stud Size?	(Yes) Yes	
	3/8		
16.	Lead Numbers	t1-t3	
17.	Frame Condition	good	
18.	Fan Condition	(P) Pass	P18

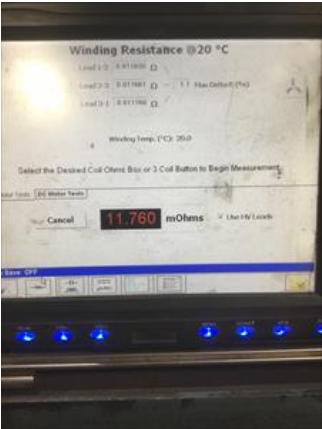
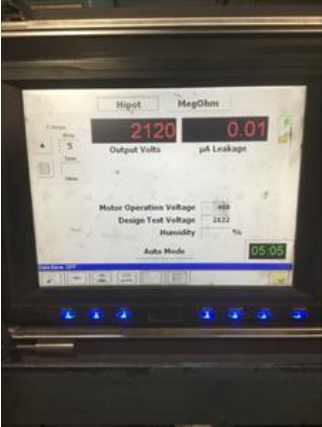
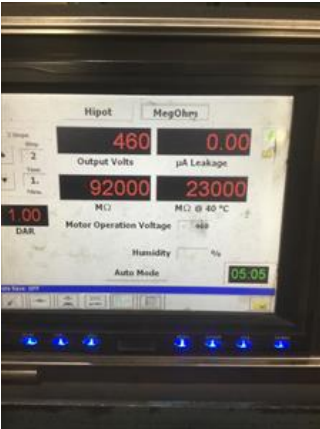
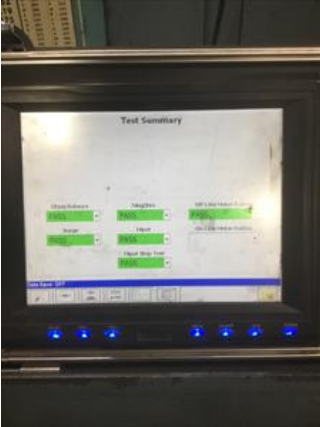
</div> </div>	<div> <div>P20</div> <div> <div></div> <div></div> </div> </div>
--	---	--

<div> <div>20. Insulation Resistance/Megger</div> <div>

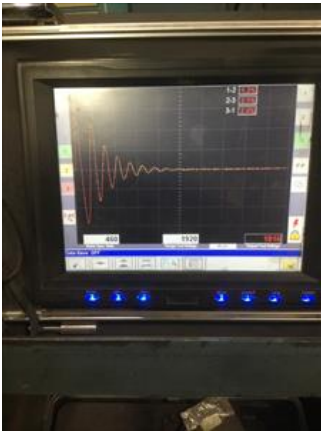
<div> <div>22. Perform Surge Test</div> <div> <div>(P) Pass</div> </div> </div>	<div> <div>P22</div> <div> <div></div> <div></div> </div> </div>
---	--

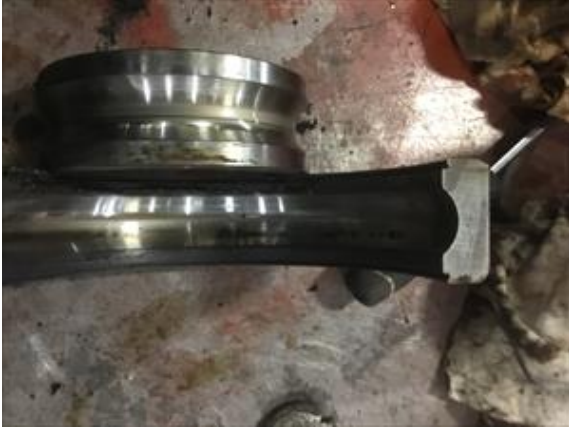
23.	Number of Stator Slots	73	
24.	Stator Condition	good	
25.	Stator Thermistors/Ohms		
26.	Stator Overloads/Ohms		
<b>Mechanical Inspection</b>			
27.	Drive End Bearing Brand	fag	
28.	Drive End Bearing Number-	6318	
29.	Drive End Bearing Qty.	1	
30.	Drive End Bearing Type	(Ball) Ball Bearing	
31.	Drive End Lubrication Type	(Grease) Grease Lubricated	
32.	Drive End Bearing Insulation or Grounding Device?	none	
33.	Drive End Wavy Washer/Snap-Ring Other Retention Device?	none	
34.	Drive End Bearing Condition	good	P34

49.	List the Parts needed for the Repair Below 1-6318 insulated bearing 1-6318 bearing 1-bearing snap ring			
50.	Signature of Technician that Disassembled Motor	James Valentine

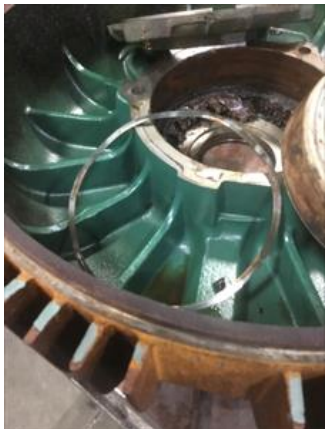
P41

41. Opposite Drive End Wavy Washer/Snap-Ring Other Retention Device?

wavy washer

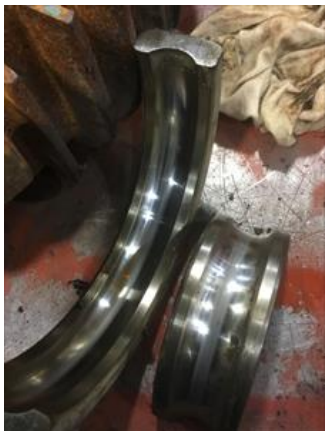
P42

42. Opposite Drive End Bearing Condition

good
