## AC Inspection as Found

Draslovka  
2571 Fite Road  
Millington, TN 38057

### AC Inspection - Rev. 2

Description: 250 Hp Allis Chalmers

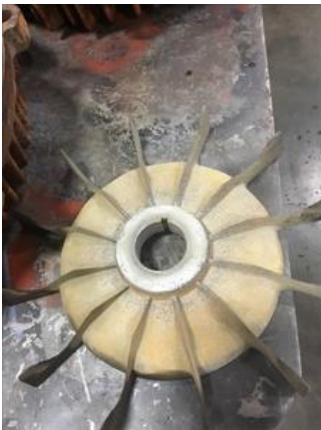
4.	Describe the Overall Condition of the Equipment as Received		
	<i>Good</i>		
5.	Distance from the end of the shaft to the Coupling/Sheave	0 inches	
6.	Report Date [COPY]		
Initial Mechanical/Electrical			<input type="checkbox"/>
7.	Does Shaft Turn Freely?	(Y) Yes	
8.	Does the shaft require T.I.R in Lathe to identify additional repairs?	(No) No	
9.	Does Shaft Have Visible Damage?	(No) No	
10.	Assembled Shaft Runout	0.002 Inches	
11.	Assembled Shaft End Play	0.002 inches	
12.	Air Gap Variation <10%		
13.	Lead Condition	(P) Pass	
14.	Lead Length	25 Inches	
15.	Does it have Lugs?, If so what is the Stud Size?	(Yes) Yes	
	3/8		
16.	Lead Numbers	t1-t3	
17.	Frame Condition	good	
18.	Fan Condition	(F) Fail	P18

19. Broken or Missing Components fan

46.	Growler Test	(Pass) Pass
47.	Number of Rotor Bars	50
48.	Rotor Condition	good
49.	List the Parts needed for the Repair Below 2-6315 bearings 1-aluminum fan
