**AC Inspection as Found**  
**Nucor-Yamato Steel Co. (0000418)**  
5929 Highway 18 E.  
Armored, AR 72310

**AC Inspection - Rev. 2**

Description: 15 HP

Manufacturer: P&H

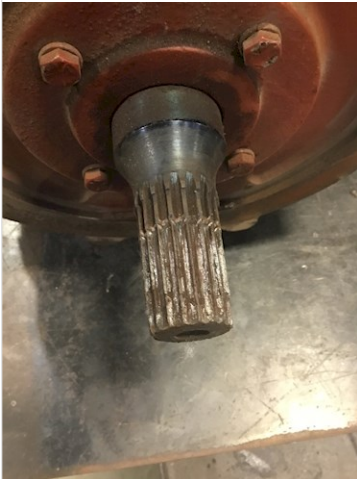
5. Does Shaft Turn Freely?	(Y) Yes	
6. Does the shaft require T.I.R in Lathe to identify additional repairs?		
7. Does Shaft Have Visible Damage?	(Yes) Yes	P8

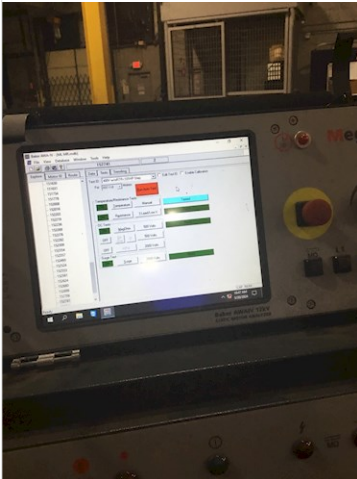
P24

☒ 21. Perform Surge Test

(P) Pass

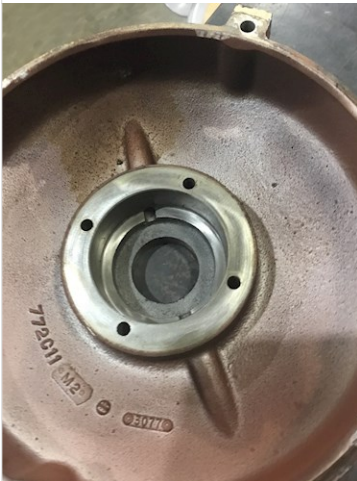
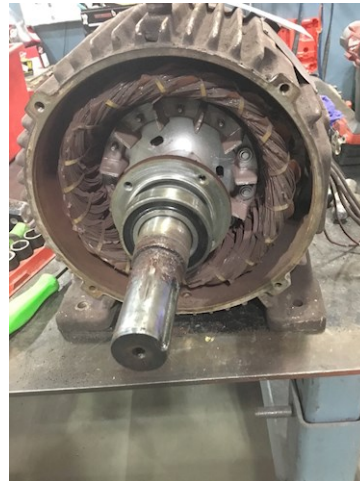
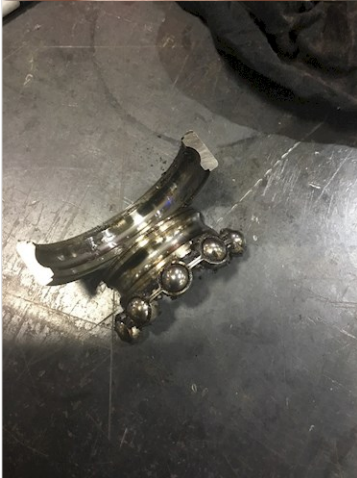
P36

28. Drive End Bearing Qty.	1
29. Drive End Bearing Type	(Ball) Ball Bearing
30. Drive End Lubrication Type	(Grease) Grease Lubricated
31. Drive End Bearing Insulation or Grounding Device?	none present
32. Drive End Wavy Washer/Snap-Ring Other Retention Device?	none present
33. Drive End Bearing Condition

**6210 2RSC3 bearing  
62092RSC3 bearing**

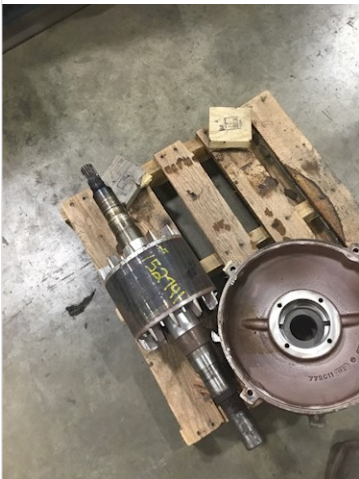
P58

44. Rotor Type/Material **(Squirrel Aluminum) Squirrel  
Cage Aluminum Die Cast**

45. Growler Test **(Pass) Pass**

47. Rotor Condition **acceptable**
