AC Inspection as Found

MARS FOOD (0001269)

AC Inspection - Rev. 2

Repair Stage: Teardown Inspection

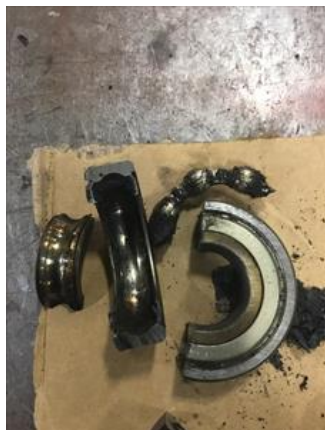
27.	Drive End Bearing Number-	6308ze	
28.	Drive End Bearing Qty.	1	
29.	Drive End Bearing Type	(Ball) Ball Bearing	
30.	Drive End Lubrication Type	(Grease) Grease Lubricated	
31.	Drive End Bearing Insulation or Grounding Device?	none	
32.	Drive End Wavy Washer/Snap-Ring Other Retention Device?	none	
33.	Drive End Bearing Condition	good	P33

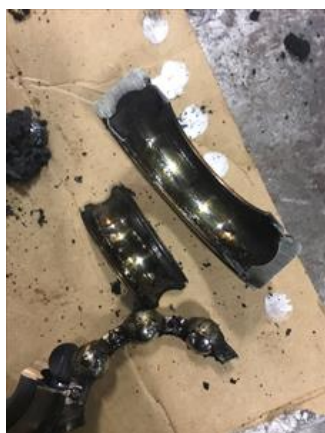
34.	Opposite Drive End Bearing Brand	nachi	
35.	Opposite Drive End Bearing Number-	6308ze	
36.	Opposite Drive End Bearing Qty.	1	
37.	Opposite Drive End Bearing Type	(Ball) Ball Bearing	
38.	Opposite Drive End Lubrication Type	(Grease) Grease Lubricated	
39.	Opposite Drive End Bearing Insulation or Grounding Device?	none	
40.	Opposite Drive End Wavy Washer/Snap-Ring Other Retention Device?	none	
41.	Opposite Drive End Bearing Condition	good	P41
