AC Inspection as Found

US Zinc

AC Inspection - Rev. 2

Description: 50 HP

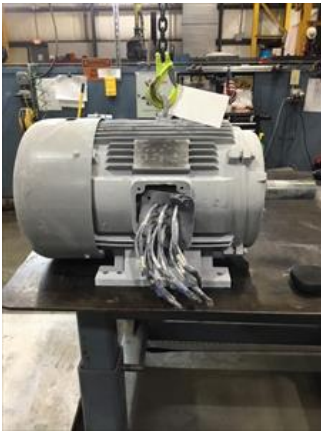
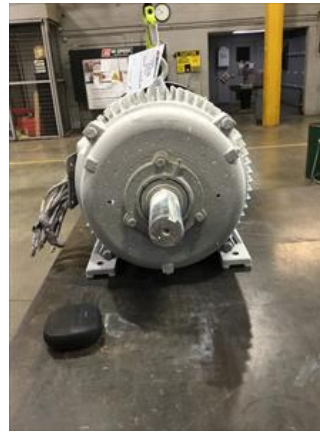
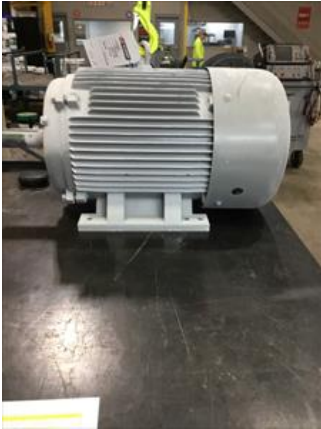
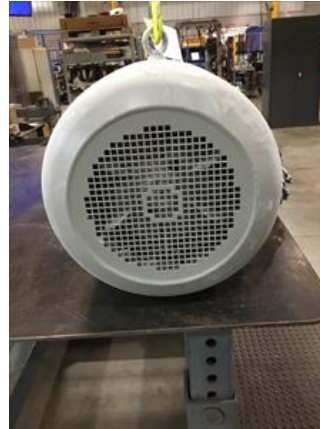
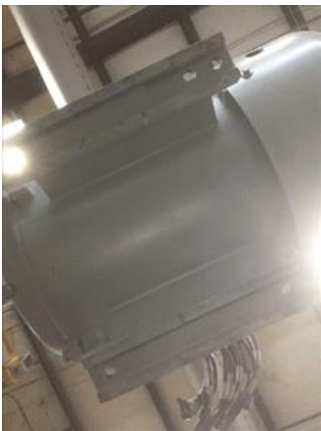
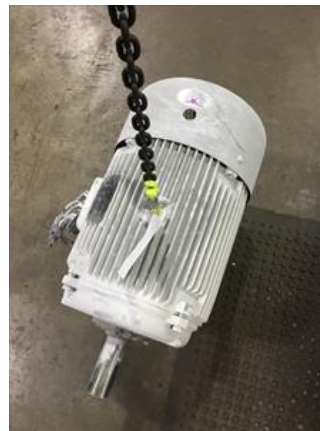
3. Photos of all six sides of the machine.

4. Describe the Overall Condition of the Equipment as Received
Bearings and grease looked clean..... minimal run time since last recondition

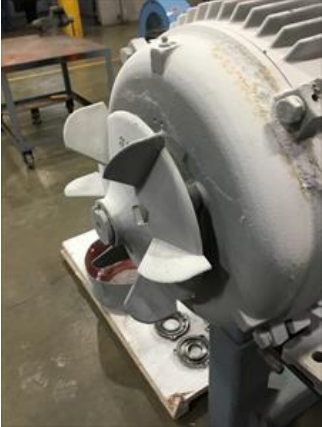
13.	Does it have Lugs?, If so what is the Stud Size?	(No) No	
14.	Lead Numbers	1-12	
15.	Frame Condition	Good	
16.	Fan Condition	(P) Pass	P19
	<i>Snap ring</i>

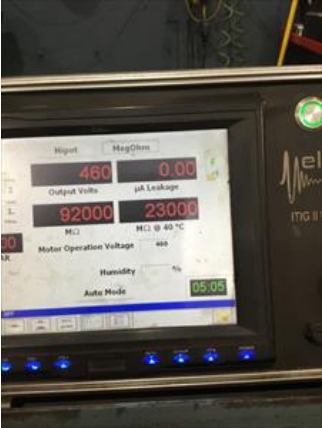
19.	Insulation Resistance/Megger	230000 Megohms	P22

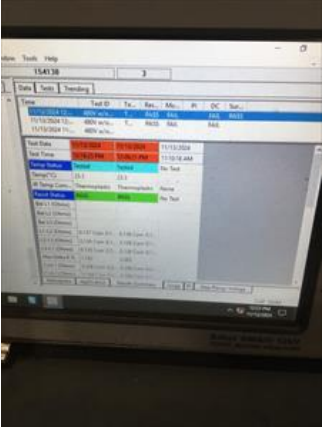
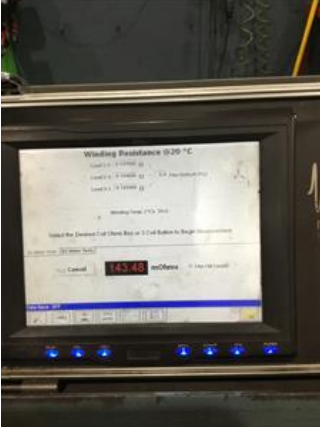
20. Winding Resistance			P23
1-2	1-3	2-3	
.143	.144	.143	
<div>

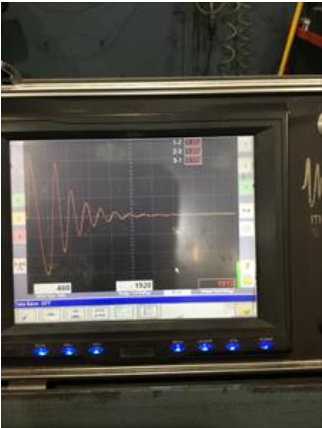
</div>			
21. Perform Surge Test	(P) Pass	P24

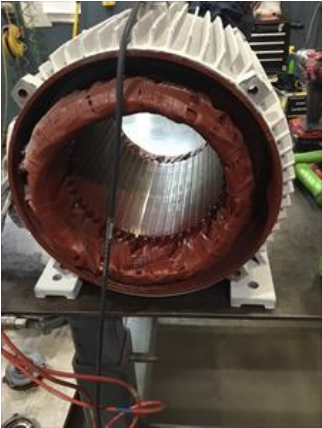
22. Number of Stator Slots	48		
23. Stator Condition	acceptable	P26

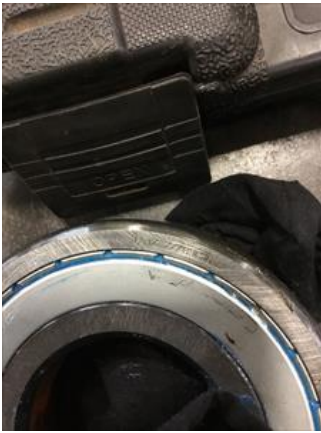
28. Drive End Bearing Qty.	1	
29. Drive End Bearing Type	(Ball) Ball Bearing	
30. Drive End Lubrication Type	(Grease) Grease Lubricated	
31. Drive End Bearing Insulation or Grounding Device?	none	
32. Drive End Wavy Washer/Snap-Ring Other Retention Device?	none	
33. Drive End Bearing Condition	good	P36

34. Opposite Drive End Bearing Brand	SKF	
35. Opposite Drive End Bearing Number-	6312 zz c3	P38

(2) 6312 bearings

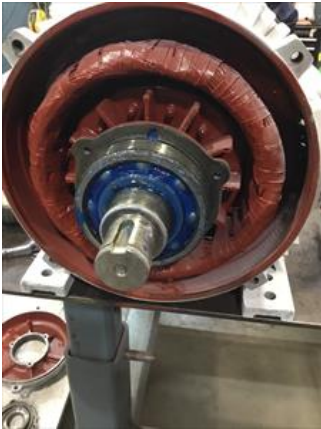
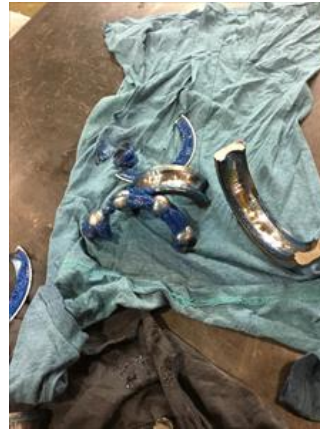
36. Opposite Drive End Bearing Qty.	1	
37. Opposite Drive End Bearing Type	(Ball) Ball Bearing	
38. Opposite Drive End Lubrication Type	(Grease) Grease Lubricated	
39. Opposite Drive End Bearing Insulation or Grounding Device?	none	
40. Opposite Drive End Wavy Washer/Snap-Ring Other Retention Device?	snap ring	
41. Opposite Drive End Bearing Condition	good	P44

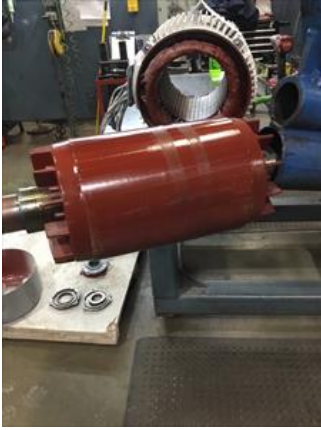
Rotor Inspection		
44. Rotor Type/Material	(Squirrel Aluminum) Squirrel Cage Aluminum Die Cast	
45. Growler Test	(Pass) Pass	
46. Number of Rotor Bars	44

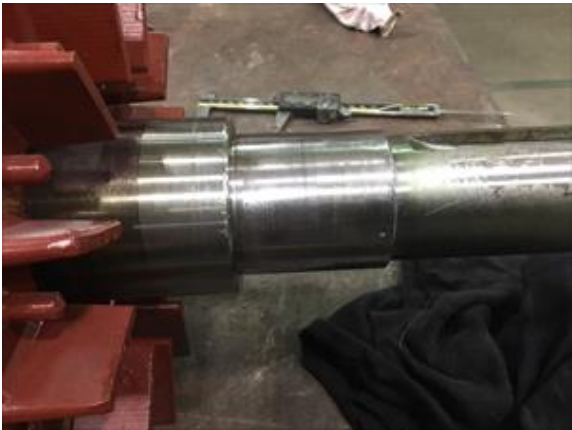
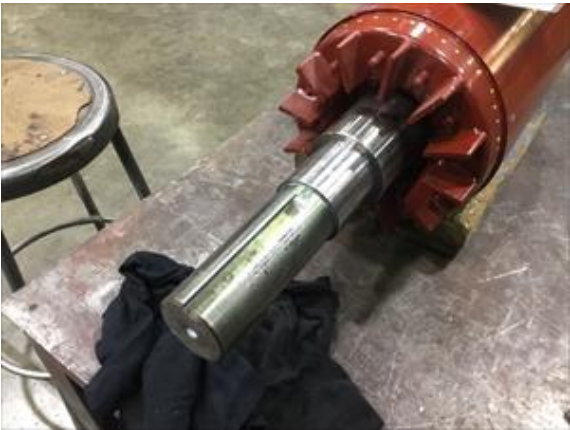
54. Drive End Bearing Shaft Fit

0 Degrees	60 Degrees	120 Degrees
2.3623	2.3623	2.3621

60mm = 2.3622 Pressfit tolerance is from 2.3623 to 2.3628

(P) Pass

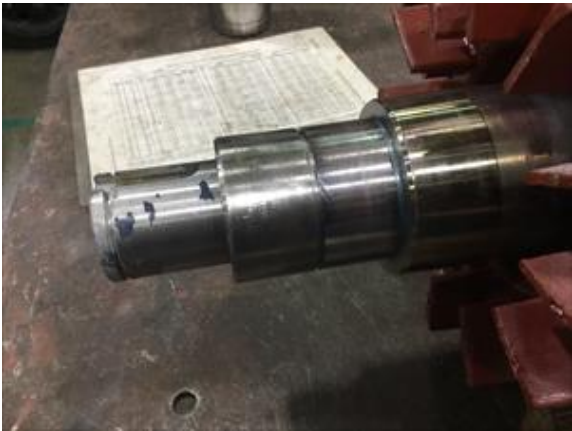
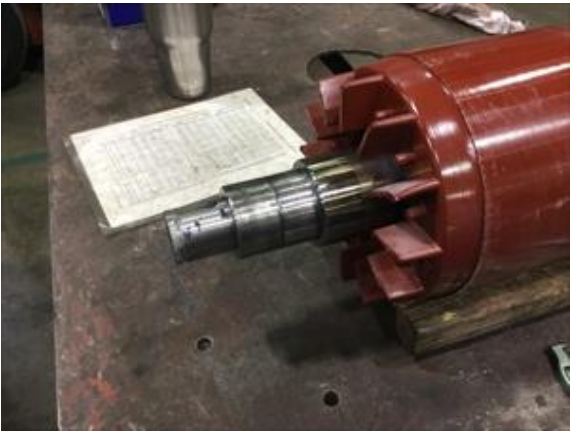
56. Opposite Drive End Bearing Shaft Fit

0 Degrees	60 Degrees	120 Degrees
2.3625	2.3624	2.3625

(P) Pass

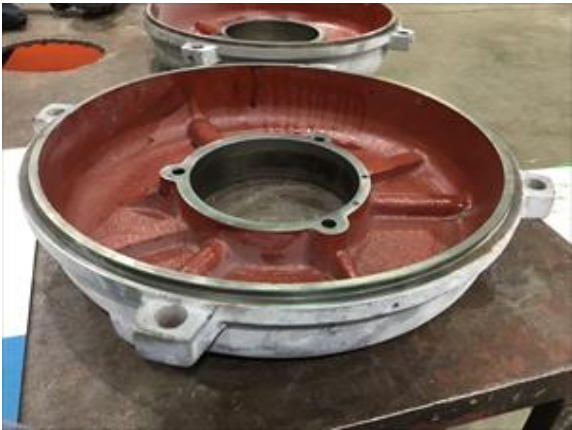
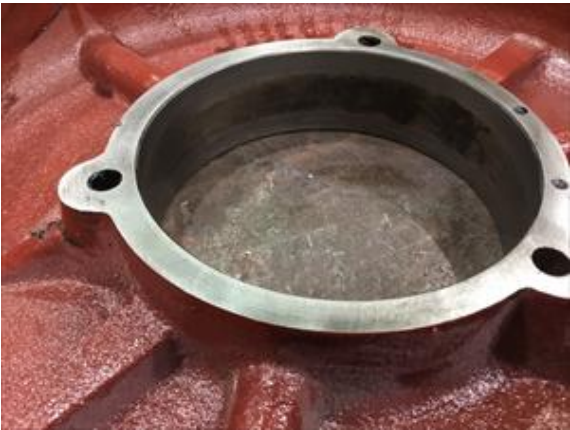
59. Drive End - Endbell Bearing Fit

0 Degrees	60 Degrees	120 Degrees
5.1205	5.1204	5.1205

130mm = 5.1181 Tolerance is from 5.1181 to 5.1191

(F) Fail

64.	End Bell Air Seal Fits	
	Drive End Air Seal	Opposite Drive End Air Seal
65.	List Machine Work Needed Below <i>Both endbells need to be bored and bushed</i>	
66.	Technician	Roger Ventrini

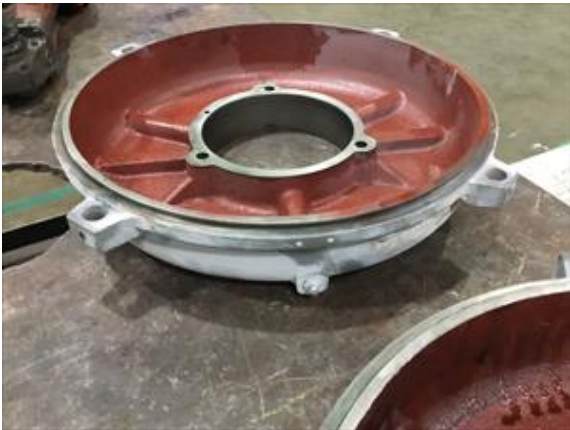
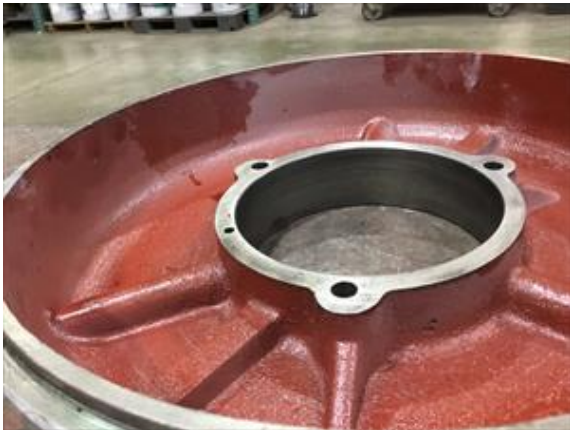
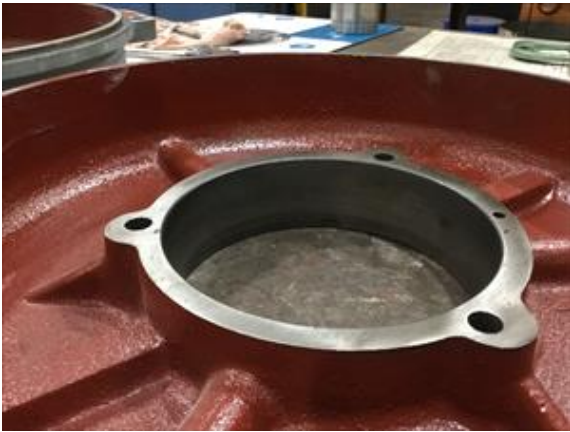
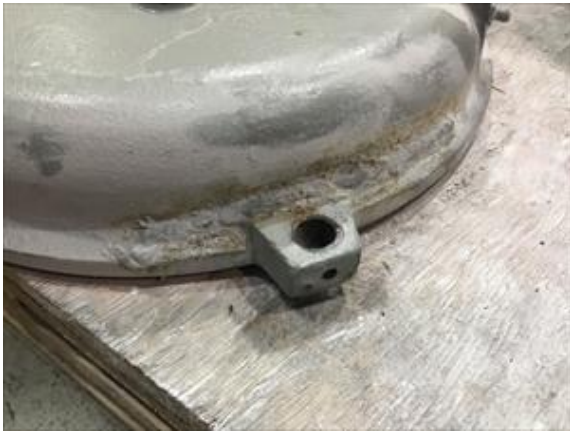
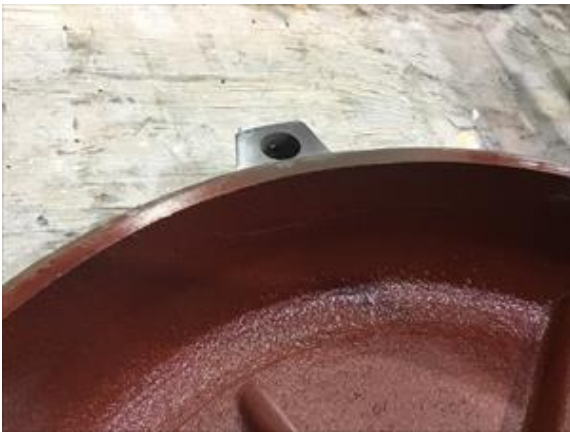
61. Opposite Drive End - Endbell Bearing Fit

0 Degrees	60 Degrees	120 Degrees
5.1213	5.1214	5.1214

130mm = 5.1181 Tolerance is from 5.1181 to 5.1191

The ODE endbell has been repaired in the past. See photos

62. Opposite Drive End - Endbell Bearing Fit Condition (F) Fail
63. Bearing Cap Condition
