## AC Inspection as Found

US Zinc

### AC Inspection - Rev. 2

Serial Number: 20121634

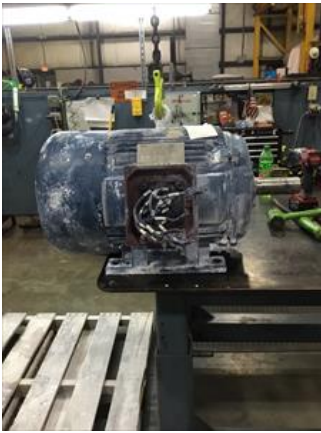
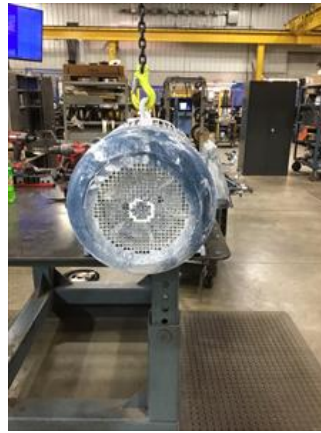
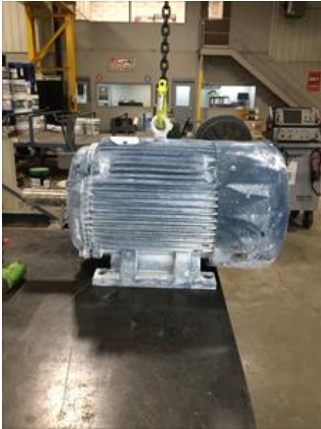
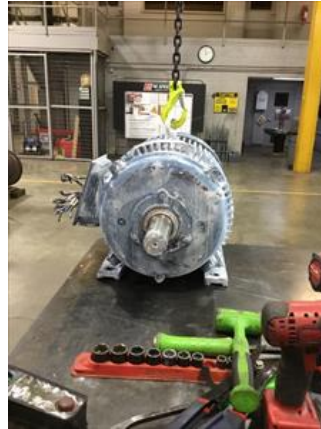
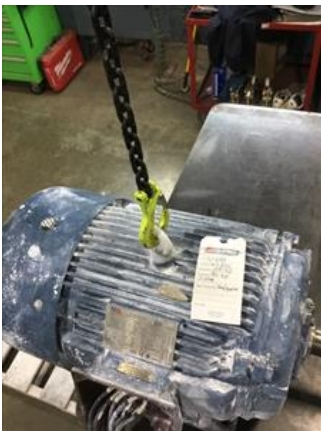
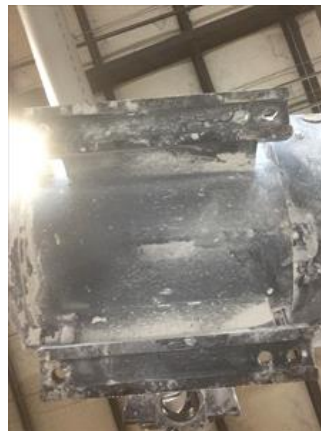
- Photos of all six sides of the machine. P3

*Dirty*

*Needs standard reconditioning*

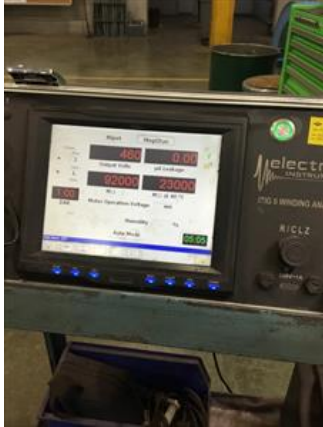
12.	Lead Length	10 Inches	
13.	Does it have Lugs?, If so what is the Stud Size?	(No) No	
14.	Lead Numbers	1-12	
15.	Frame Condition	acceptable	
16.	Fan Condition	(P) Pass	
17.	Broken or Missing Components	no	
Initial Electrical Inspection			
18.	Insulation Resistance/Megger	23000 Megohms	P22

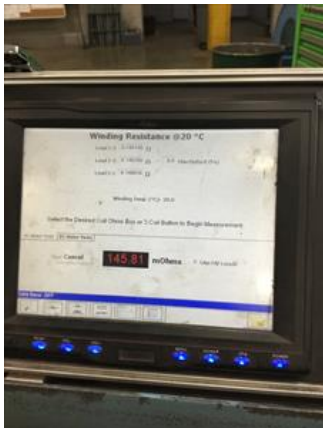
19.	Winding Resistance	P23	
	1-2	1-3	2-3
	.1457	.1457	.1458

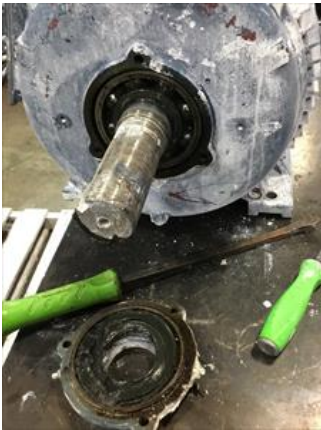
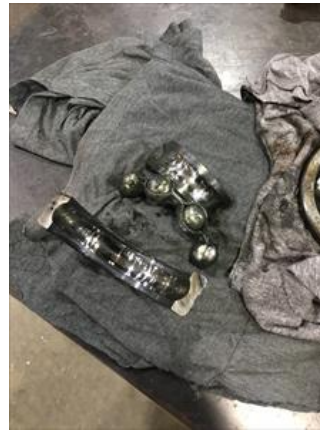
P36

25. Drive End Bearing Brand	C&U
26. Drive End Bearing Number-	6312 C3 ZZ
27. Drive End Bearing Qty.	1
28. Drive End Bearing Type	(Ball) Ball Bearing
29. Drive End Lubrication Type	(Grease) Grease Lubricated
30. Drive End Bearing Insulation or Grounding Device?	none
31. Drive End Wavy Washer/Snap-Ring Other Retention Device?	none
32. Drive End Bearing Condition	worn

43. Rotor Type/Material	(Squirrel Aluminum) Squirrel Cage Aluminum Die Cast
44. Growler Test	(Pass) Pass
45. Number of Rotor Bars	44
46. Rotor Condition	acceptable
47. List the Parts needed for the Repair Below (2) 6312ZZ C3 bearings	
48. Signature of Technician that Disassembled Motor	Brian Goines

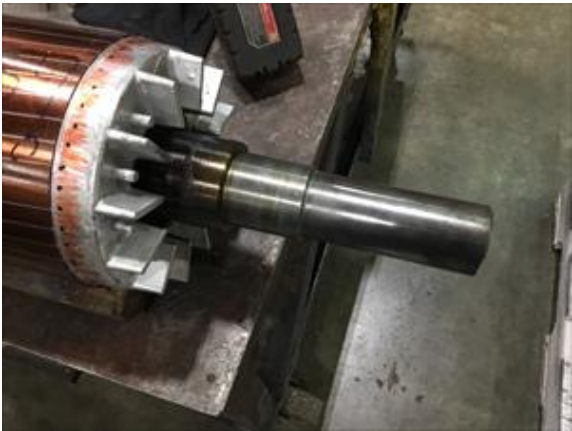
51. Coupling Fit Closest to Bearing Housing			
0 Degrees	90 Degrees	120 Degrees	
2.1245	2.1245	2.1245	
52. Coupling Fit Closest to the end of the Shaft			
0 Degrees	60 Degrees	120 Degrees	
2.1245	2.1245	2.1245	
53. Drive End Bearing Shaft Fit			P65
0 Degrees	60 Degrees	120 Degrees	
2.3625	2.3625	2.3625	
60mm = 2.3622 Pressfit tolerance is from 2.3623 to 2.3628

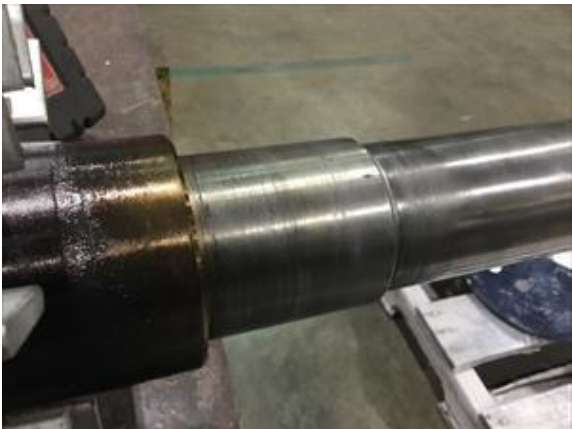
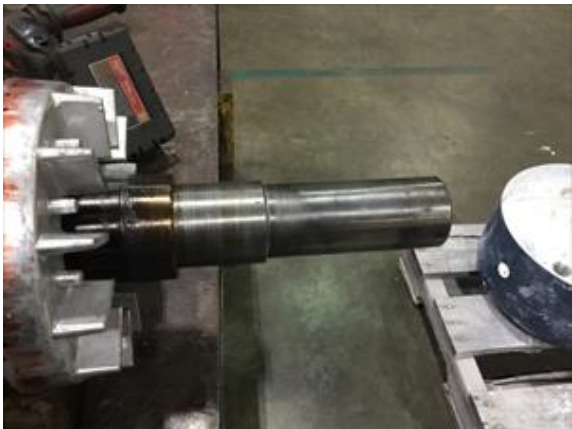
54. Drive End Bearing Shaft Fit Condition	(P) Pass	P66
---	----------	-----

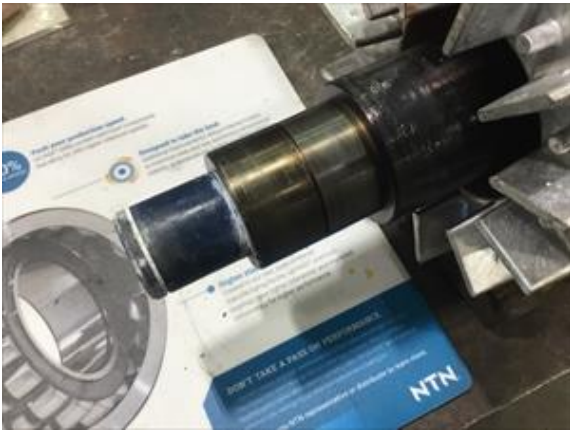
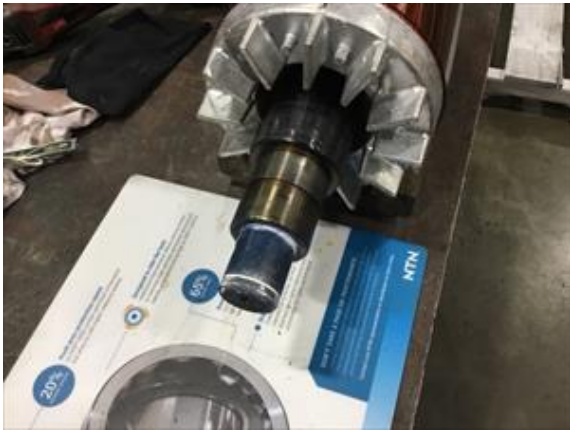
55. Opposite Drive End Bearing Shaft Fit

0 Degrees	60 Degrees	120 Degrees
2.3625	2.3627	2.3625

60mm = 2.3622 Pressfit tolerance is from 2.3623 to 2.3628

(P) Pass

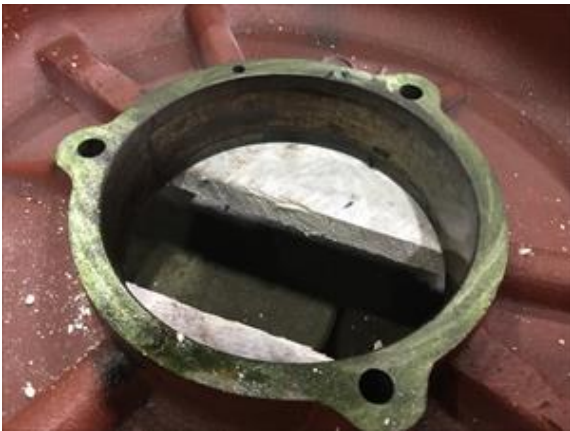
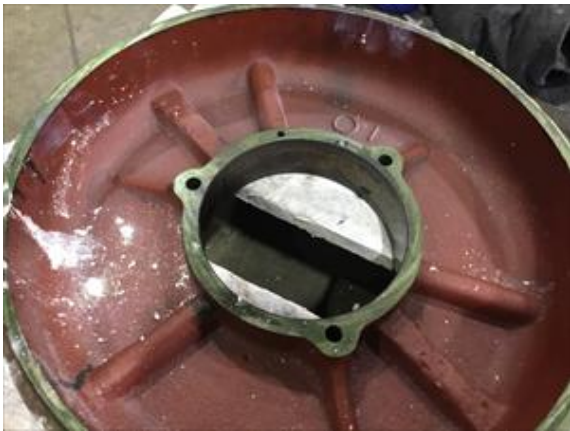
58. Drive End - Endbell Bearing Fit

0 Degrees	60 Degrees	120 Degrees
5.1205	5.1207	5.1207

130mm = 5.1181 Tolerance is from 5.1181 to 5.1191

(F) Fail

64. List Machine Work Needed Below  
*Again both endbells need to be bored and bushed*

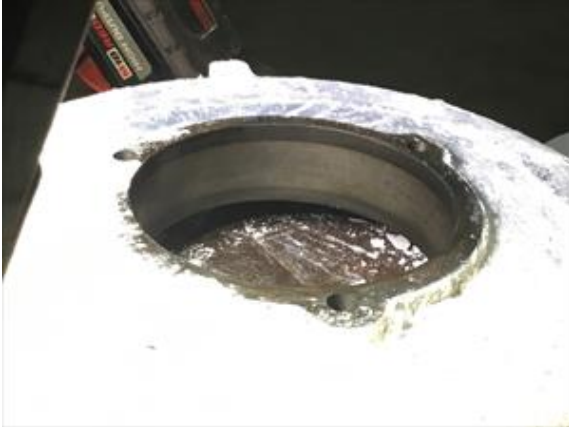
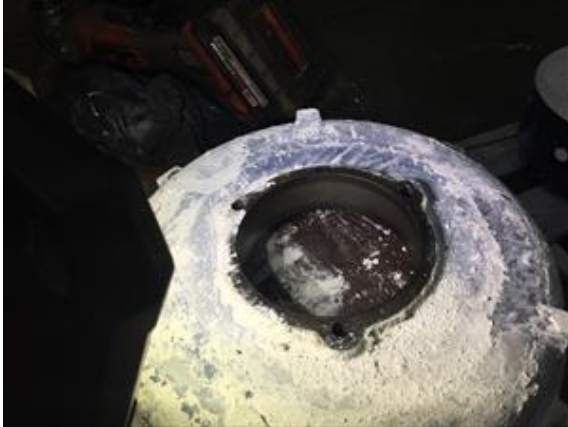
60. Opposite Drive End - Endbell Bearing Fit

0 Degrees	60 Degrees	120 Degrees
5.1208	5.121	5.1207

130mm = 5.1181 Tolerance is from 5.1181 to 5.1191

61. Opposite Drive End - Endbell Bearing Fit Condition (F) Fail
