**AC Inspection as Found**  
**Carlisle SynTec Inc. Motor Shop.**  
1201 Scott Street  
Senatobia, MS 38668

**AC Inspection - Rev. 2**

| Product Number: | 5KAF511SAA323 |
| Serial Number: | LJFT329U001 |

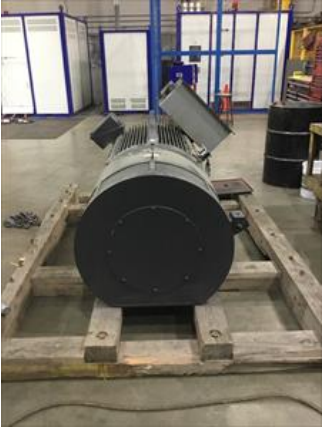
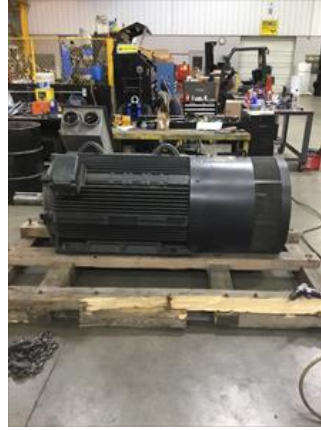
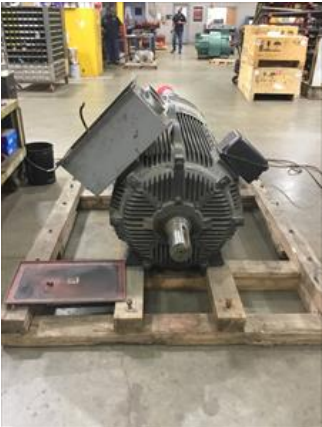
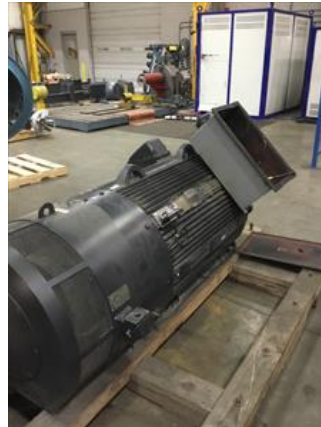
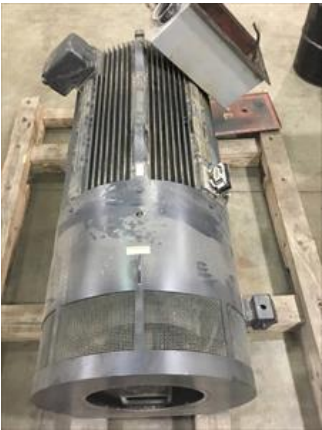
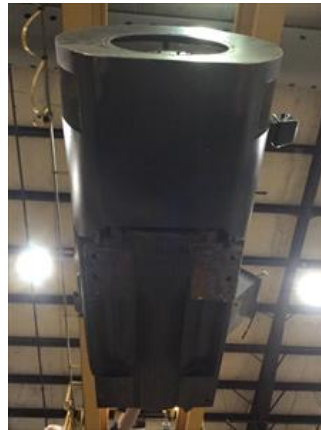
3. Photos of all six sides of the machine.

*Encoder 13/16 on the shaft  
Motor is a rewind*

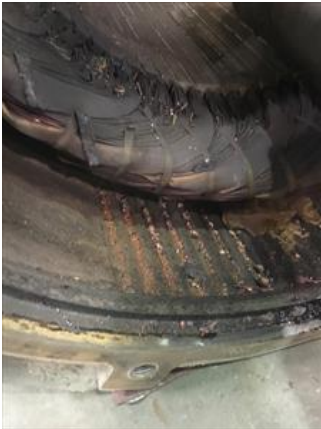
| 21. | Winding Resistance | P21 | |

| 20. | Insulation Resistance/Megger | 0 Megohms | |
| | 1-2 | 1-3 | 2-3 |
| | 0 | 0 | 0 |
| | Failed | | |

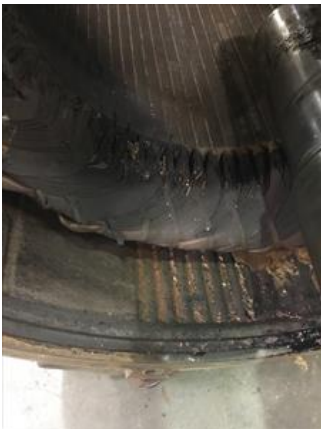
| 24. | Stator Condition | failed P24 | |

| 22. | Perform Surge Test | (F) Fail | |

68. Failure locations  
Winding failed

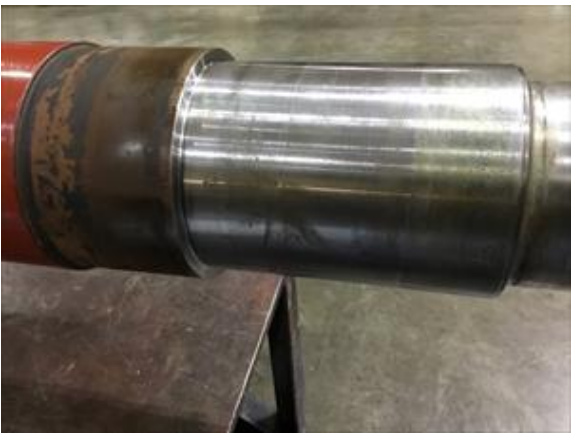
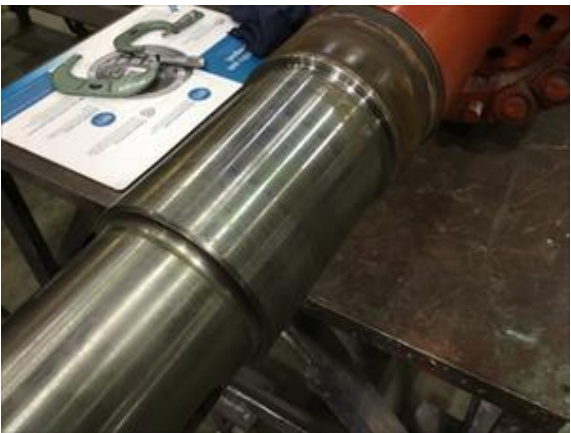
| 55. | Drive End Bearing Shaft Fit | | |

| | 4.7252 | 4.7252 | 4.7252 |
| | 120mm = 4.7244 Pressfit tolerance is from 4.7249 to 4.7255 | | |
| 56. | Drive End Bearing Shaft Fit Condition | (P) Pass | |

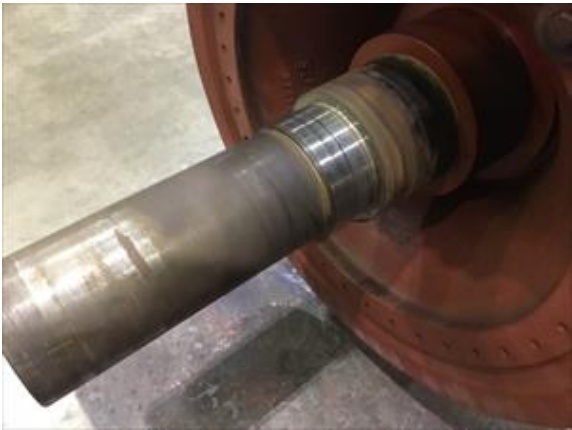
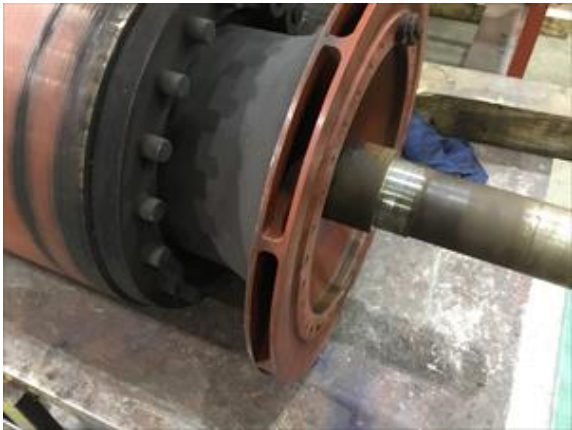
57. Opposite Drive End Bearing Shaft Fit

| 0 Degrees | 60 Degrees | 120 Degrees |
|---|---|---|
| 2.9533 | 2.9533 | 2.9533 |

75mm = 2.9527 Pressfit tolerance is from 2.9529 to 2.9534

(P) Pass

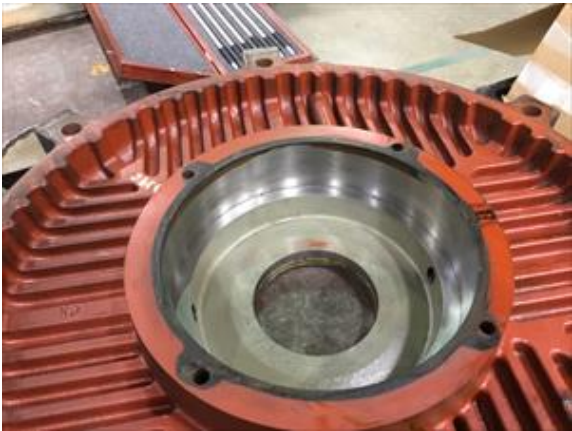
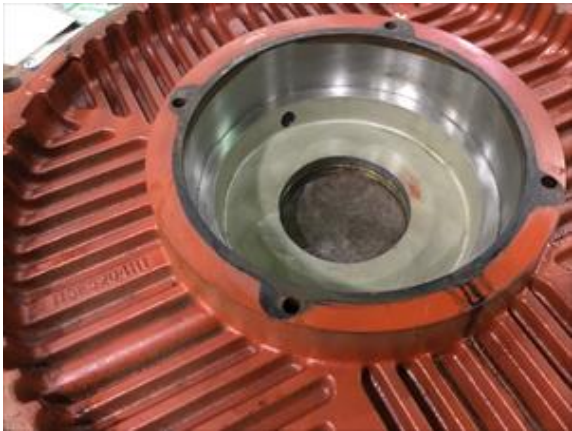
60. Drive End - Endbell Bearing Fit

| 0 Degrees | 60 Degrees | 120 Degrees |
|---|---|---|
| 10.2375 | 10.2375 | 10.2375 |

260mm = 10.2362 Tolerance is from 10.2362 to 10.2375

(P) Pass

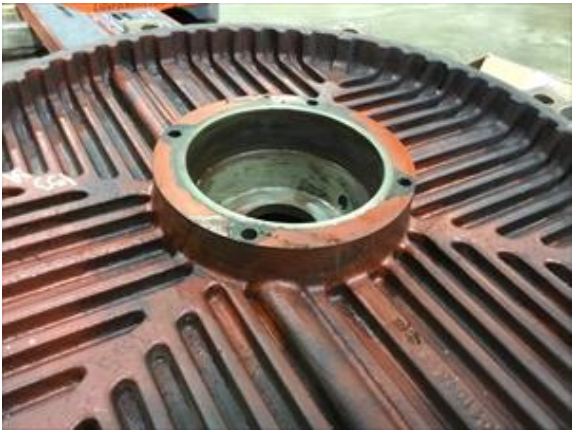
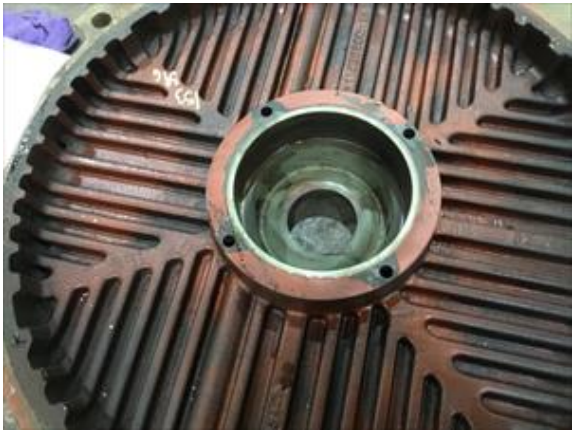
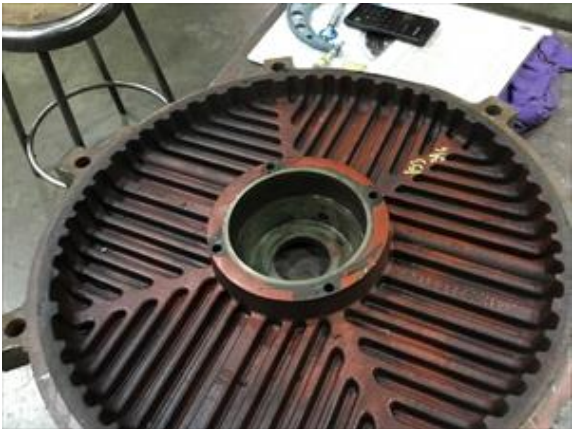
62. Opposite Drive End - Endbell Bearing Fit

| 0 Degrees | 60 Degrees | 120 Degrees |
|---|---|---|
| 6.3002 | 6.3002 | 6.3002 |

160mm = 6.2992 Tolerance is from 6.2992 to 6.3002

63. Opposite Drive End - Endbell Bearing Fit Condition (P) Pass
