**AC Inspection as Found**  
**Carlisle SynTec Inc. Motor Shop.**  
1201 Scott Street  
Senatobia, MS 38668

**AC Inspection - Rev. 2**

Location: Shop  
Serial Number: LJFT310S029  
Description: 2 Hp Motor

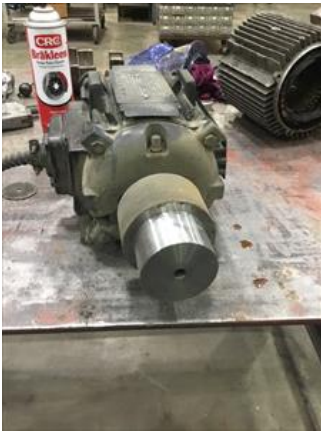
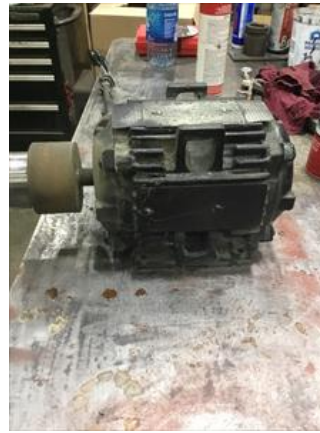
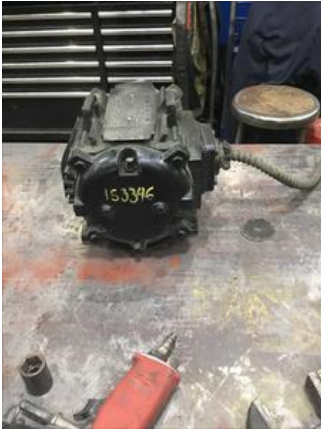
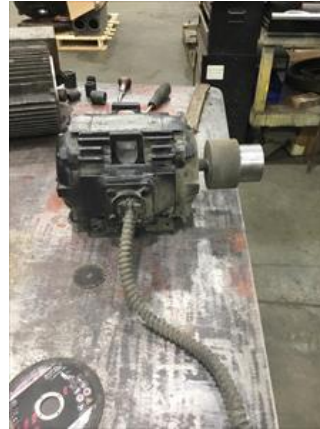
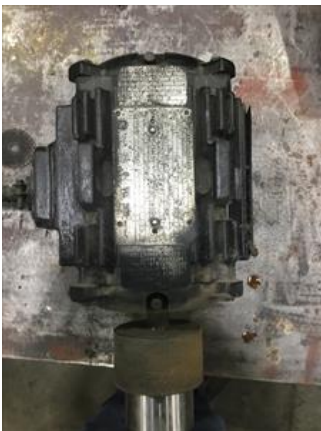
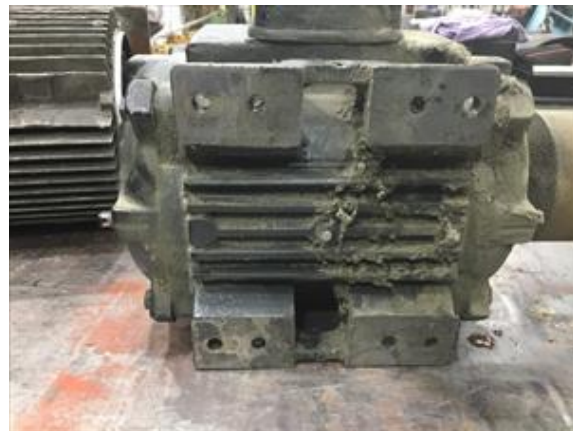
| ● 3. Photos of all six sides of the machine. | | P3 |

4. Describe the Overall Condition of the Equipment as Received  
*Good*

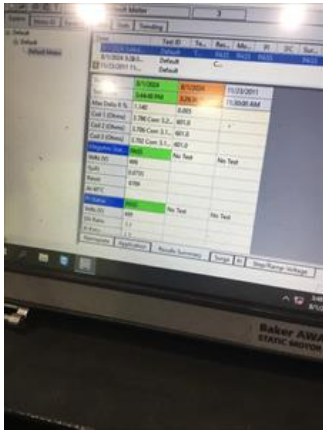
18.	Insulation Resistance/Megger	2789 Megohms	P18
-----	------------------------------	--------------	-----

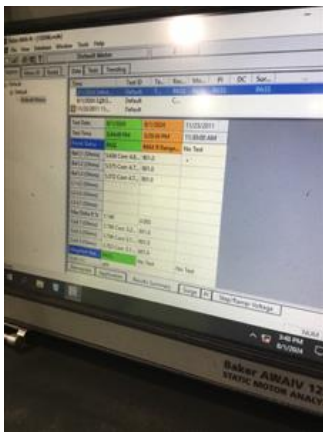
19.	Winding Resistance		P19
-----	--------------------	--	-----

1-2

1-3

2-3

5.636

5.575

5.572

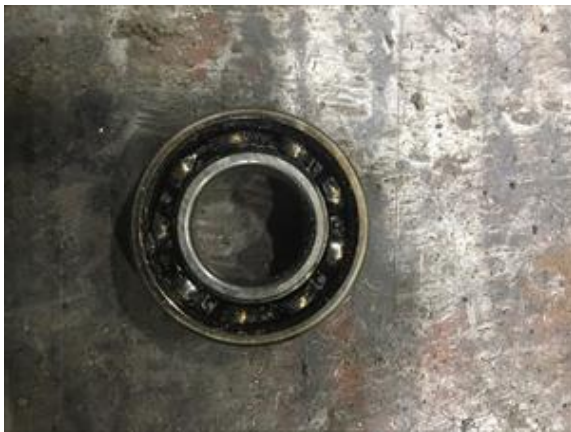
25. Drive End Bearing Brand	c and u 6205z
26. Drive End Bearing Number-	6205z
27. Drive End Bearing Qty.	1
28. Drive End Bearing Type	(Ball) Ball Bearing
29. Drive End Lubrication Type	(Grease) Grease Lubricated
30. Drive End Bearing Insulation or Grounding Device?	none
31. Drive End Wavy Washer/Snap-Ring Other Retention Device?	none
32. Drive End Bearing Condition	good

*2-6205 2rs bearings*

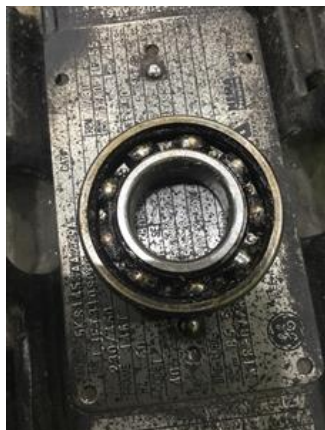
33. Opposite Drive End Bearing Brand	c&u
34. Opposite Drive End Bearing Number-	6205z
35. Opposite Drive End Bearing Qty.	1
36. Opposite Drive End Bearing Type	(Ball) Ball Bearing
37. Opposite Drive End Lubrication Type	(Grease) Grease Lubricated
38. Opposite Drive End Bearing Insulation or Grounding Device?	none
39. Opposite Drive End Wavy Washer/Snap-Ring Other Retention Device?	wavy washer
