AC Inspection as Found

UNITED SOLUTIONS
1052 INDUSTRIAL PARK RD
SARDIS, MS 38666

AC Inspection - Rev. 2

Hi-Speed Job Number:	152050
Manufacturer:	US Motors/Nidec
Serial Number:	R087441476-0002M0001
HP/kW:	25 (HP)
RPM:	2905 (RPM)
Frame:	256JM
Voltage:	460
Current:	29 (Amps)
Phase:	Three
Hz:	60 (Hz)
Service Factor:	1.15
Enclosure:	DP
# of Leads:	12
J-box Included:	Half
Coupling/Sheave:	None
Date Received:	02/20/2024
Bearing RTDs:	No
Stator RTDs:	No
Repair Stage:	Teardown Inspection
Rewind:	No
Shaft Machined Fit Repairs Required:	Yes
Bearing Housing Machined Fit Repairs Required:	No
Bearing Type:	Rolling Element

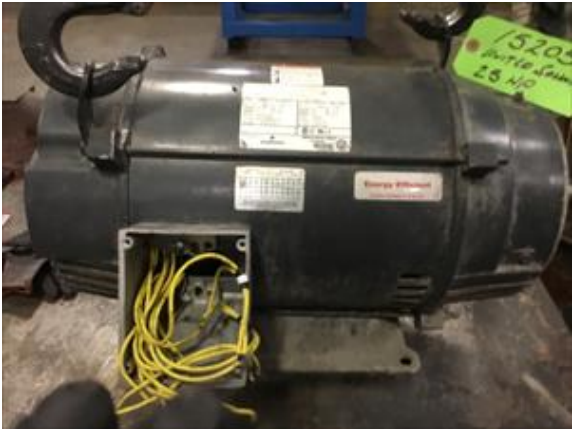
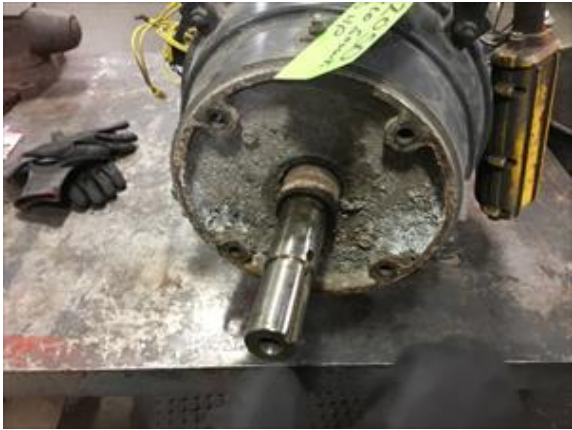
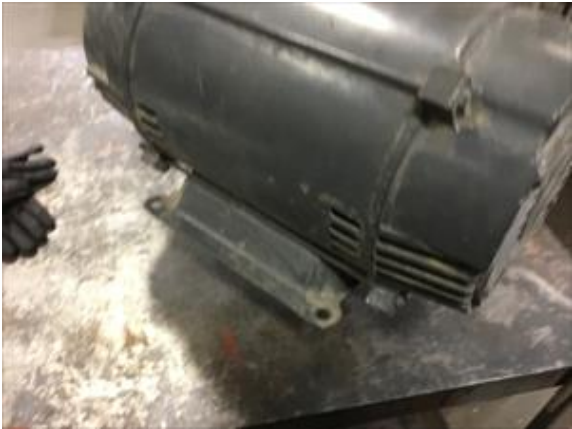
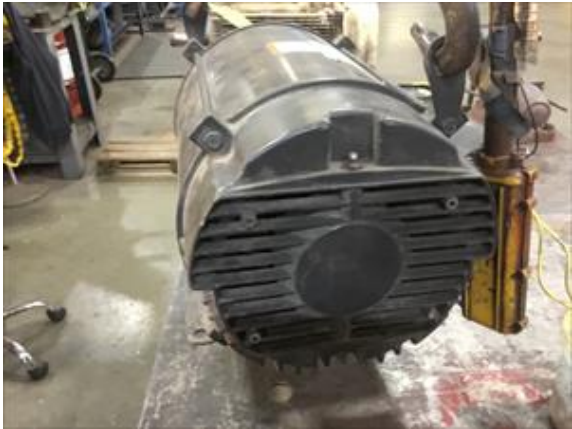
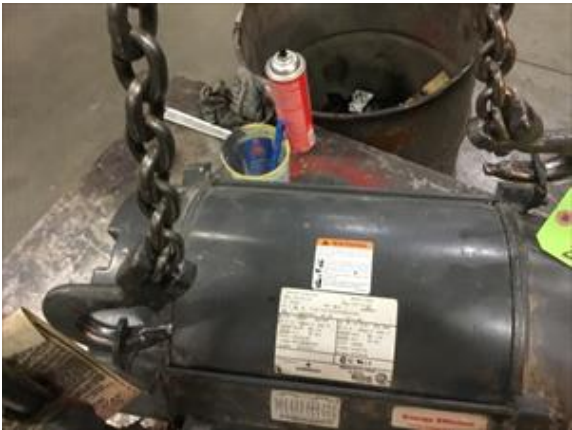
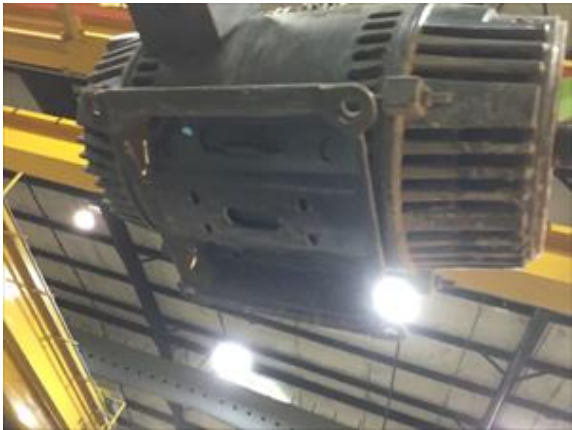
3. Photos of all six sides of the machine.

4. Describe the Overall Condition of the Equipment as Received
*Electrical good.
Bearing failure.*

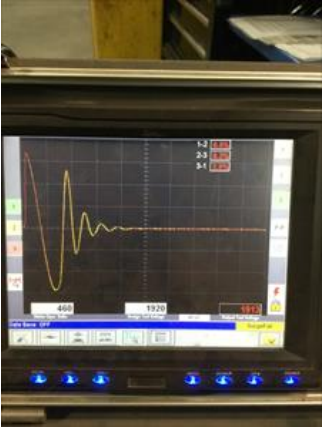
21. Perform Surge Test	(P) Pass	P21

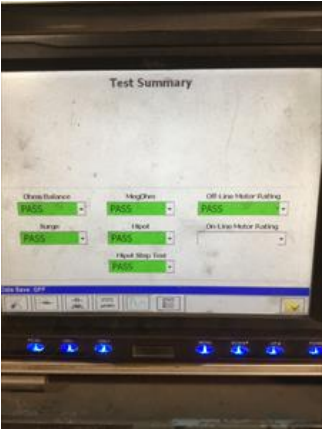
22. Number of Stator Slots	36	
23. Stator Condition	good	P23

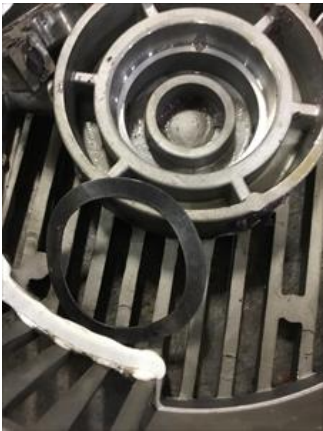
34.	Opposite Drive End Bearing Brand	peer	
35.	Opposite Drive End Bearing Number-	6207	
36.	Opposite Drive End Bearing Qty.	1	
37.	Opposite Drive End Bearing Type	(Ball) Ball Bearing	
38.	Opposite Drive End Lubrication Type	(Grease) Grease Lubricated	
39.	Opposite Drive End Bearing Insulation or Grounding Device?	none	
40.	Opposite Drive End Wavy Washer/Snap-Ring Other Retention Device?	wavy washer	P40

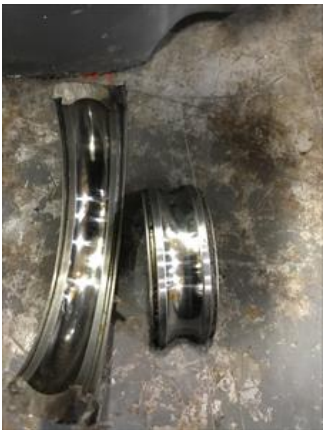
41.	Opposite Drive End Bearing Condition	good	P41
-----	--------------------------------------	------	-----

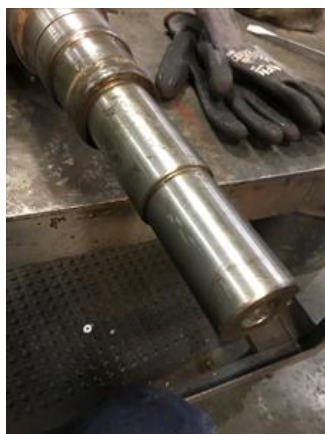
52. Coupling Fit Closest to Bearing Housing

0 Degrees

90 Degrees

120 Degrees

1.2535

1.254

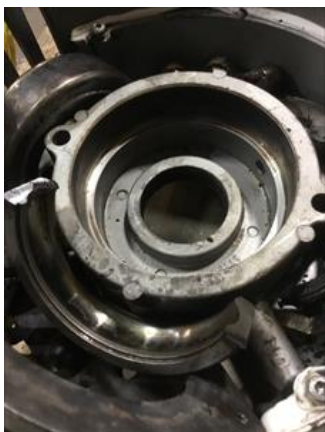
0 Degrees	60 Degrees	120 Degrees
4.33	4.3299	4.3289
4.3307/4.3316

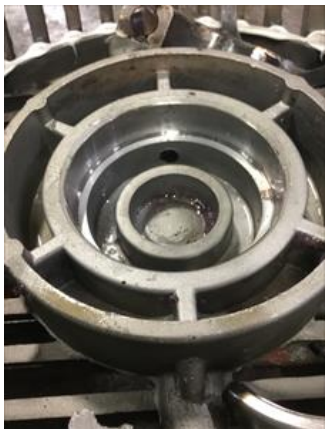
0 Degrees	60 Degrees	120 Degrees
2.839	2.8369	2.834
2.8346/2.83532

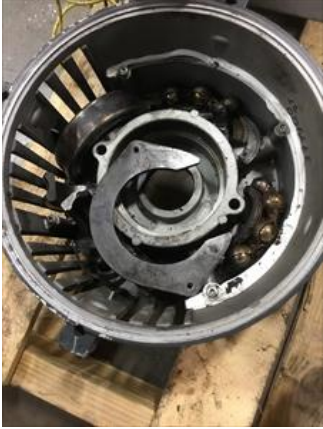
63. Bearing Cap Condition		P63
Drive End Bearing Cap	Opposite Drive End Bearing Cap	
good	n/a
