Hi-Speed Industrial Service
7030 Ryburn Dr
Millington, Tn 38053
901-873-5300

AC Inspection as Found

KTG USA
400 Mahannah
Memphis, TN 38107

Description: 125 HP AC

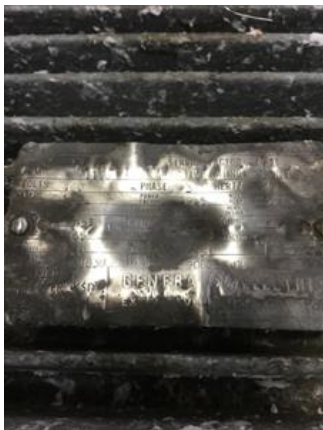
P2

2. Nameplate Picture

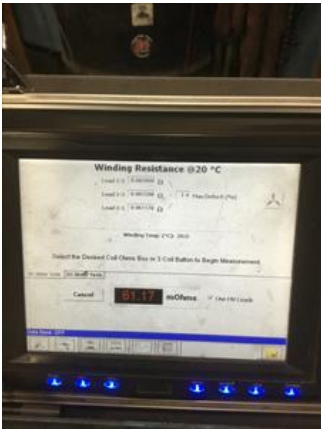
P19

19. Winding Resistance

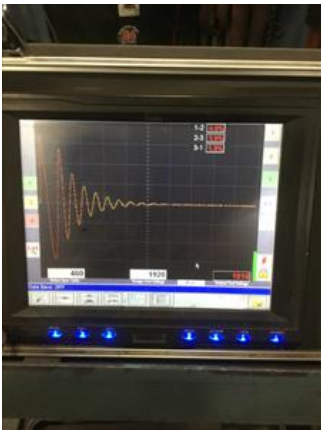
P20

20. Perform Surge Test

(P) Pass

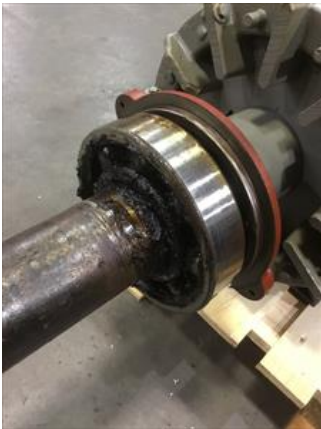
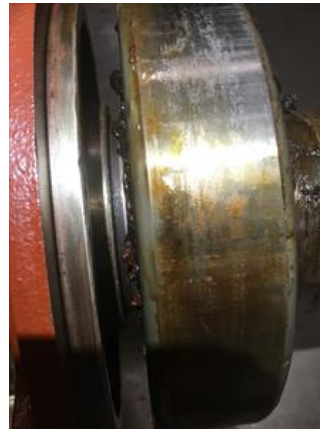
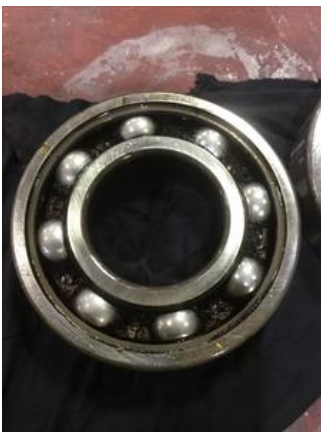
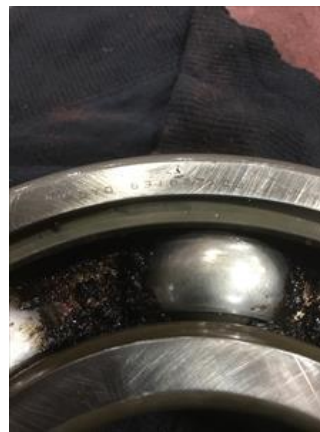
P25

Good condition. Drive end bearing spun on shaft and shaft requires repair. Passed all electrical tests. Drive end bearing was electric fluted. Recommend adding AEGIS ring and insulated bearing.

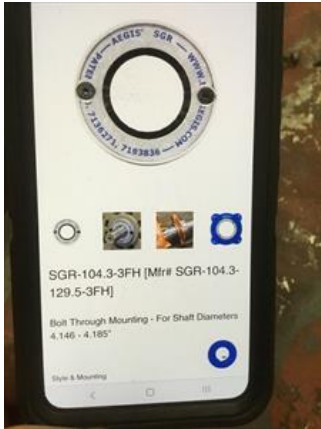
P47

47. List the Parts needed for the Repair Below

Fan

6318 ZZ C3

6318 ZZ C3 insulated

Aegis ring SGR-104.3-3FH

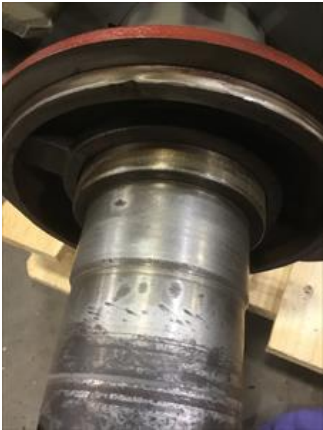
53. Drive End Bearing Shaft Fit

0 Degrees	60 Degrees	120 Degrees
3.5428	3.5429	3.5425

Tolerance is 3.5434-3.5440
Bearing pulled of shaft. Requires repair.

54. Drive End Bearing Shaft Fit Condition (F) Fail

Drive end bearing

Spun on shaft.

Repair drive end shaft bearing fit. Normal turn and metalizing.

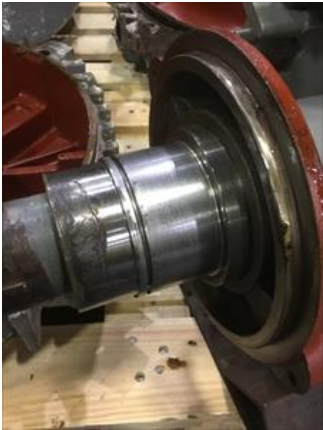
P55

55. Opposite Drive End Bearing Shaft Fit

0 Degrees	60 Degrees	120 Degrees
3.5435	3.5435	3.5435

Tolerance is 3.5434-3.5440

56. Opposite Drive End Bearing Shaft Fit Condition (P) Pass

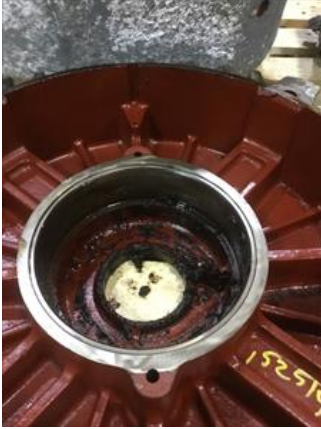
P58

58. Drive End - Endbell Bearing Fit

59. Drive End - Endbell Bearing Fit Condition

(P) Pass

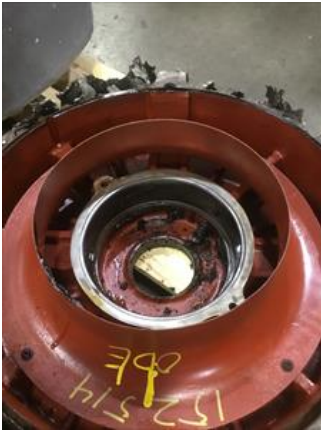
P60

60. Opposite Drive End - Endbell Bearing Fit

61. Opposite Drive End - Endbell Bearing Fit Condition

(P) Pass
