AC Inspection as Found

MIG Construction (0004123)

AC Inspection - Rev. 2

Hi-Speed Job Number:	153239
Manufacturer:	Other
Product Number:	7-850095-01-ON
Spec/ID #:	NA
Serial Number:	BT04
HP/kW:	10 (HP)
RPM:	1430 (RPM)
Frame:	S215T
Voltage:	230 / 460
Current:	32.2/16.1 (Amps)
Phase:	Three
Hz:	60 (Hz)
Enclosure:	DP
# of Leads:	9
J-box Included:	Half
Coupling/Sheave:	Sheave
Date Received:	08/01/2024
Bearing RTDs:	No
Stator RTDs:	No
Repair Stage:	Teardown Inspection
Rewind:	Yes
Heaters:	No
Winding Type :	Random Wound
Bearing Type:	Rolling Element

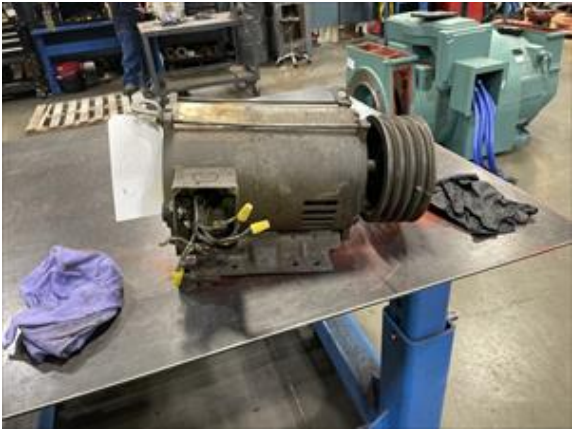
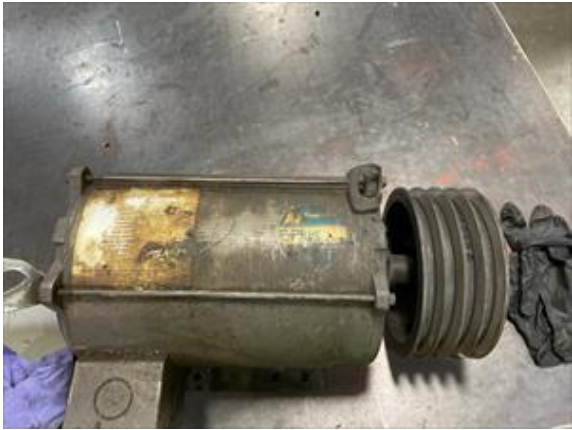
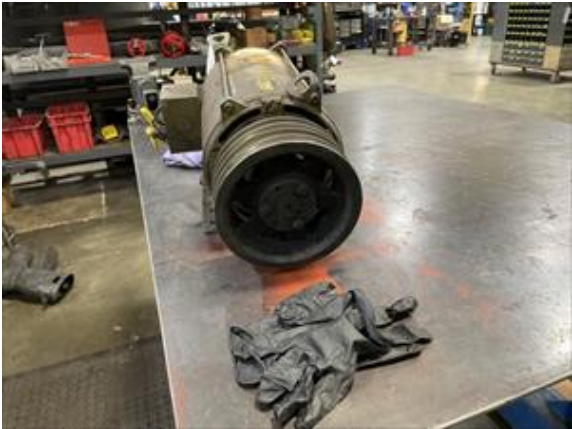
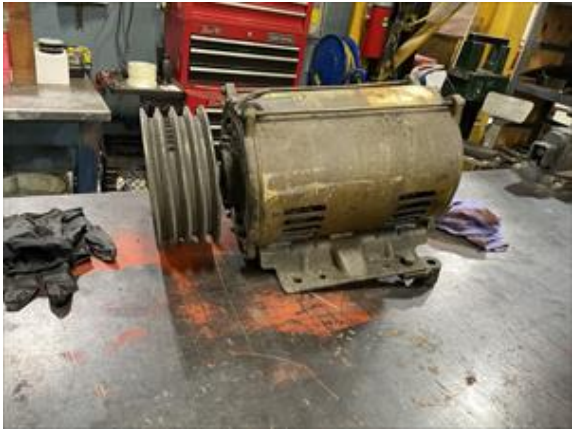
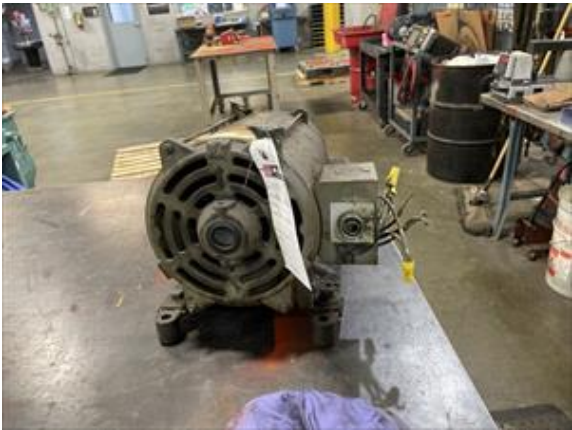
P3

4. Describe the Overall Condition of the Equipment as Received
Stator is in need of rewind due to failing surge test

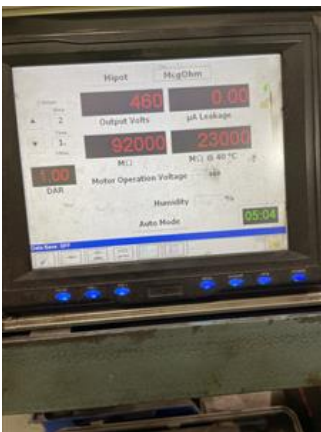
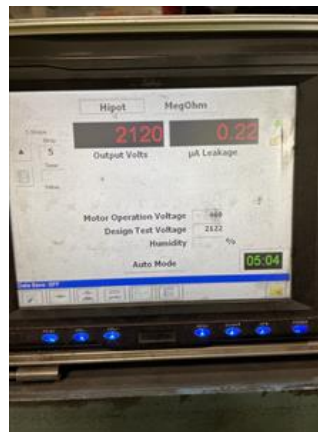
19.	Insulation Resistance/Megger	92000 Megohms	P19
-----	------------------------------	---------------	-----

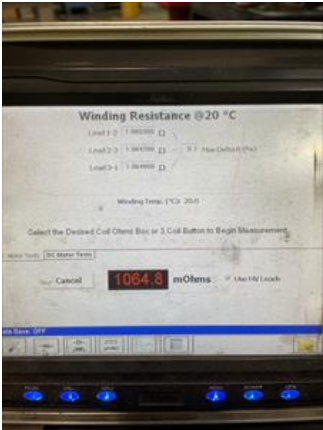
20. Winding Resistance		P20
1-2	1-3	2-3
1.0653	1.0648	1.0647

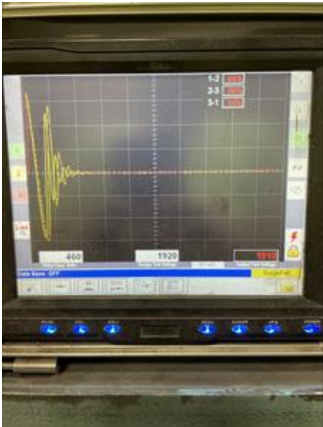
21. Perform Surge Test	(F) Fail	P21

Root Cause of Failure			
67.	Failure locations		
	Failed surge test		
68.	Root cause of failure		
	Root cause is a break down in insulation between phases

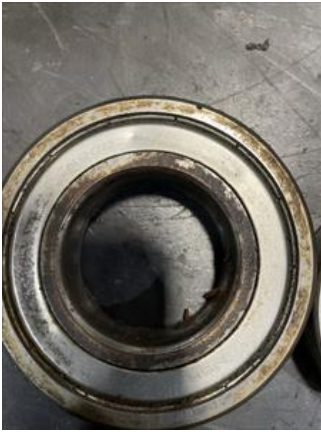
P27

6208z

*Shielded on one side*

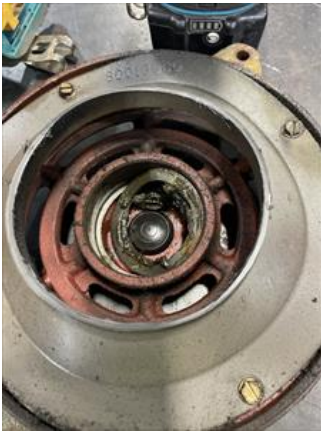
P40

40. Opposite Drive End Wavy Washer/Snap-Ring Other Retention Device? wavy washer
