## AC Inspection as Found

USG Interiors  
850 No Broadway  
Greenville, MS 38701

### AC Inspection - Rev. 2

Description: 50 Hp

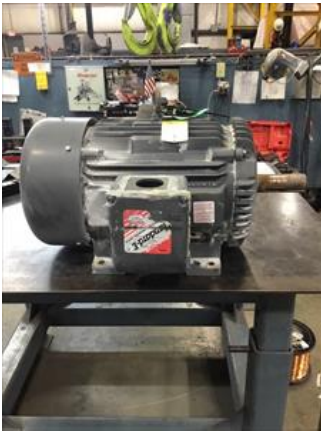
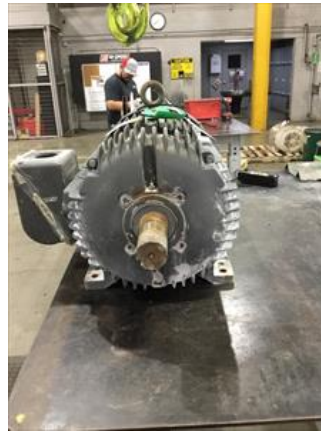
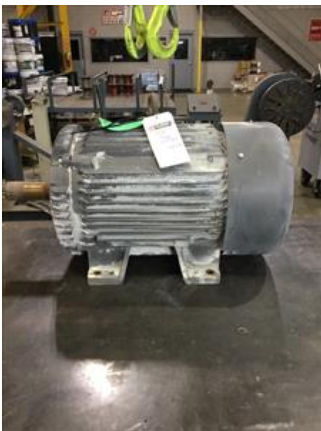
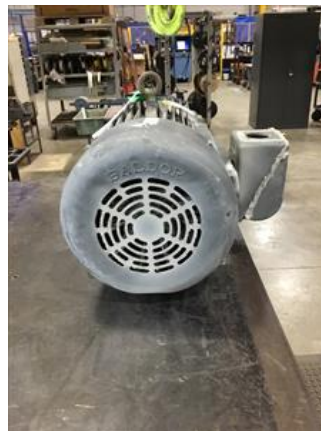
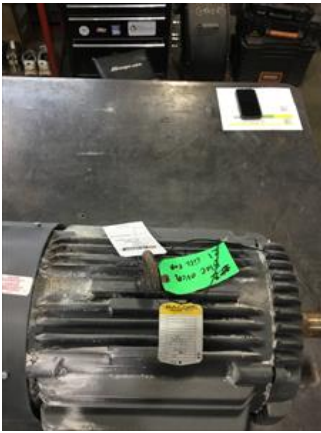
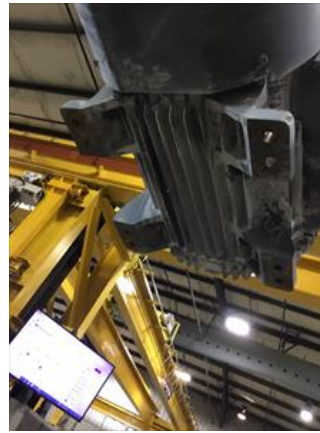
P3

4. Describe the Overall Condition of the Equipment as Received  
*Drive end bearing crashed dropped into the iron causing winding fail*

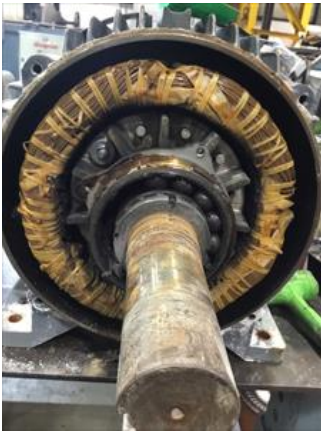
5. Does Shaft Turn Freely? (N) No P6  
*Turns but rough*

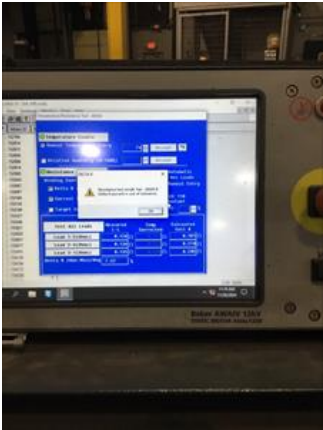
P23

18. Insulation Resistance/Megger

0 Megohms

19. Winding Resistance

1-2

1-3

2-3

.126

.136

.135

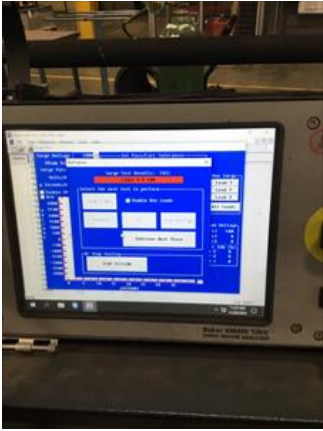
P24

20. Perform Surge Test

(F) Fail

| 47. List the Parts needed for the Repair Below<br><i>6312 C3 bearing<br/> 6309 C3 bearing<br/> Rewind</i> | |

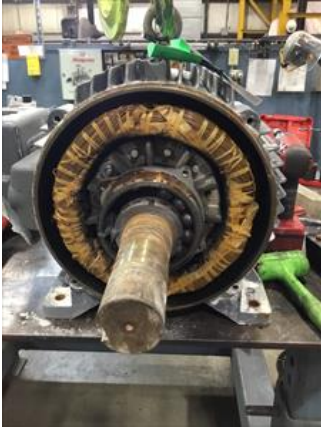
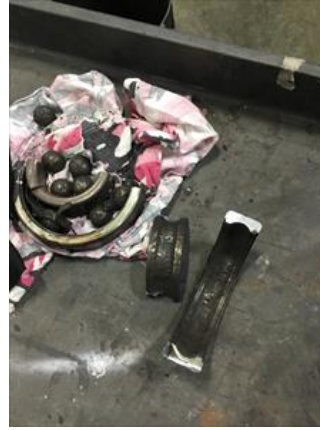
P36

32. Drive End Bearing Condition

crashed

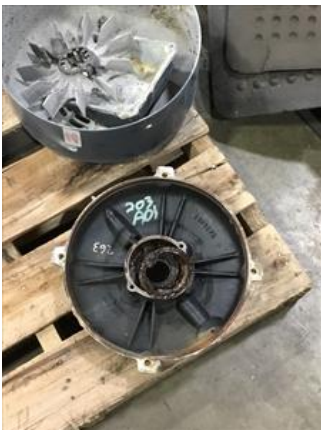
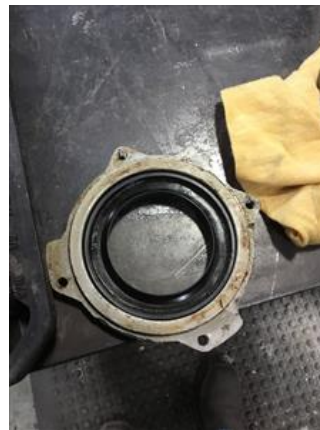
P43

Plastic piece in ode bearing cap

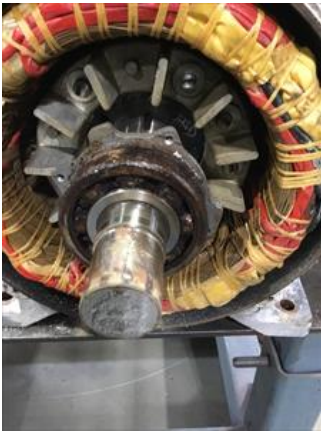
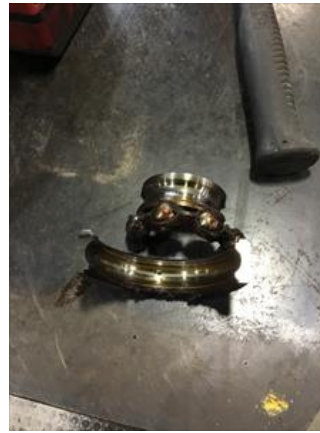
P44

40. Opposite Drive End Bearing Condition

dirty mixed grease

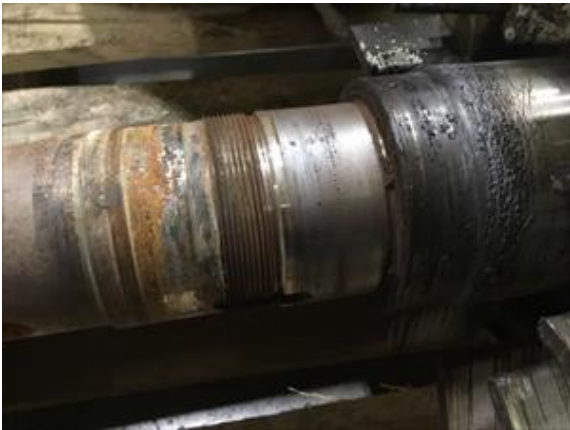
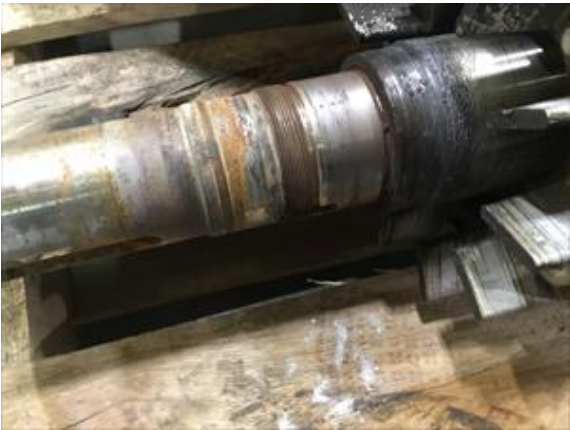
53. Drive End Bearing Shaft Fit

0 Degrees	60 Degrees	120 Degrees
2.353	2.353	2.353

60mm = 2.3622 Pressfit tolerance is from 2.3623 to 2.3628

54. Drive End Bearing Shaft Fit Condition

(F) Fail

*DE shaft fit needs to be metalized and both endbells need to be bored and bushed*

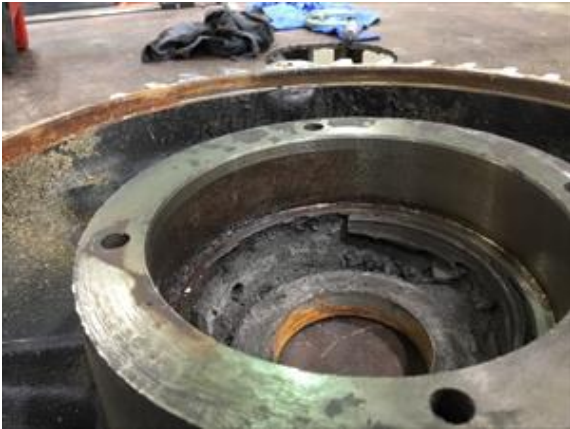
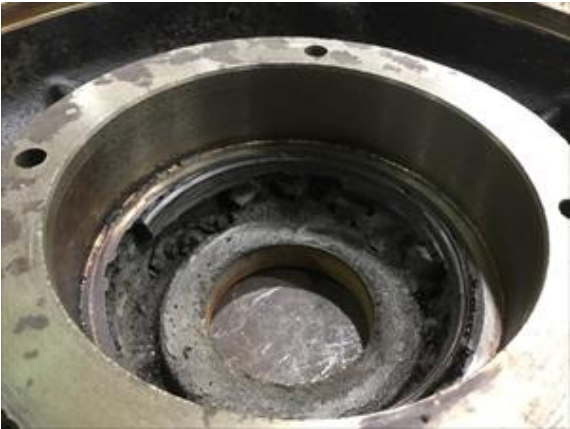
58. Drive End - Endbell Bearing Fit

0 Degrees	60 Degrees	120 Degrees
5.1202	5.1201	5.12

130mm = 5.1181 Tolerance is from 5.1181 to 5.1191

59. Drive End - Endbell Bearing Fit Condition

(F) Fail

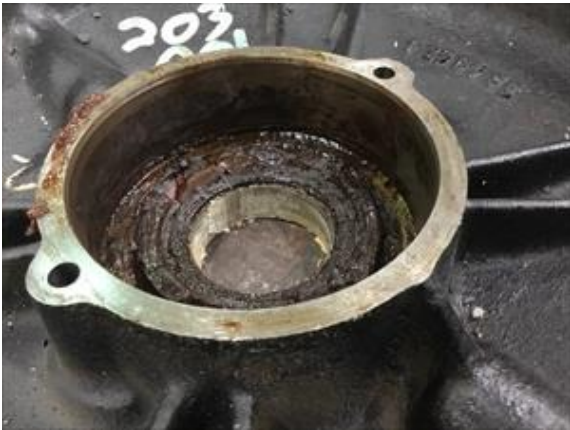
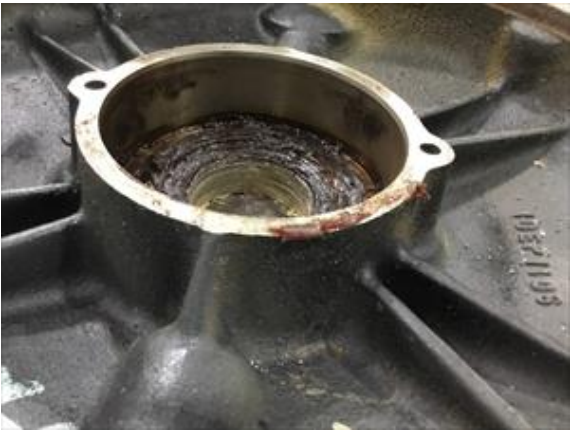
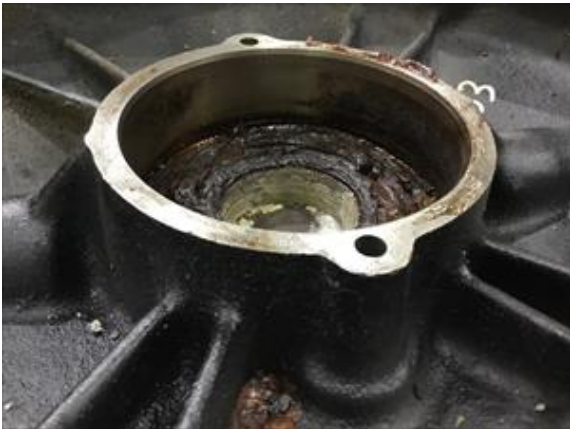
60. Opposite Drive End - Endbell Bearing Fit

0 Degrees	60 Degrees	120 Degrees
3.9392	3.9395	3.9394

100mm = 3.9370 Tolerance is from 3.9370 to 3.9379

61. Opposite Drive End - Endbell Bearing Fit Condition (F) Fail
