**American Yeast
2024 Annual Infrared Survey Report**

All electrical panels throughout the Memphis Plant were scanned using a

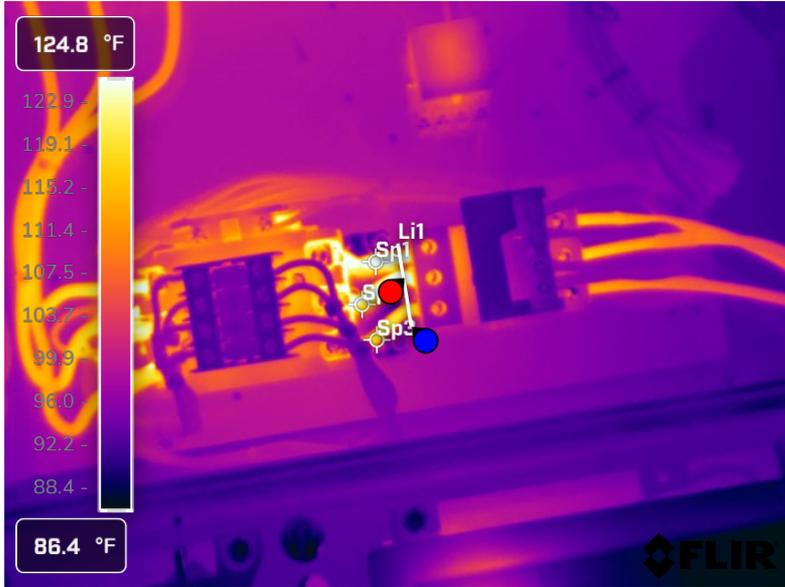
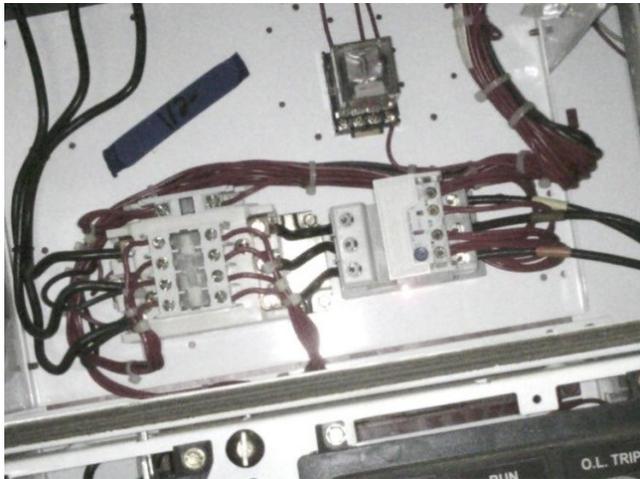
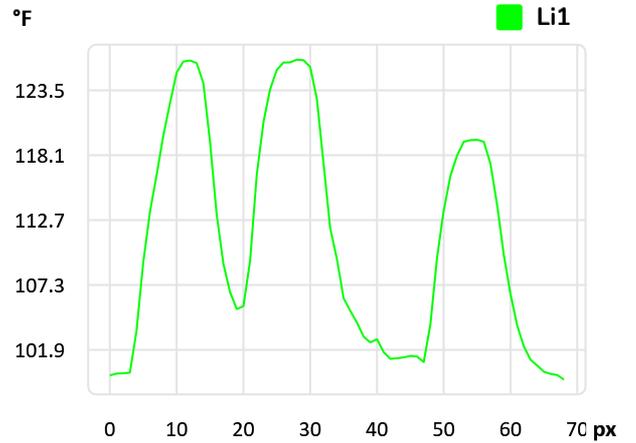
Sterile Molasses Tank Pump #1

Leads

Li1	
Max	126.1 °F
Avg	111.4 °F
Min	99.5 °F
Sp1	127.3 °F
Sp2	119.6 °F
Sp3	117.5 °F

Lead Connection

CLASS I

Wire may be undersized for the load or there may be a connection issue. Check amperage on each lead and ensure wire is rated for load. Also, ensure all connections are clean and tight.

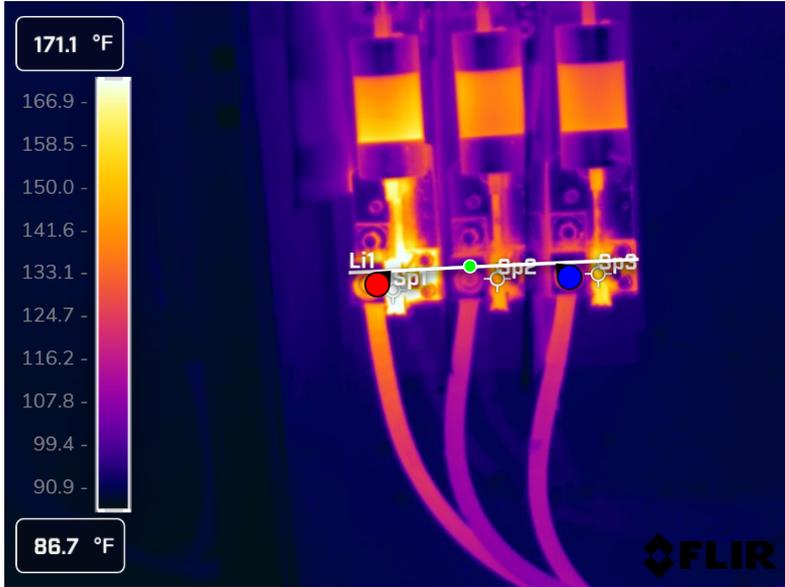
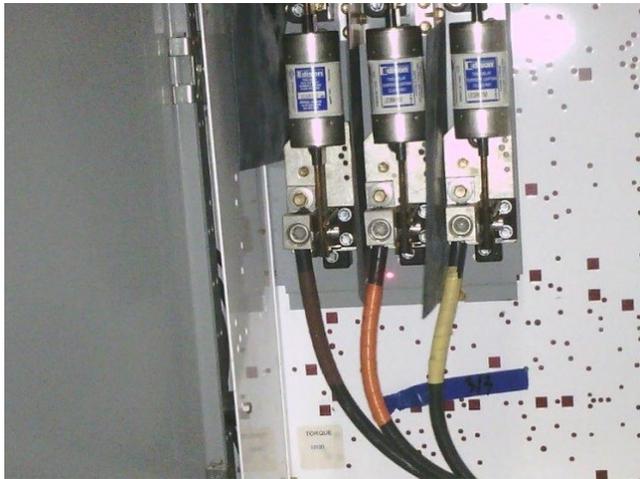
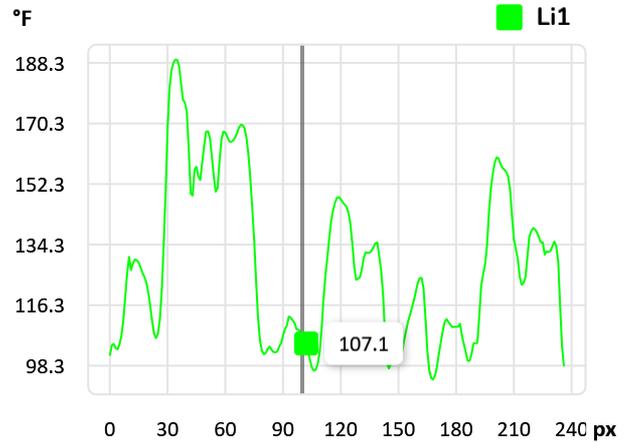
RVF2 Vacuum

A Phase Fuse Connection

Li1	
Max	189.3 °F
Avg	128.9 °F
Min	94.2 °F
Sp1	194.5 °F
Sp2	147.0 °F
Sp3	156.5 °F

Faulty Fuse Connection

CLASS II

A phase fuse connection on load side appears to have an issue. Check lead connection and fuse clip assembly. Clean and ensure a tight connection. Fuse holder assembly may need to be replaced due to wear.

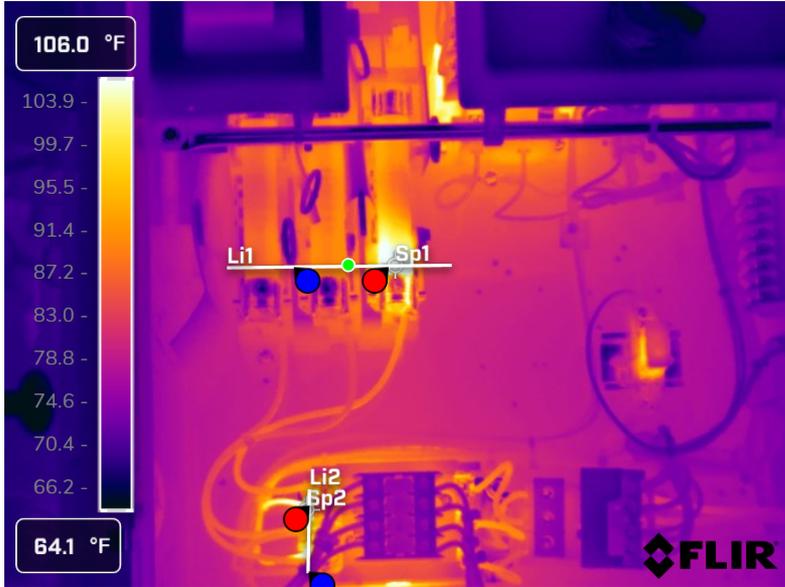
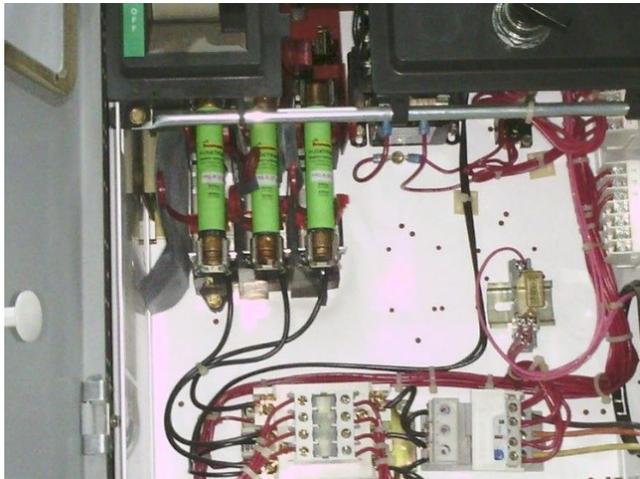
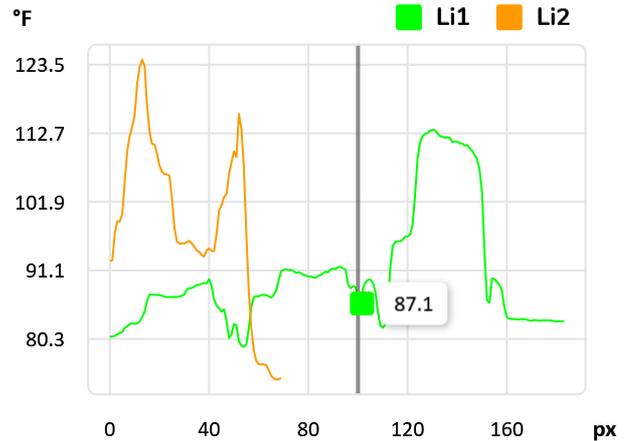
Supply Fan Turblex Rm

Fuse and lead connections

Li1	
Max	113.3 °F
Avg	90.6 °F
Min	79.1 °F
Li2	
Max	124.3 °F
Avg	98.4 °F
Min	74.0 °F
Sp1	111.5 °F
Sp2	109.7 °F

Faulty Fuse and lead connection

CLASS I

There appears to be two issues in this cabinet. The first issue is the C phase fuse on the load side. We recommend changing this fuse as it appears to have an internal issue. The second issue is likely a connection issue. Check connections on the terminal block ensuring a clean and tight connection.

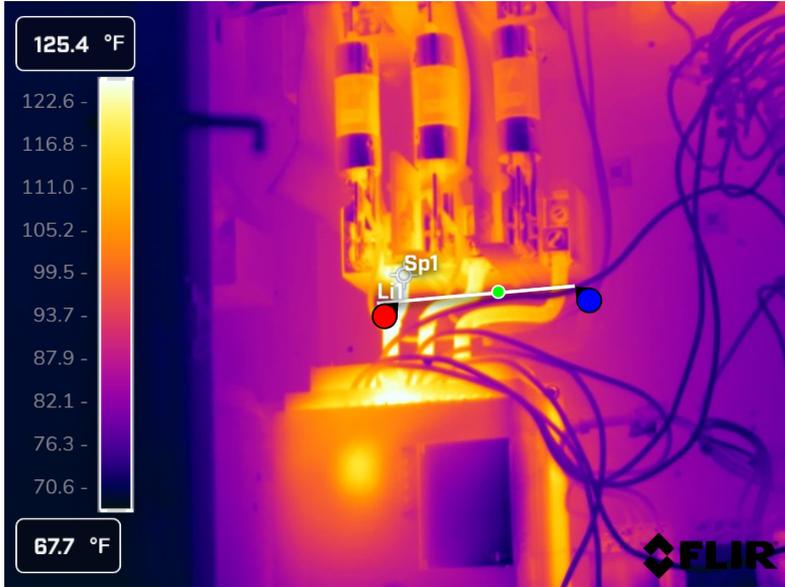
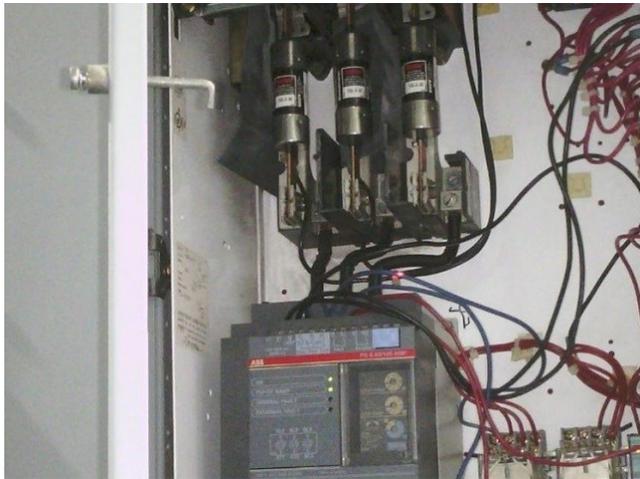
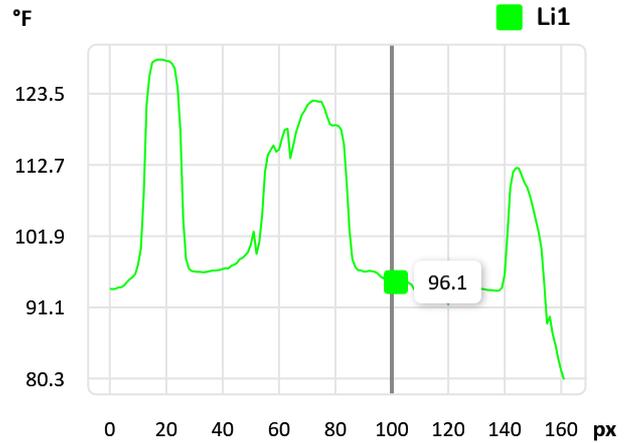
Warm Well Water Distribution Pump P1

A phase lead

Li1	
Max	128.7 °F
Avg	103.1 °F
Min	80.2 °F
Sp1	126.5 °F

Load/connection issue

CLASS I

Wire may be undersized for the load or there may be a connection issue. Check connections and check wire for rated load.

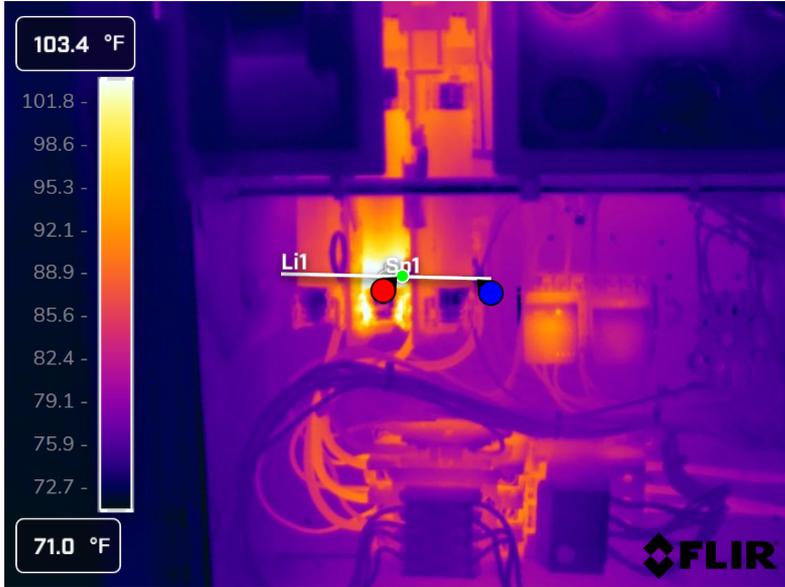
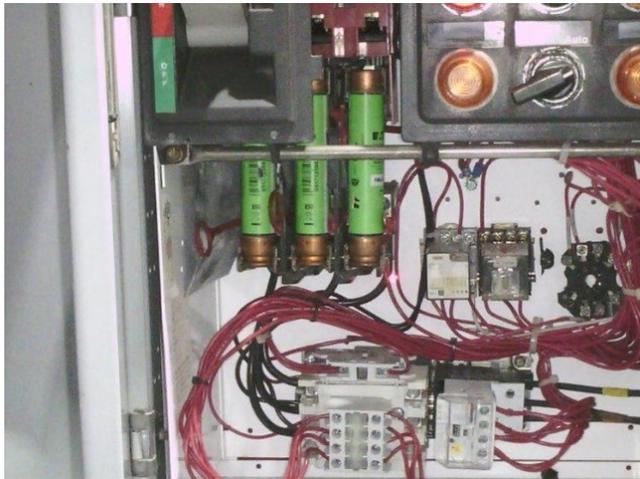
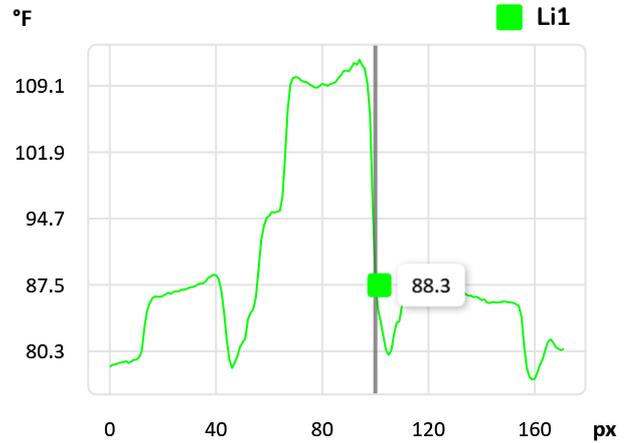
Waste water pit pump P2

B phase fuse

Li1	
Max	112.0 °F
Avg	89.9 °F
Min	77.3 °F
Sp1	110.3 °F

Weak/faulty fuse

CLASS I

B phase fuse appears to have an issue. It is recommended to change fuse as time allows. Ensure fuse holder/clip is in good shape and not worn or faulty.
