USG Greenville, MS April 2024 Infrared Survey Report

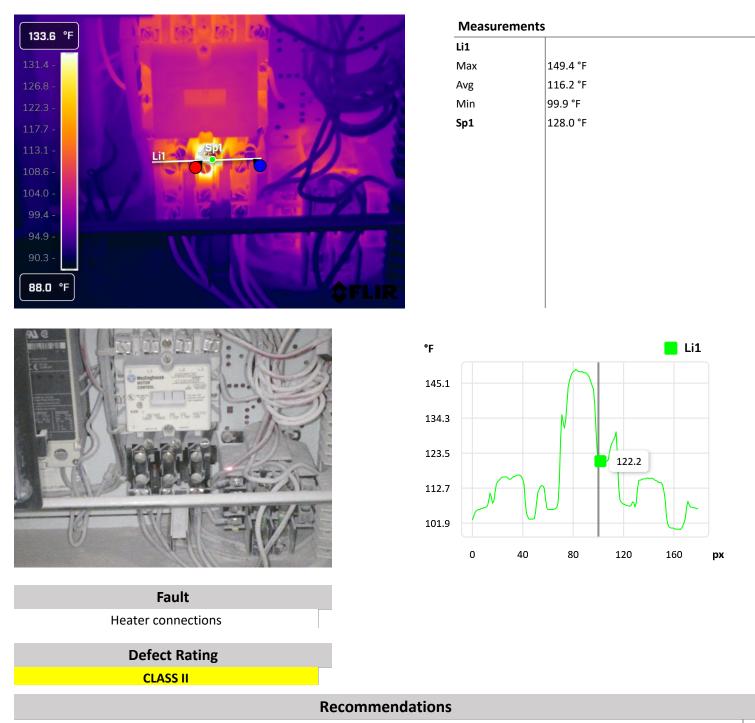
MCC 9B1 M0134 South 2x4 Hopper Conveyor

Thermal Heater

B phase thermal heater appears to have an issue. It is recommended to replace heater and ensure clean and tight connections.

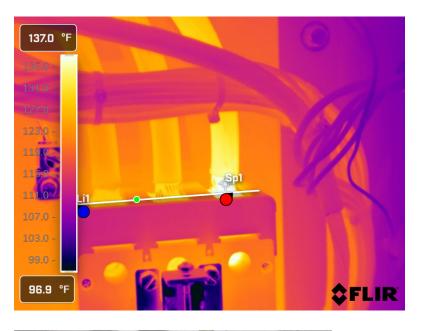
#1 Wisconsin Oven Line Side Main Breaker

Lead connection/lug

Avg 126.9 °F Min 117.7 °F	Li1		
Min 117.7 °F	Max	139.5 °F	
	Avg	126.9 °F	
Sp1 137.8 °F	Min	117.7 °F	
	Sp1	137.8 °F

Fault Connection issue Defect Rating CLASS I

IR image shows C phase incoming power lead to have a slight delta-T. Check connection ensuring the connection is clean and tight.

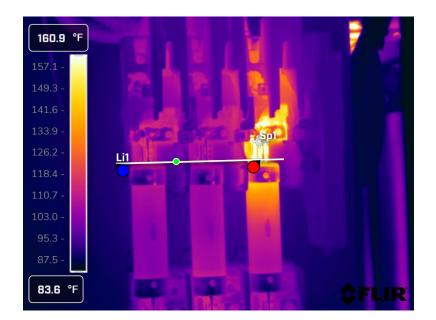
IHEI Oven Control Panel Main Power Disconnect

Fuse Clip

Li1		
Max	179.2 °F	
Avg	113.4 °F	
Min	91.7 °F	
Sp1	177.6 °F

Fault Loose worn fuse clip Defect Rating CLASS II

C phase fuse clip on line side appears to have an issue. Connection at fuse tab/clip may be loose and or dirty. Clean and ensure fuse tab/clip has tight connection.

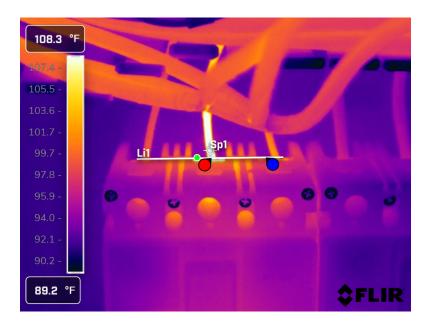
IHEI Oven Control Panel 105 MCP

lead connection

Li1		
Max	116.2 °F	
Avg	99.8 °F	
Min	93.9 °F	
Sp1	114.2 °F

Fault Connection issue Defect Rating CLASS I

IR image shows some slight delta-T on middle lead on 105 MCP. Check lead connection and ensure a clean and tight connection.

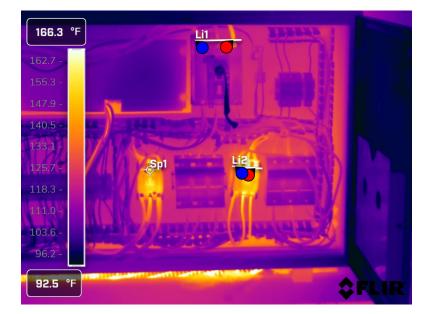
South Wrapper Heat Tunnel Unit Panel

Contactors/Main Breaker Line Side C Phase

Li1		
Max	150.5 °F	
Avg	129.1 °F	
Min	116.8 °F	
Li2		
Max	180.3 °F	
Avg	153.0 °F	
Min	117.8 °F	
Sp1	161.7 °F

Fault Contactor and connection issues

Defect Rating CLASS I

A couple of issues were found in this panel. The main breaker C phase connection on line side has a slight delta-T while the two contactors appears to have some heat present. These contactors were opening and closing every second which is likely hard on these components. It is recommended to check connection on main breaker and see if some settings and can be adjusted to help with the contactors opening and closing so often.
