QualiTest® Diagnostics

May 9, 2024

Tracy Irving
Bio-Energy Development
Memphis, TN

The following is a summary of findings from the Chiller vibration survey that was performed on May 9, 2024.

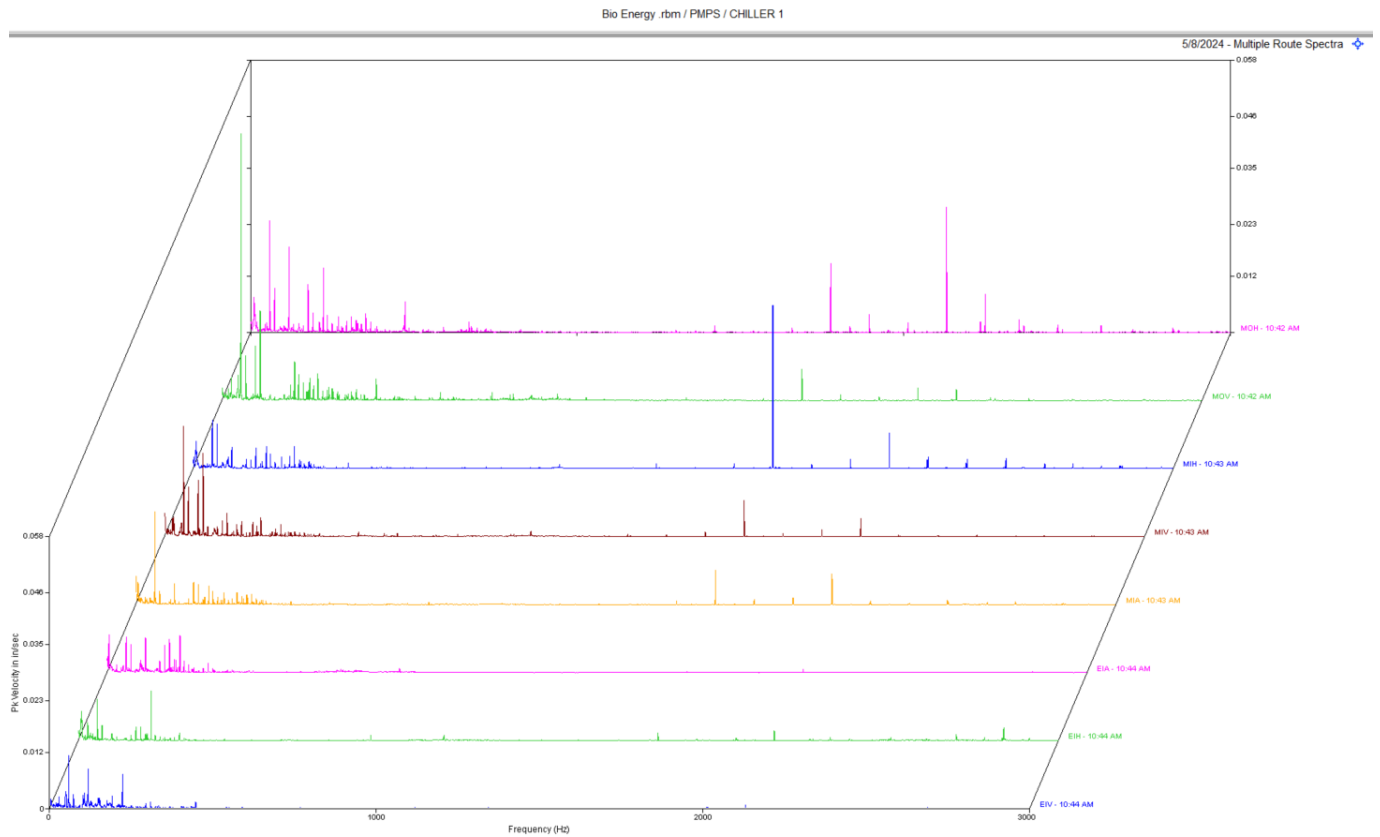
Chiller 1 CLASS I

There is a vibration peak at 30 x rpm which may be rotor bar pass frequency if rotor has 30 bars. Some sidebands of 2 x line frequency can also be seen.

This motor was recently reconditioned. Overall vibration is low, but there is some evidence of slight rotor eccentricity or air gap variation between the rotor and the stator. The motor was also under minimal load compared to Chiller 2. We recommend collecting more vibration data with motor under at least 70 % load to see if this vibration changes any based on load.

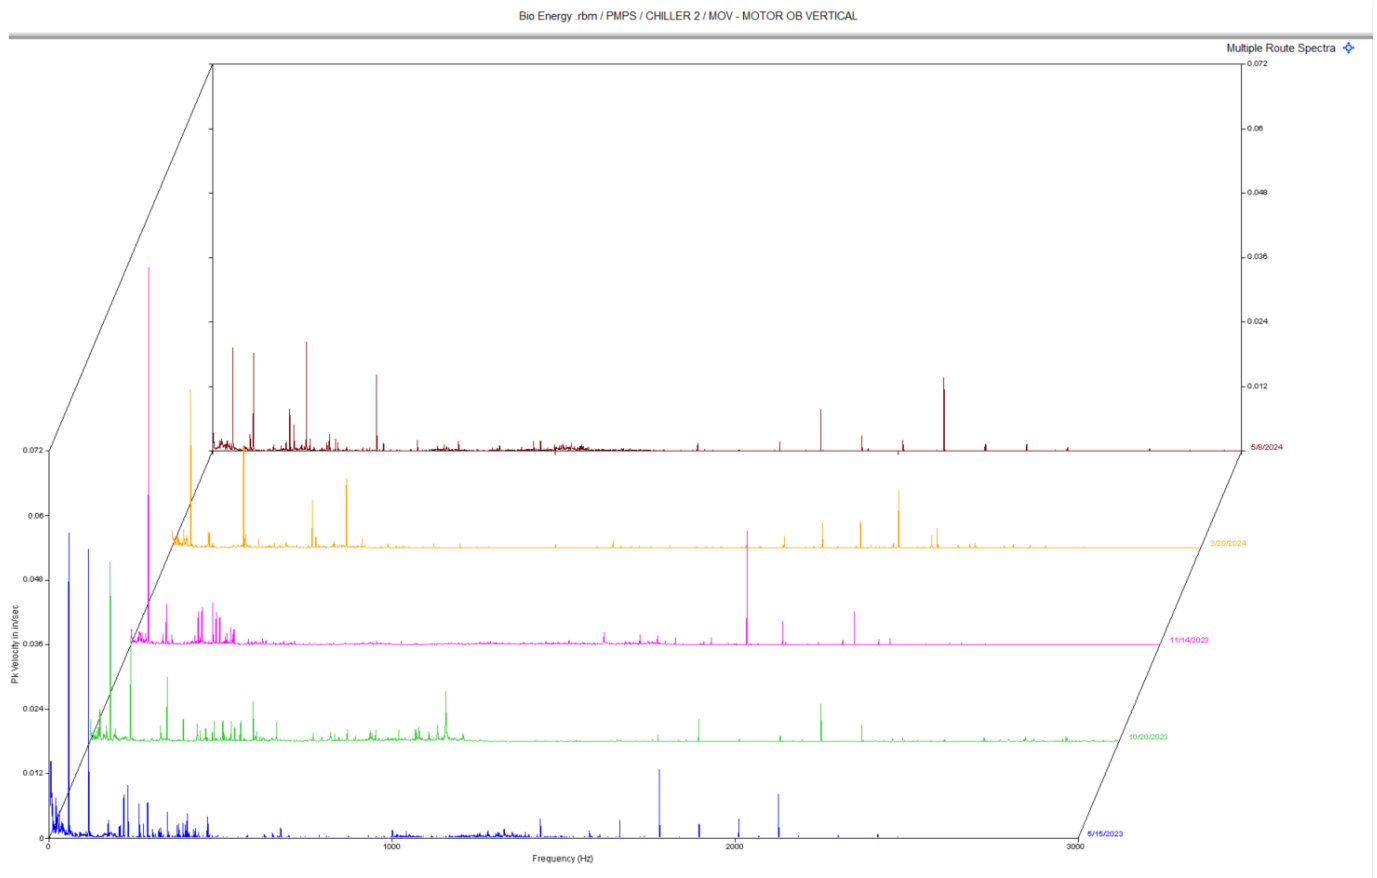
Chiller 2

Vibration data shows low amplitude vibration at 30 x rpm (similar to Chiller 1 but lower amplitude and very small sideband activity). Overall amplitude of motor and chiller points are all under .1 ips-pk.

No recommendations are necessary at this time. Continue to monitor as normal.
