# LR Field Services

Prepared for Bridgestone Americas Tube (10108-FTD)

## DC Motor Maintenance Inspection Form

1. Job Number	103074
2. Customer	Firestone
3. Report Date	07/02/2024
4. Machine	Banbury
5. Manufacturer	GE

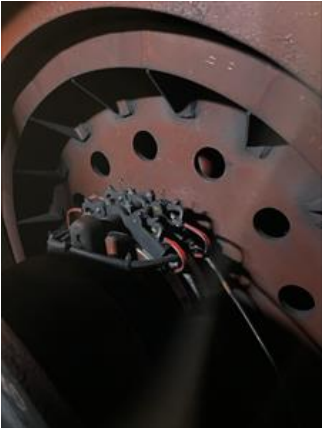
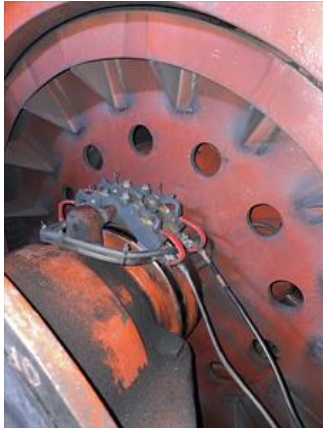
10. Serial #	YX8275827
<b>Inspection</b>	
11. Field Ohms	5.803
12. Field Megohms	0
13. Interpole and Brush Rack Megohms	0
<div></div> <i>Brush rack was showing to be grounded.</i>	
14. Armature Megohms	2
<div></div> <i>Rotor is showing to have 2 megaohms.</i>	
15. Internal Visual Appearance	
<i>Dusty and has a little carbon dust buildup.</i>	
<div>

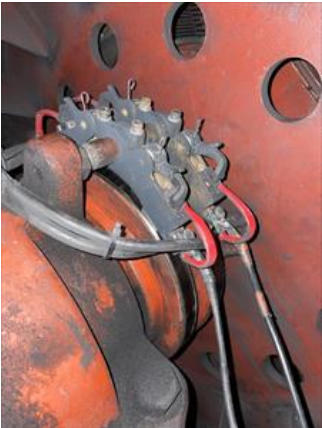
</div>	
16. Remaining Brush Length	50 %
<div></div> <i>Brushes are between 50 and 75%. Brush holder is not allowing brushes to make contact once half worn on front ring.</i>	
17. Number of Brushes	4
18. Brush Holder Condition	(F) Fail
<div></div> <i>One hammer is worn not allowing the brush to wear past the top of the holder.</i>	
<div>

*One brush was down to the point that the hammer wouldn't let it go down any further. Rotor has 2 megaohms because of carbon buildup and is very humid down in the pit. Rings need turned and brush rack needs fixed when the motor is pulled from service for recondition.*

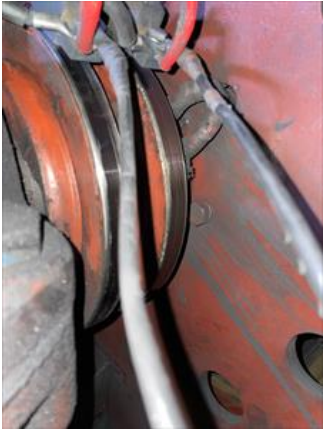
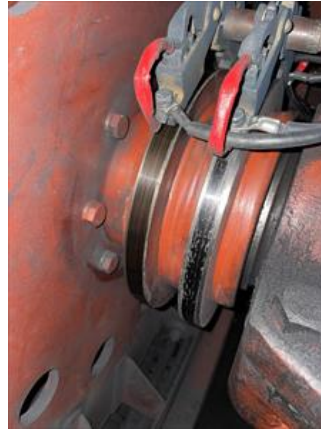
</div>	
19. Brush Spring Condition	(P) Pass
20. Commutator Condition	
<i>Rear ring has some grooving, front ring has some streaking but not very bad.</i>

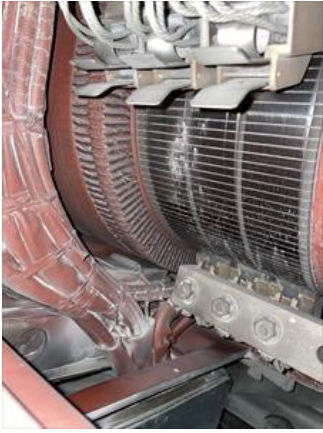
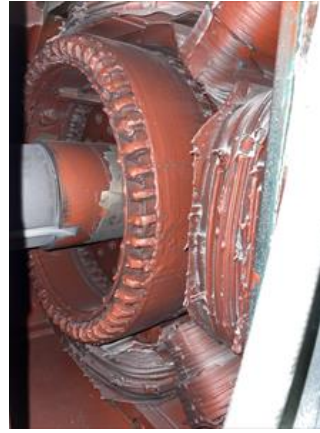
15. Internal Visual Appearance

Very dusty

*Motor is dusty so I blew it out. Commutator could be turned next time motor is pulled from service for recondition.*

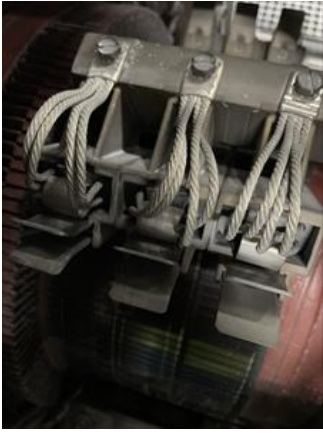
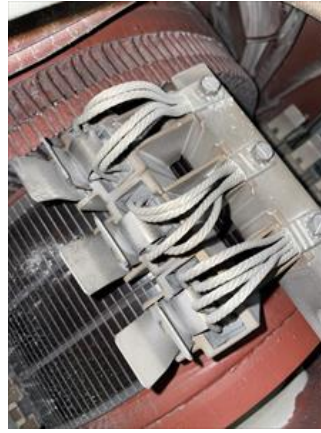
20. Commutator Condition

*Has a good carbon film. Commutator has some grooves in it.*

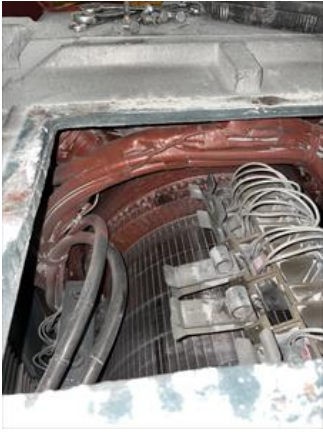
16. Remaining Brush Length

50 %

Need replaced.

*Motor needed brushes changed so I changed them. Commutator needs turned and undercut when motor is pulled for service. I smoothed out commutator as best as I could with two stones. Coupling needs to be moved back about a quarter inch so it isn't so close to gearbox coupling.*

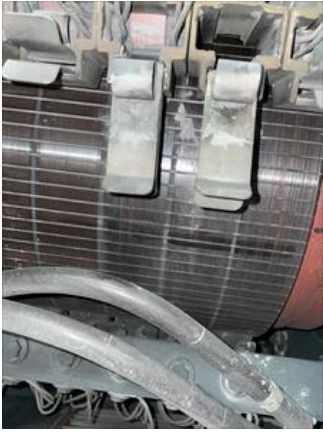
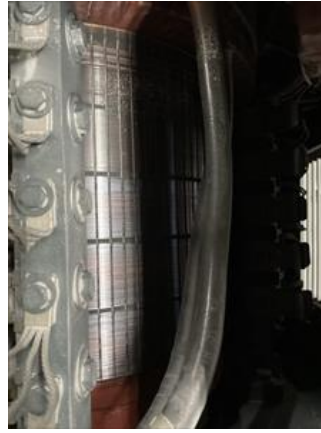
20. Commutator Condition

Commutator is grooved. Has a good carbon film.

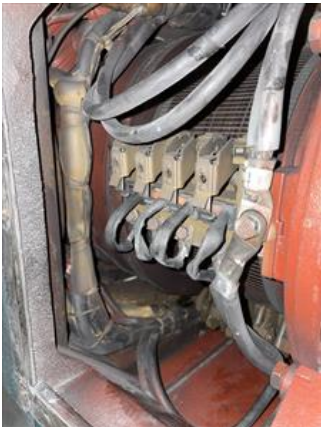
11. Field Ohms	34.834
12. Field Megohms	1047.61
13. Interpole and Brush Rack Megohms	1.73
14. Armature Megohms	3
15. Internal Visual Appearance	<i>Has minor dust in it</i>

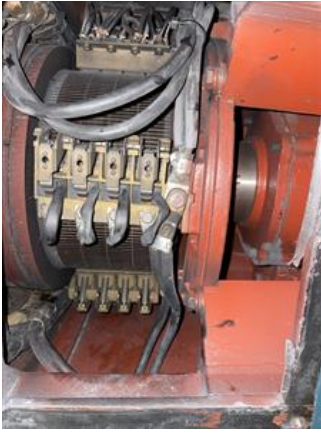
16. Remaining Brush Length	50 %
■ <i>Brushes need changed</i>	
17. Number of Brushes	16
■ 16	
● 18. Brush Holder Condition	(P) Pass

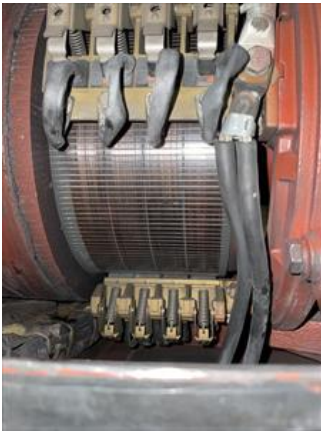
20. Commutator Condition

*Has slight grooving*

*Commutator has grooving in it and needs to be turned and undercut when pulled for recondition. Armature, interpoles and brush rack are grounded. Motor needs to be reconditioned.*
