**Atlantic Dry Ice  
Brandon, MS  
Ammonia Compressor MCC Infrared Survey Report  
February 2024**

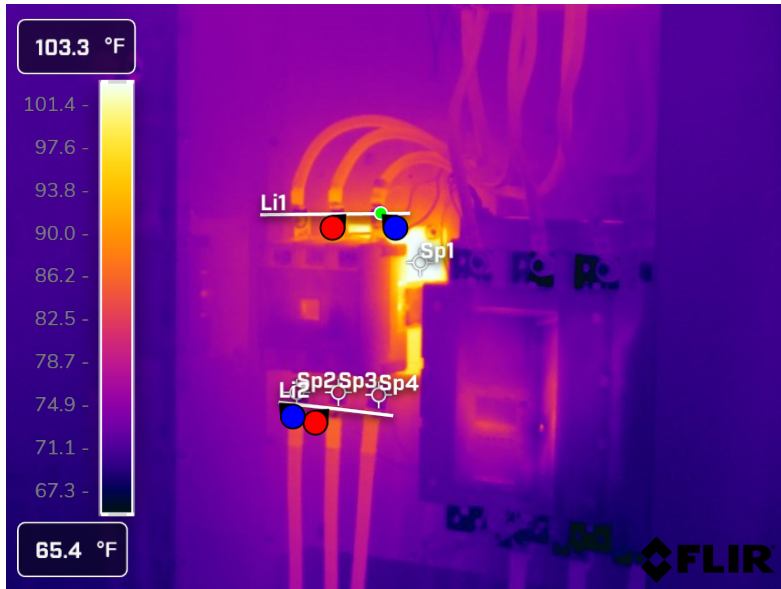
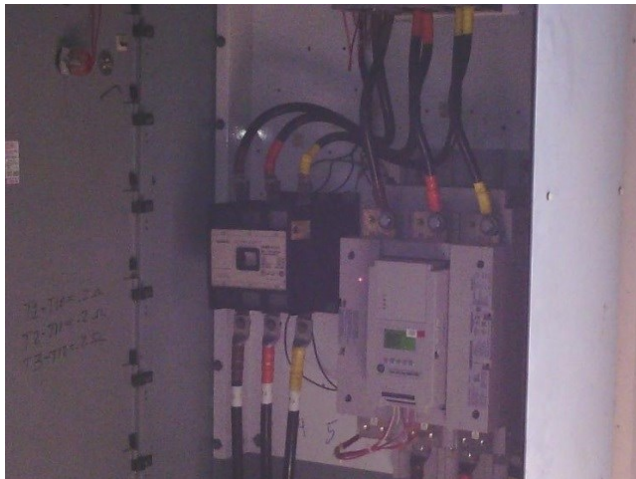
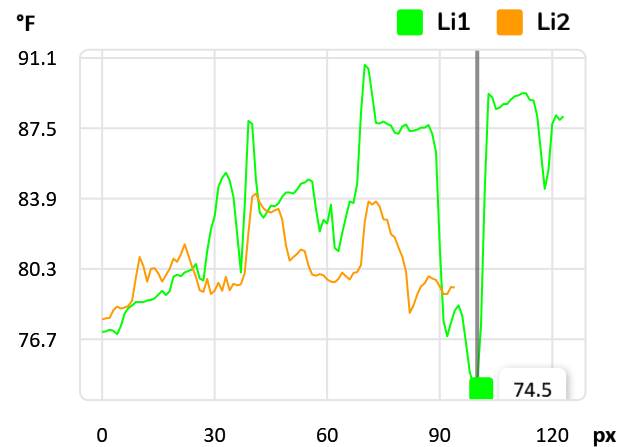
Component
N/A
Equipment/Bucket ID
CM-2RVAT

<b>Li1</b>	
Max	90.8 °F
Avg	83.5 °F
Min	74.4 °F
<b>Li2</b>	
Max	84.2 °F
Avg	80.5 °F
Min	77.7 °F
<b>Sp1</b>	104.2 °F
<b>Sp2</b>	80.0 °F
<b>Sp3</b>	81.9 °F
<b>Sp4</b>	83.1 °F

<b>Fault</b>	None
<b>Defect Rating</b>	N/A
<b>Recommendations</b>

No issues to note this survey.

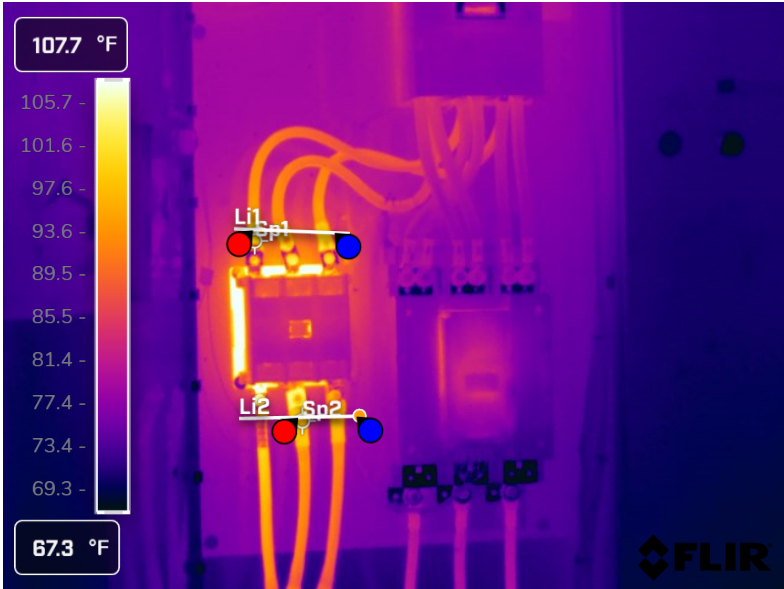
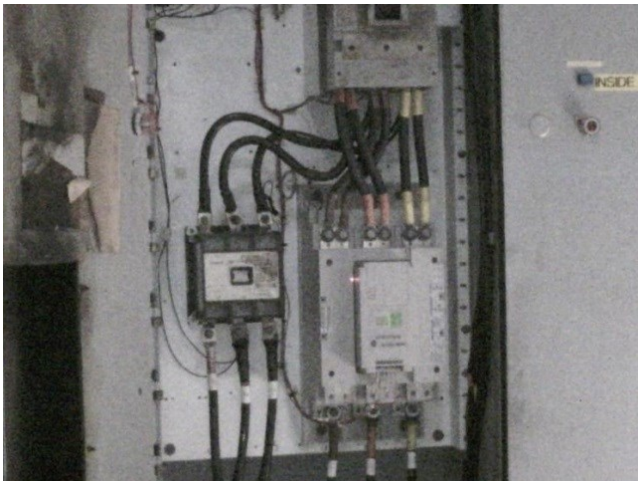
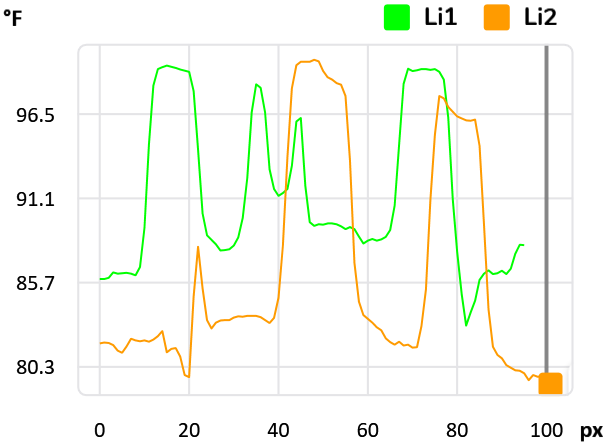
CM-3RVAT

Li1	
Max	99.6 °F
Avg	91.4 °F
Min	83.0 °F
Li2	
Max	100.0 °F
Avg	86.4 °F
Min	79.5 °F
Sp1	100.0 °F
Sp2	97.8 °F

None

N/A

No issues to note this survey.

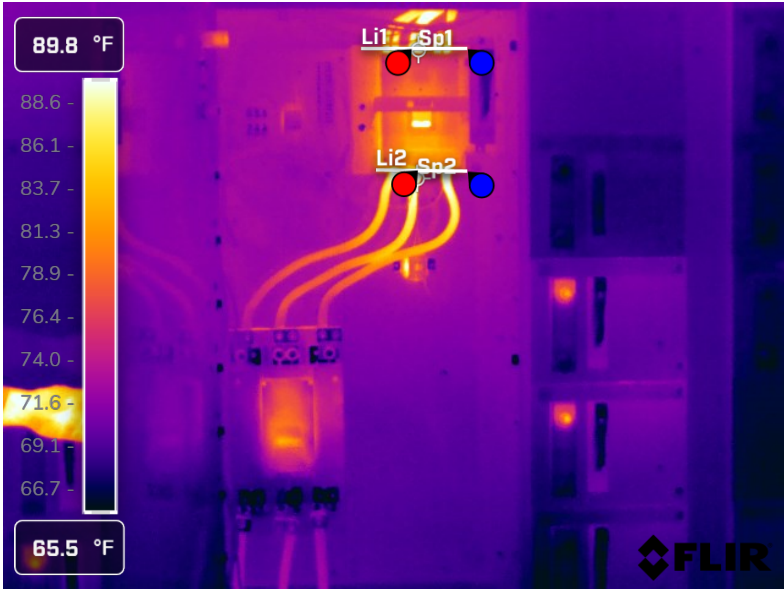
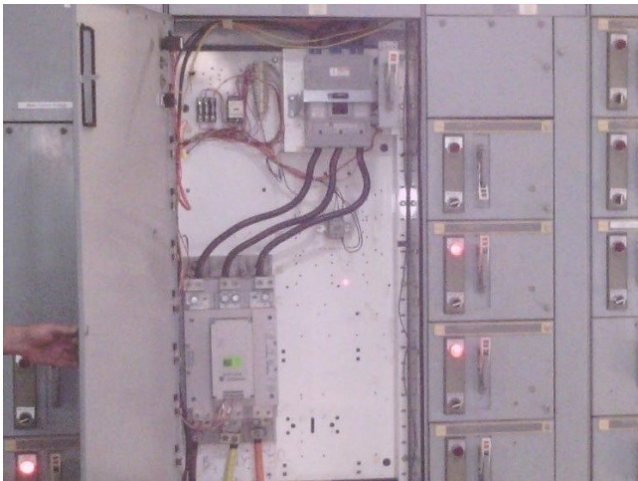
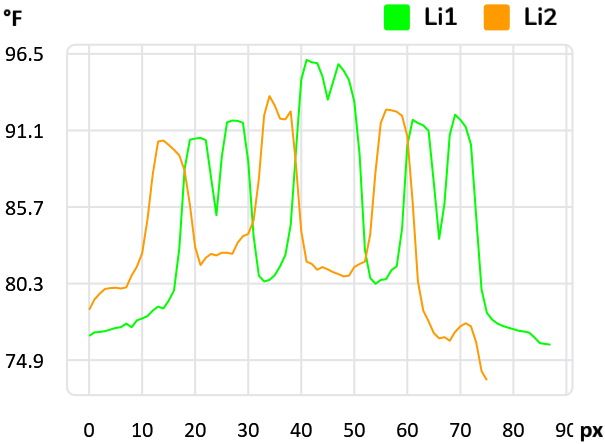
CM-1 RVAT

Li1	
Max	96.1 °F
Avg	84.5 °F
Min	76.0 °F
Li2	
Max	93.6 °F
Avg	83.6 °F
Min	73.5 °F
Sp1	95.9 °F
Sp2	89.9 °F

None

N/A

No issues to note this survey.
