Gearbox Inspection
MISSISSIPPI SILICON, LLC
P.O. BOX 316
BURNSVILLE, MS 38833

Gearbox Inspection

Hi-Speed Job Number: 152629

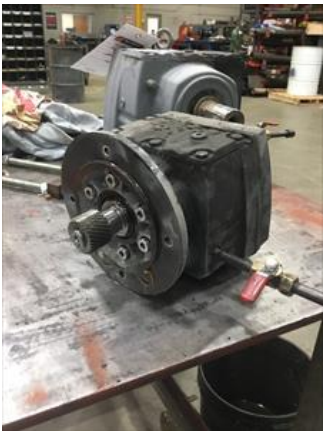
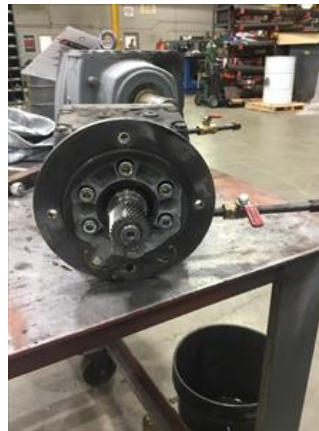
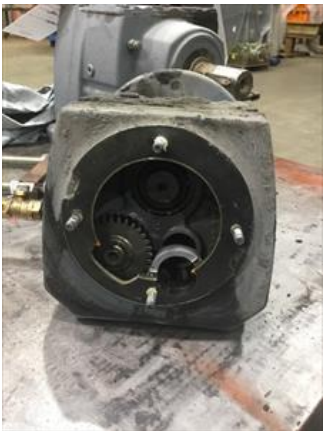
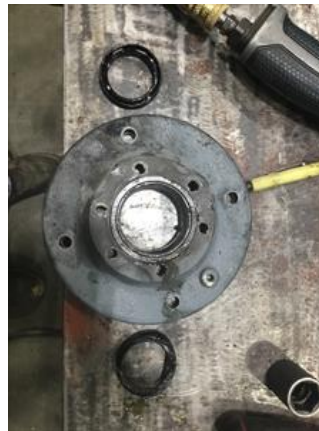
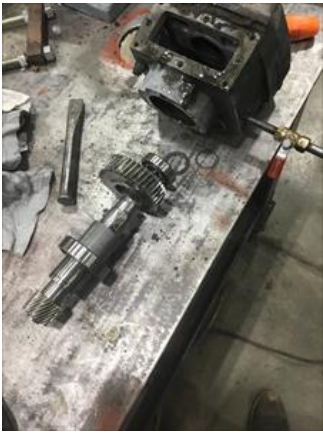
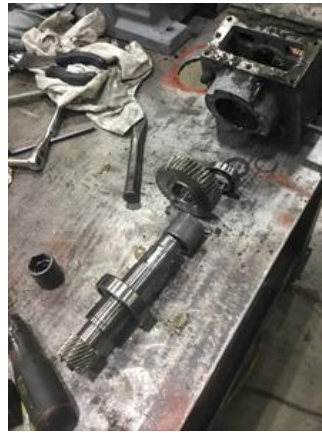
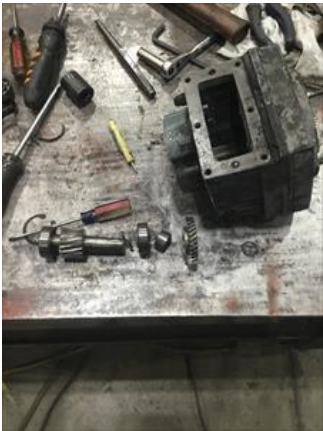
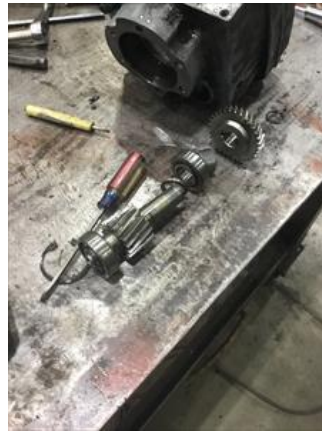
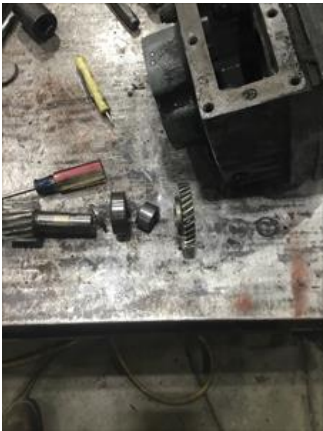
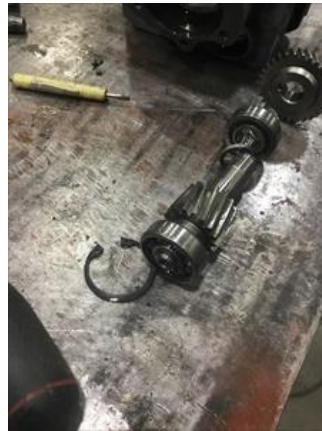
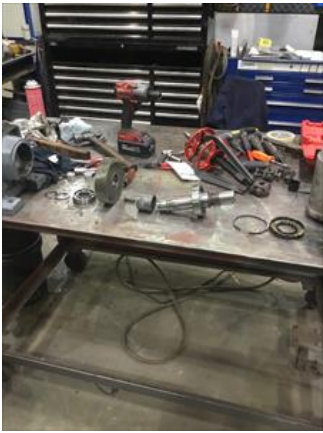
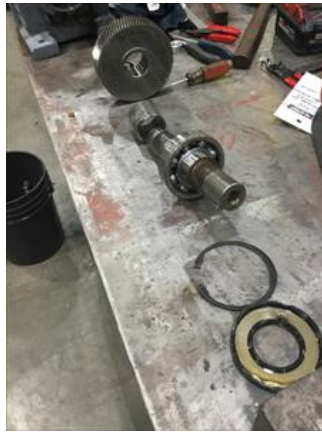
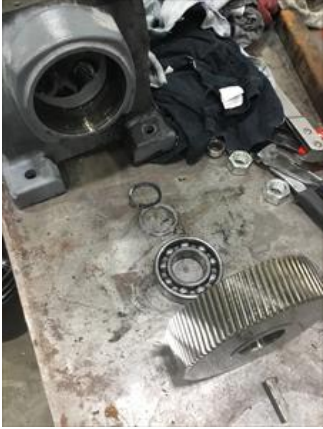
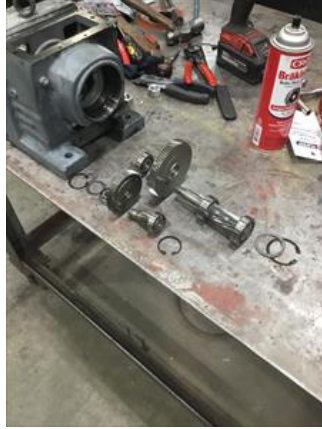
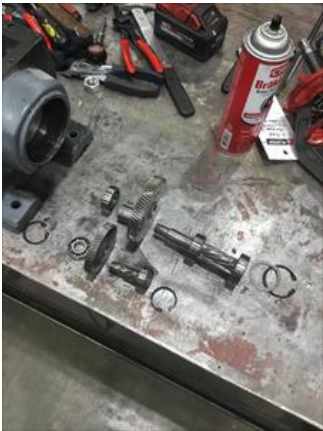
P1

●	2. Oil Condition		
	Wear	Physical	Contaminants
■	Dirty		
●	3. Gears:		
	Wear	Physical	Contaminants
■	Good		
●	4. Seals:		
	Wear	Physical	Contaminants

<i>Bad replace</i>

<i>Oil leaking</i>

19. Condition of seals & bearings	(Fail) Unacceptable

24. Appearance of lubricant	(Fail) Unacceptable

<i>Replace all</i>

1-6206 zz c3 bearing
1- ima f-554185 01 roller bearing
1- 6301 open bearing
1- external Snapring for. 6301 bearing
1- 6005 open bearing
2- 35-47-7 lipseal
1- gear box hole cap for the 6301 bearing hole
1- 47-90-10/7 lipseal
1- 6308 zz c3 bearing
1- 6207 open bearing
1- 47-7. Cr 0098 gearbox bearing hole cap
2- 6202 open bearings
1- 6302 open bearing
1- ina f 553575.01 roller bearing
1- 6303 open bearing
