## Gearbox Inspection

Quikrete (0001756)  
4362 Millington Road  
Memphis, TN 38127

Serial Number: 87190271002

Description: Small Gearbox

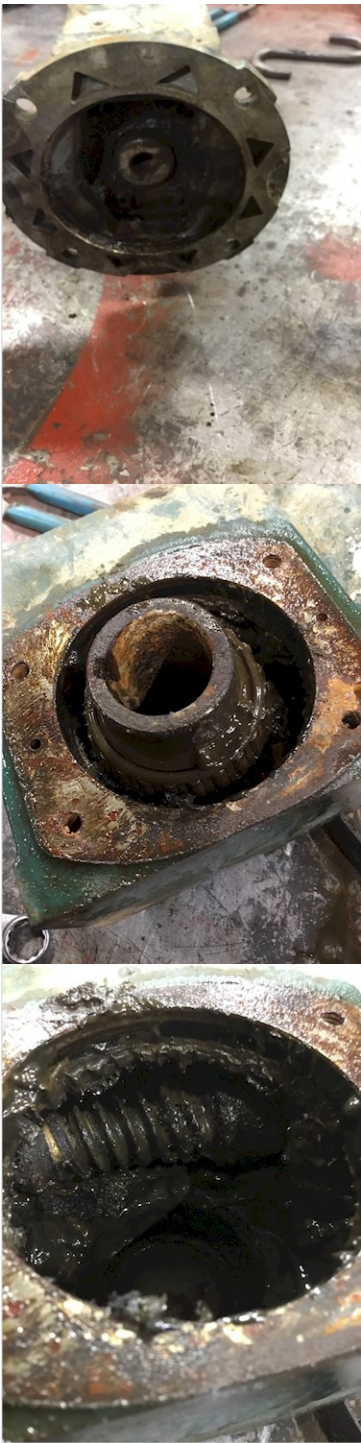
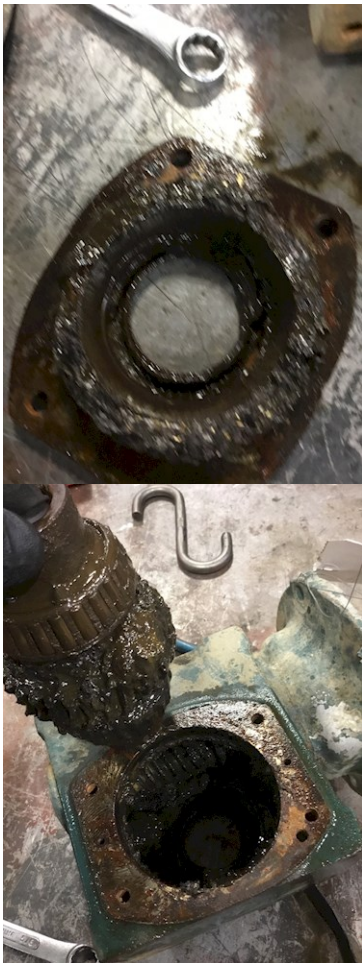
2. Oil Condition			
Wear	Physical	Contaminants	
<div> <div></div> <div>Bad</div> </div>			
3. Gears:			
Wear	Physical	Contaminants	
<div> <div></div> <div>No visible damage</div> </div>			
4. Seals:			
Wear	Physical	Contaminants

<div> <div></div> <div> 1- 40mm/62mm 2-45mm/72mm </div> </div>		
5.	Environmental Conditions	
	Ambient Temperature (F)	Humidity
6.	Physical Issues	
	Signs of Excessive Heat?	Signs of Lubricant Leaks?

28.	Degree of Gear Wear	(Mild) Mild
29.	Gear tooth Contact	(Pass) Acceptable
<b>Gearbox Summary</b>		
30.	Summary of Issues and Overall Condition of the Gearbox <i>Needs</i> 1- 40mm/62mm 2-45mm/72mm 1-7306 bearing/with snap ring 3-lm102910 outer Lm102349 inner tapered roller bearings
