Gearbox Inspection
MISSISSIPPI SILICON, LLC
P.O. BOX 316
BURNSVILLE, MS 38833

Gearbox Inspection

Hi-Speed Job Number: 152629

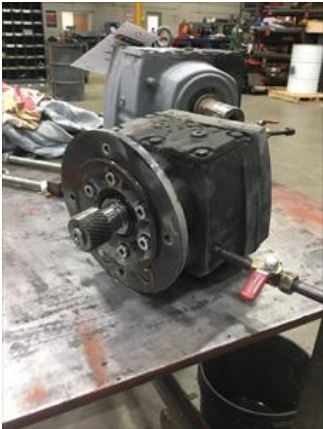
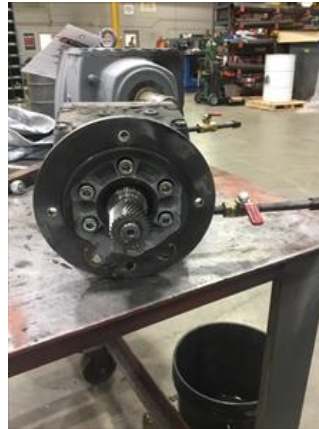
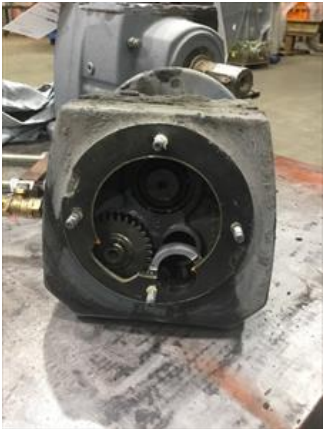
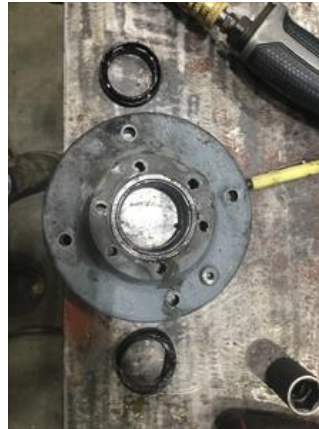
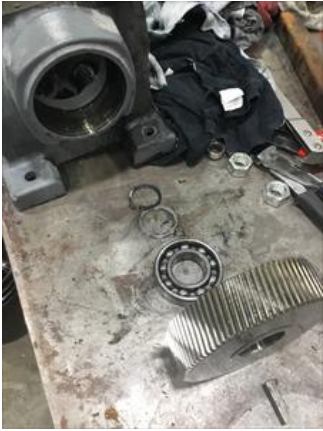
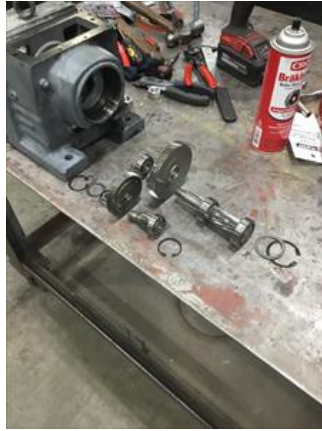
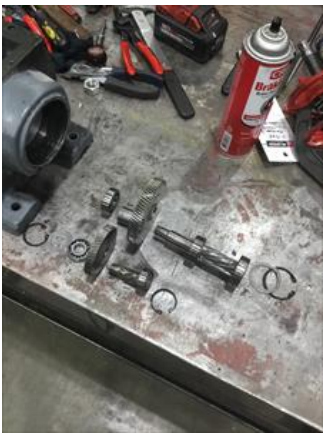
P1

●	2. Oil Condition		
	Wear	Physical	Contaminants
■	Dirty		
●	3. Gears:		
	Wear	Physical	Contaminants
■	Good		
●	4. Seals:		
	Wear	Physical	Contaminants

<i>Bad replace</i>

<i>Oil leaking</i>

19. Condition of seals & bearings	(Fail) Unacceptable

24. Appearance of lubricant	(Fail) Unacceptable

<i>Replace all</i>

1-6206 zz c3 bearing
1- ima f-554185 01 roller bearing
1- 6301 open bearing
1- external Snapring for. 6301 bearing
1- 6005 open bearing
2- 35-47-7 lipseal
1- gear box hole cap for the 6301 bearing hole
1- 47-90-10/7 lipseal
1- 6308 zz c3 bearing
1- 6207 open bearing
1- 47-7. Cr 0098 gearbox bearing hole cap
2- 6202 open bearings
1- 6302 open bearing
1- ina f 553575.01 roller bearing
1- 6303 open bearing
