**QualiTest® Diagnostics**

The following is a summary of findings from the South Thune Press Gearbox vibration analysis that was performed on February 19, 2024. Motor rpm was approximately 1485 rpm (24.75 Hz) while gearbox had an approximate 984 rpm (16.4 Hz).

## South Thune Press Gearbox **CLASS III**

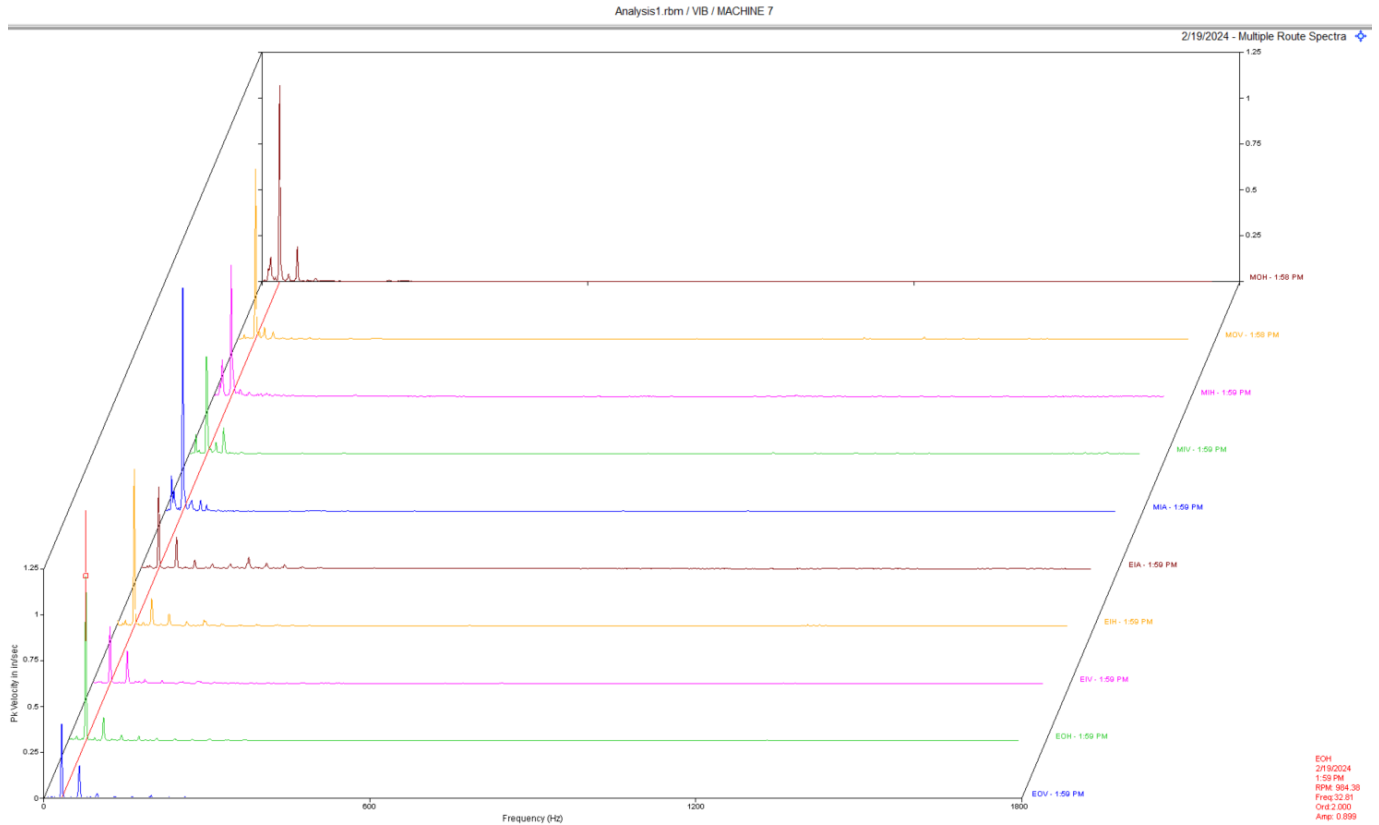
Data plot above is the multipoint spectral waterfall for the motor and the gearbox. There is a dominant vibration at 32.8 Hz. present in the motor and gearbox with highest amplitude in the motor inboard axial. This frequency appears to be 2 x gearbox rpm.

The 32.8 Hz vibration present in the motor and gearbox appears to be very dominant and amplitude is quite high. 2 x rpm vibration is typically caused by misalignment, bent shaft at the coupling, or cocked bearing/sheave. A visual inspection of the unit was performed while on site. We did not find any base or fastener issues to note. For now, it is recommended to inspect the sheaves for angular/parallel misalignment and face run-out using a dial indicator/mag base. Check the gearbox shaft for run-out as well. Given that this motor is controlled by a VFD, it is possible that the unit was operating near a resonant frequency, therefore, it is also recommended to lower the Hz. on the drive some to see if vibration decreases. If vibration decreases significantly after lowering speed, then the unit is likely operating near a resonant frequency.
