# GOLD STRIKE.

Robinsonville, MS  
Casino & Hotel  
2024 Infrared Survey Report

On September 19 and 20, 2024, all electrical panels/switches at the Gold Strike Casino and Hotel in Robinsonville, MS were scanned using a

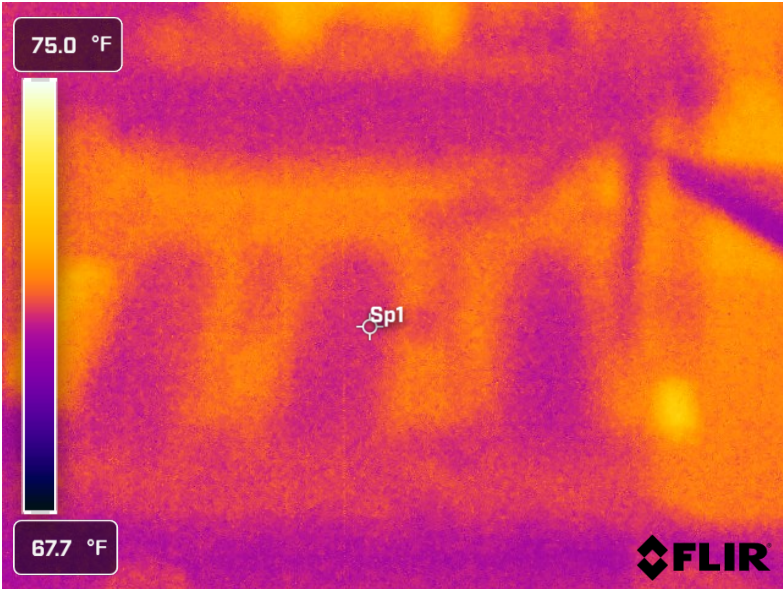
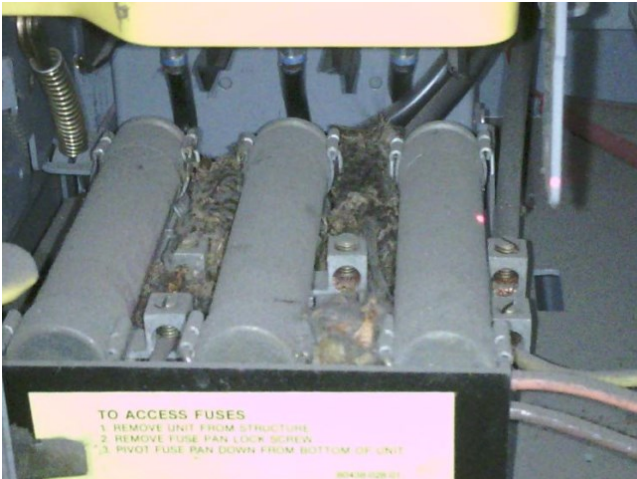
Component
Fuses
Equipment/Bucket ID
CMCCE FIRE PUMP CONTROL JOCKEY PUMP

Fault
Contamination
Defect Rating
CLASS II

Recommendations
The issue here is not heat. The issue is that the panel has dead mice and nests. Panel need to be turned off, locked out cleaned out asap.

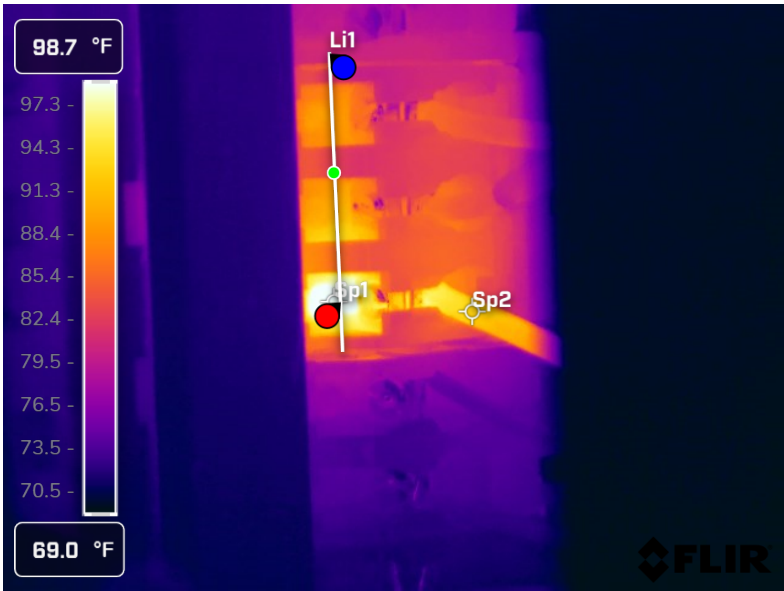
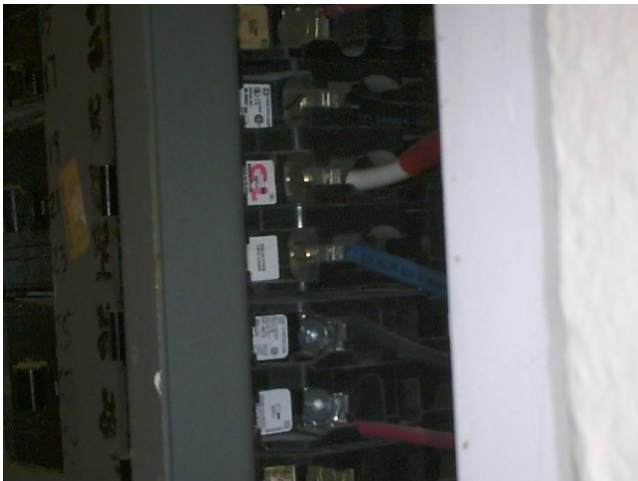
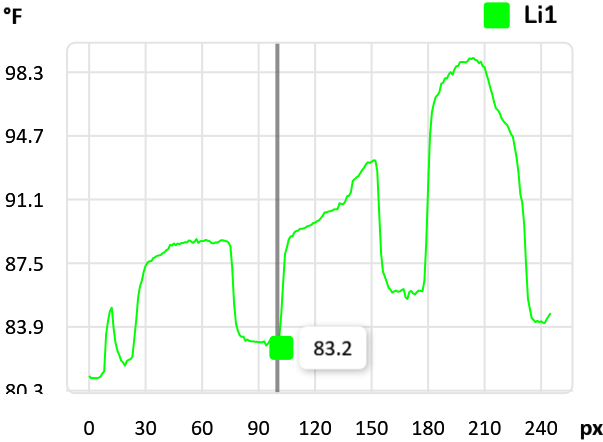
Breaker 30 Panel LPB

Li1	
Max	99.1 °F
Avg	89.0 °F
Min	81.0 °F
Sp1	101.8 °F
Sp2	93.0 °F

Faulty Breaker

CLASS I

Breaker has internal heat with minimal load. Breaker likely has internal issue and should be replaced as time allows.

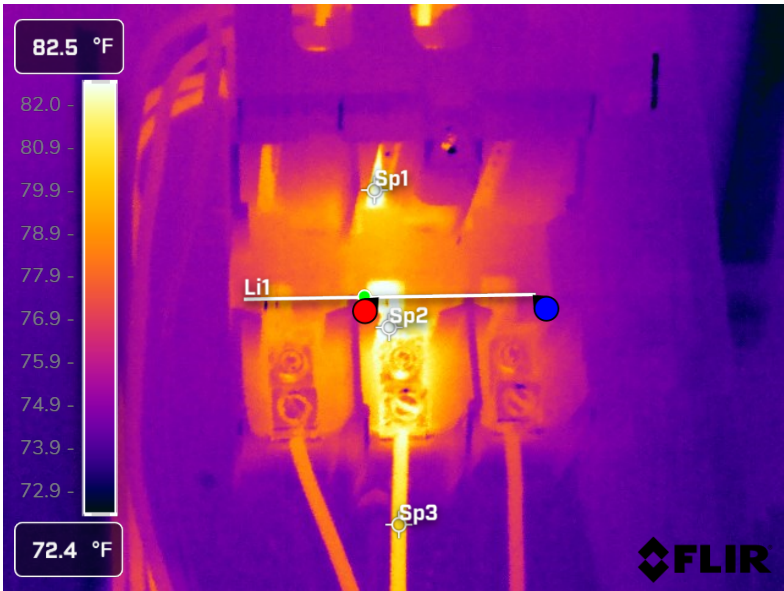
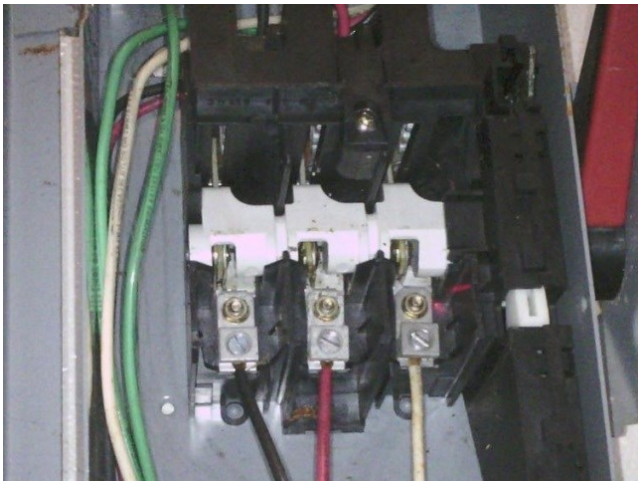
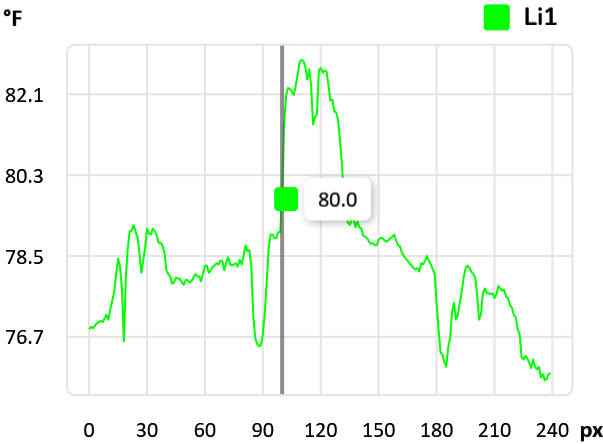
KCK 3436 ice maker disconnect

<b>Li1</b>	
Max	82.9 °F
Avg	78.5 °F
Min	75.8 °F
<b>Sp1</b>	82.4 °F
<b>Sp2</b>	82.6 °F
<b>Sp3</b>	80.6 °F

Faulty connection

**CLASS I**

There appears to be some delta-T on B phase at the knife blade. This appears to be minor at this time but will likely worsen over time. It is likely that this is due to internal wear of the switch. The best fix is to replace the disconnect switch. Perform as scheduling allows.

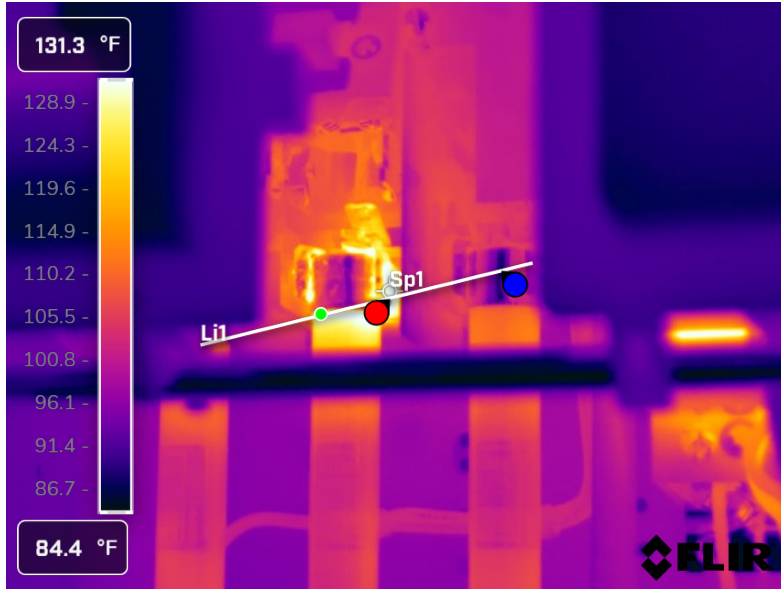
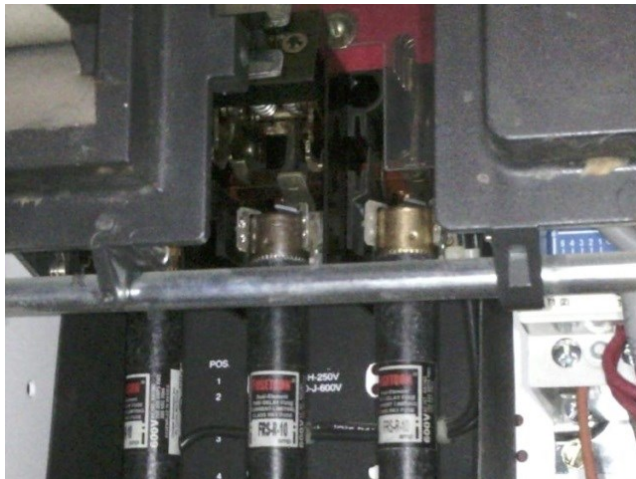
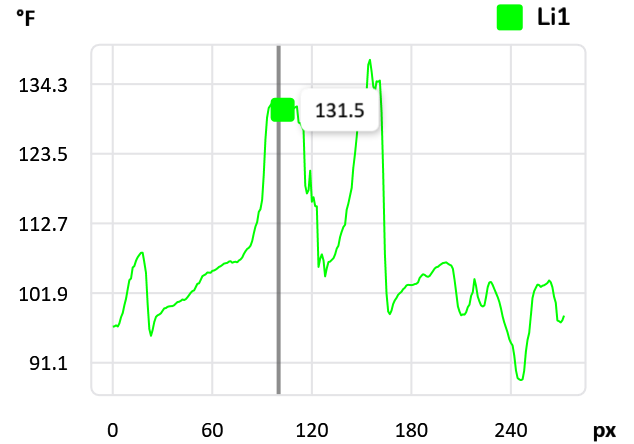
XMCCB Buffet Left East Side Venth Hood

<b>Li1</b>	
Max	138.1 °F
Avg	107.8 °F
Min	88.4 °F
<b>Sp1</b>	135.8 °F

Faulty fuse connection

**CLASS II**

IR image shows some delta-T on B phase line side of fuse. This is likely a clip/holder issue. Ensure B phase fuse has a tight and clean connection at the line side.

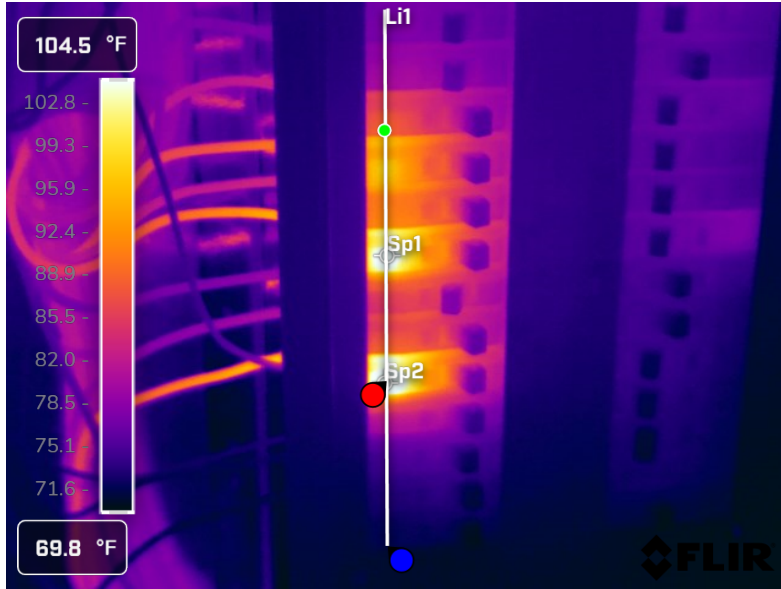
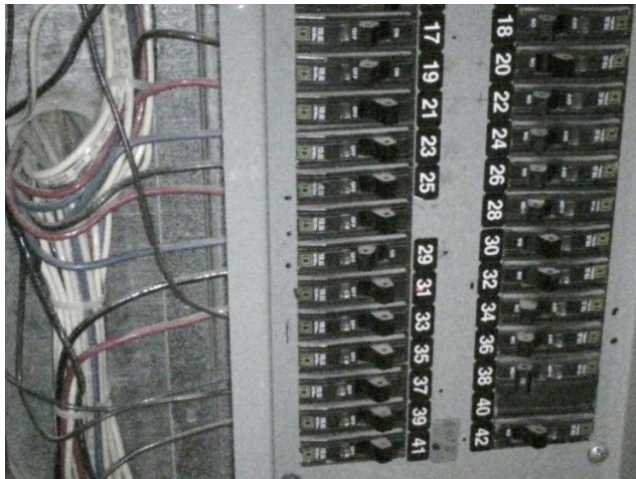
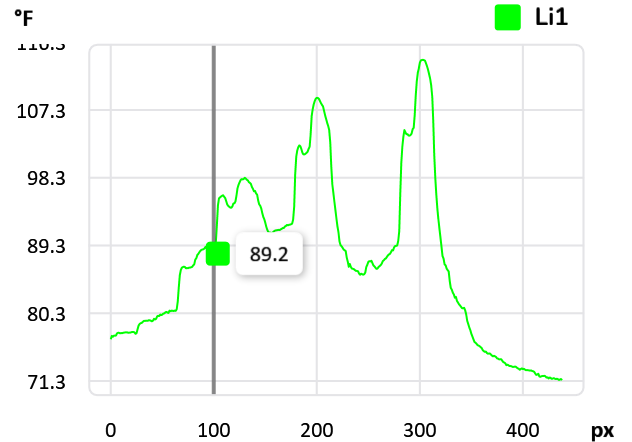
Breaker 27 and 33 Panel SC2

<b>Li1</b>	
Max	114.0 °F
Avg	87.5 °F
Min	71.4 °F
<b>Sp1</b>	108.9 °F
<b>Sp2</b>	113.3 °F

Heavy load on breakers

**CLASS I**

IR imaging shows some delta-T on breakers 27 and 33. Amp load was measured and found to be near load limit (17-18 amps). These breakers are rated for 20 amps but wire size will allow for breakers to be swapped out with 30 amp breakers. We recommend replacing circuit 27 and 33 with 30 amp breakers as time allows.
