Harlow's
Casino Resort & Spa

2024 Infrared Electrical Survey Report

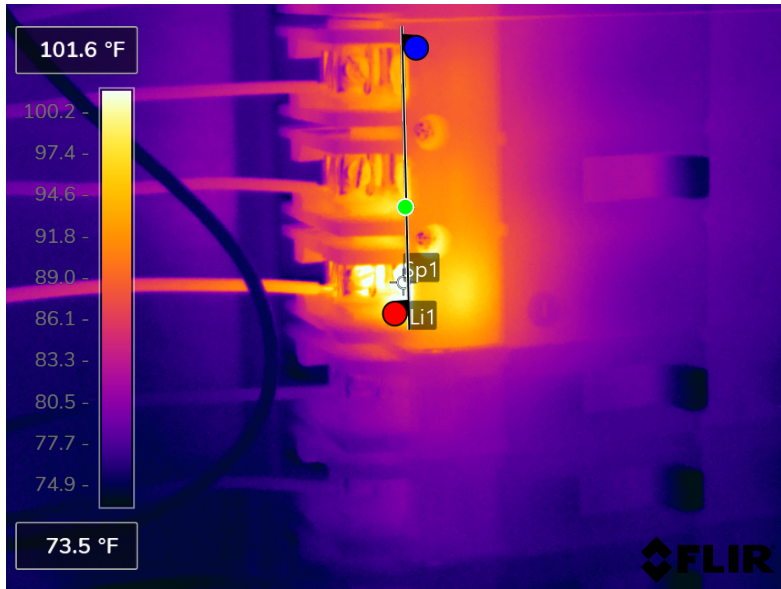
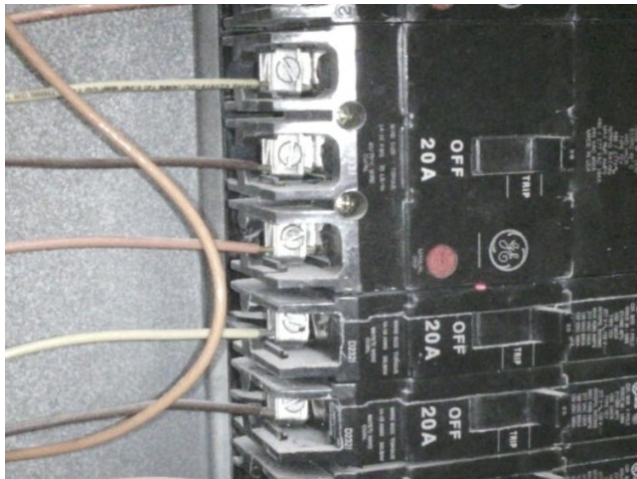
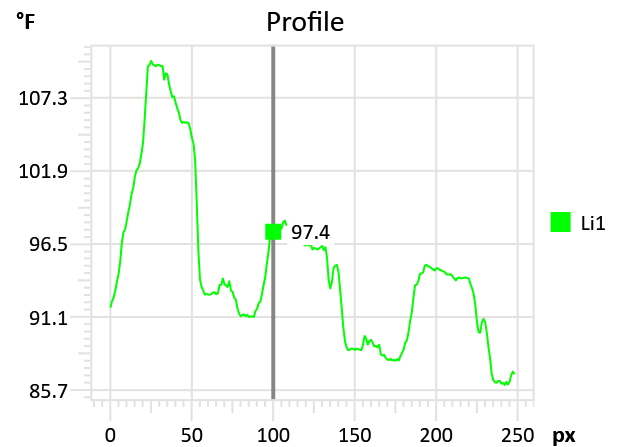
Surv Electrical Room Panel HBOH1 Breaker lead 35

Breaker lug connection

Li1	
Max	110.1 °F
Avg	94.8 °F
Min	86.1 °F
Sp1	107.7 °F

Faulty connection

CLASS I

Lead 35 likely has an issue with the lug connection according to the IR image. Image shows heat to be on the lug which may indicate internal connection issue with the lug. Inspect breaker lug and lead ensuring a clean tight connection. Breaker may need to be replaced.
