Matt Buda KTG Memphis

The following is a summary of findings from the vibration analysis performed on 10/1/24. We collected vibration data on a 1000 HP AC Motor and a 350 HP AC Motor. Below, you will find data plots along with a brief summary of our analysis.

Summary

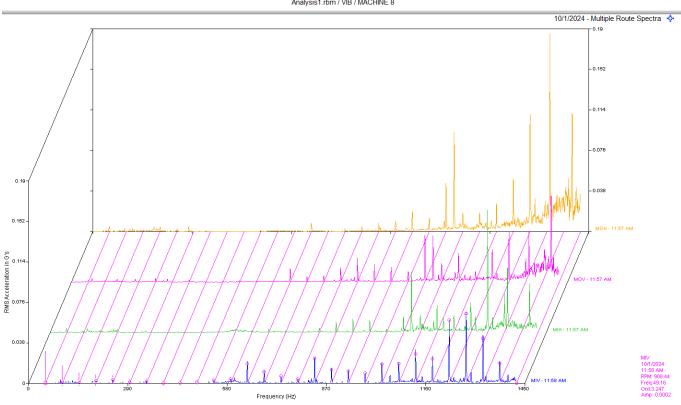
1000 HP AC Motor

Motor data shows non-synchronous peaks in motor spectra that indicate bearing defects are present in the motor bearings. Amplitudes do not appear to be at alarm levels; however, the presence of these peaks is concerning. The peaks at 3.24 orders of rpm in the higher frequency range are possible signs of electrical fluting. It is recommend that the motor be inspected for bearing issues as scheduling allows. Rated as a CLASS II defect.

OVERALL LEVEL	1K-20KHz
MOH	.029 In/Sec	.760 G-s
MOV	.017 In/Sec	1.231 G-s
MIH	.019 In/Sec	2.827 G-s
MIU	.014 In/Sec	2.099 G-s

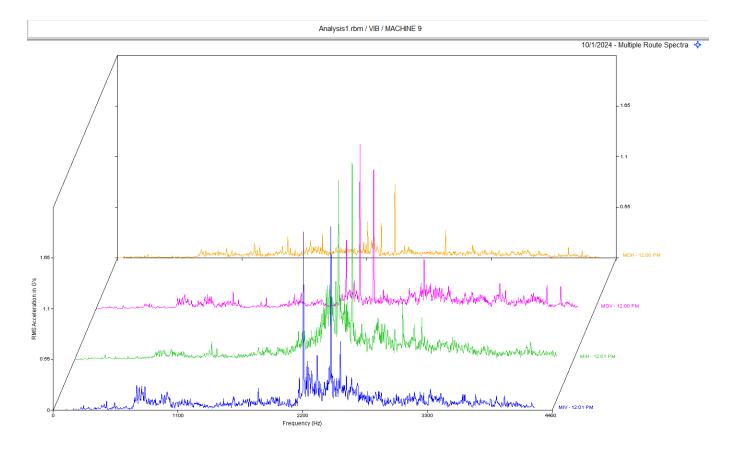
350 HP Motor

Spectral data of the motor show random noise floor with elevated acceleration amplitude. Data indicates lubrication issue and/or bearing wear. It is recommended that the motor be inspected for these types of issues as scheduling allows. Because of the high frequency amplitude, this is rated as a **CLASS III** defect.

OVERALL LEVEL	1K-20KHz
MOH	.115 In/Sec	2.105 G-s
MOV	.171 In/Sec	3.853 G-s
MIH	.255 In/Sec	7.199 G-s
MIU	.230 In/Sec	4.986 G-s
