**USG**  
**Greenville, MS**  
**March 2024 Infrared Survey Report**

Scheduled electrical panels were scanned using a **FLIR T865** infrared camera. The following report only contains defects that were found during the survey. Below is our classification system for each defect included in this report. If there are any questions or comments, please feel free to contact us at any time.

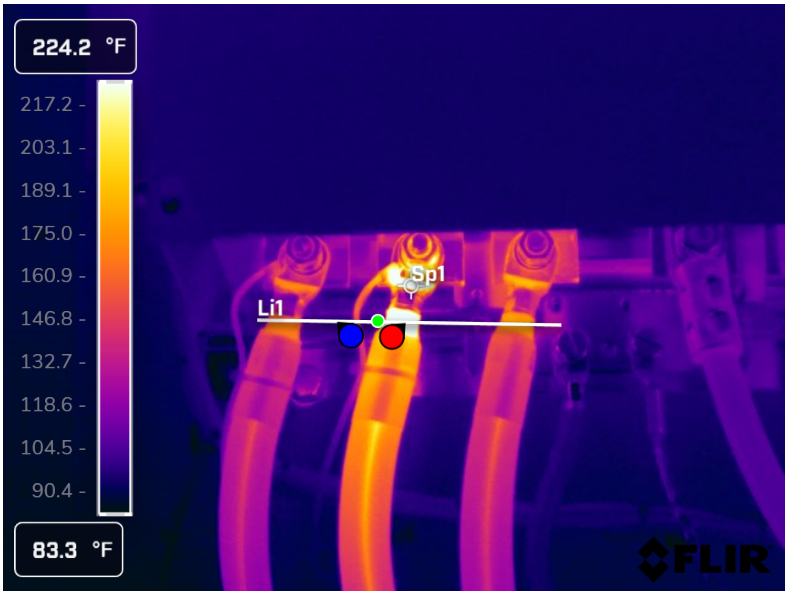
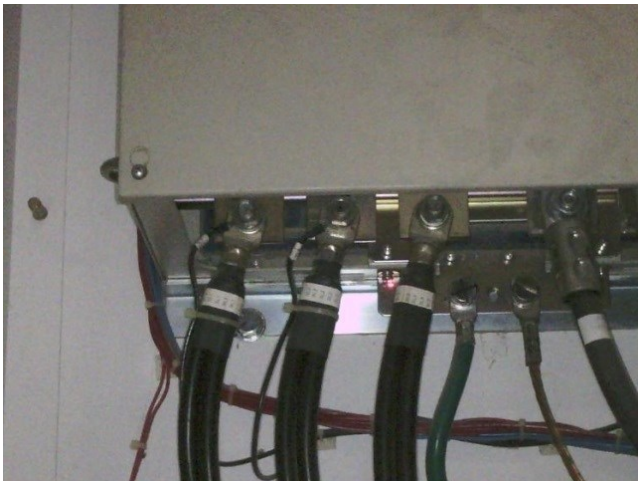
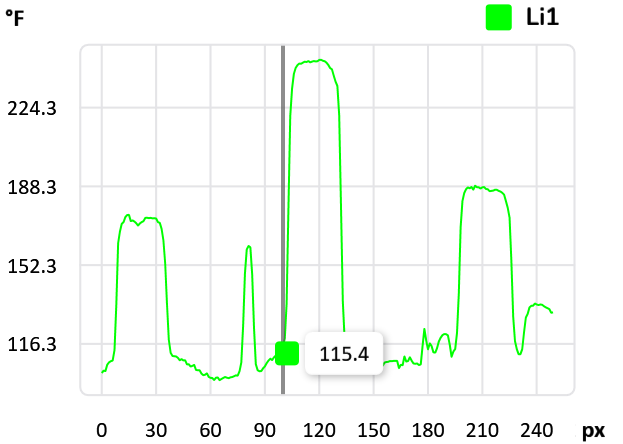
Vacuum Pump #1 VFD

Lead connection

<b>Li1</b>	
Max	246.2 °F
Avg	142.7 °F
Min	99.7 °F
<b>Sp1</b>	247.8 °F

Connection issue

**CLASS II**

IR image shows significant dela-T on the B phase connection. Check lug and lead connection soon. Ensure all connections are clean and tight.

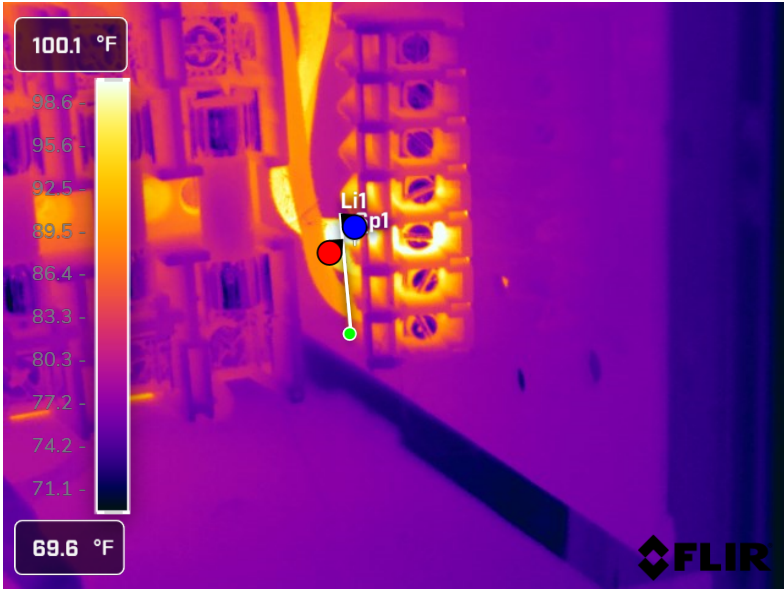
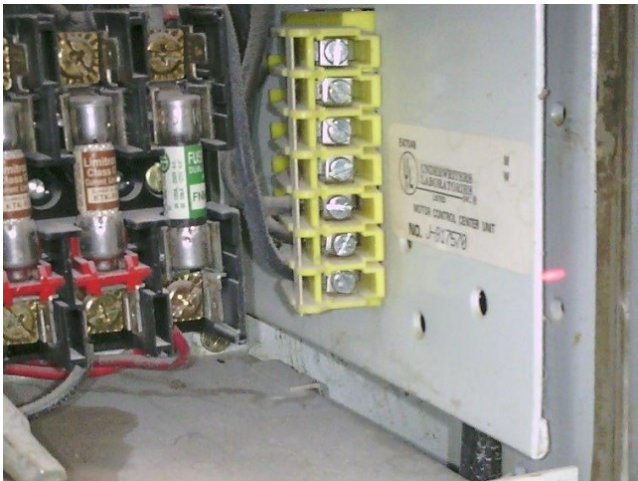
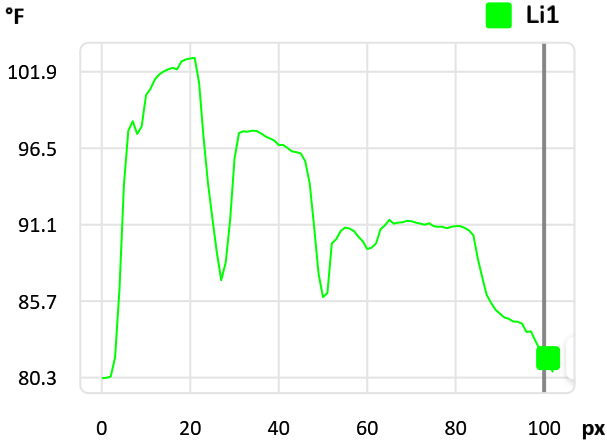
Wet End Coating Agitator M1369 MCC-7C1

lead connection

Li1	
Max	102.9 °F
Avg	91.9 °F
Min	80.3 °F
Sp1	103.6 °F

connection issue

CLASS I

Slight issue with lead connection. Ensure connections are clean and tight.

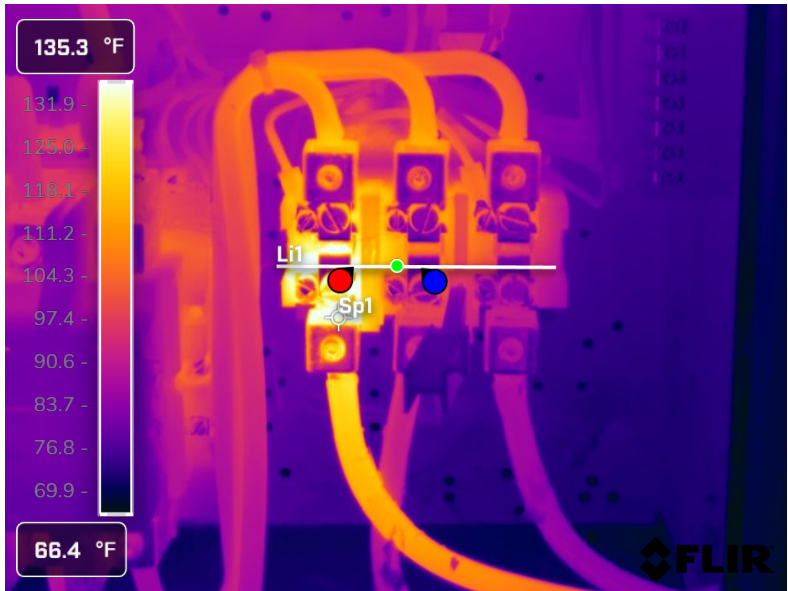
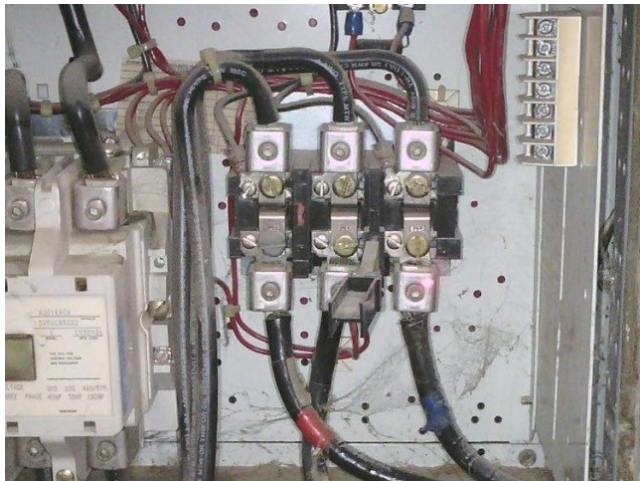
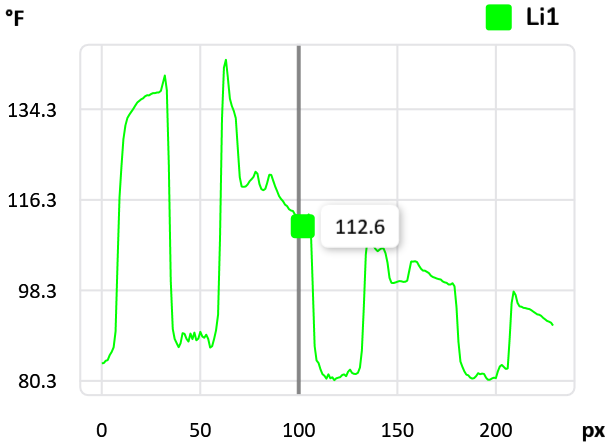
#3 Machine White Water Pump M1377 MCC-7C1

lead connection

<b>Li1</b>	
Max	144.2 °F
Avg	102.4 °F
Min	80.5 °F
<b>Sp1</b>	134.5 °F

connection issue

**CLASS II**

IR image shows issue with A phase lead connection. Ensure connections are clean and tight.

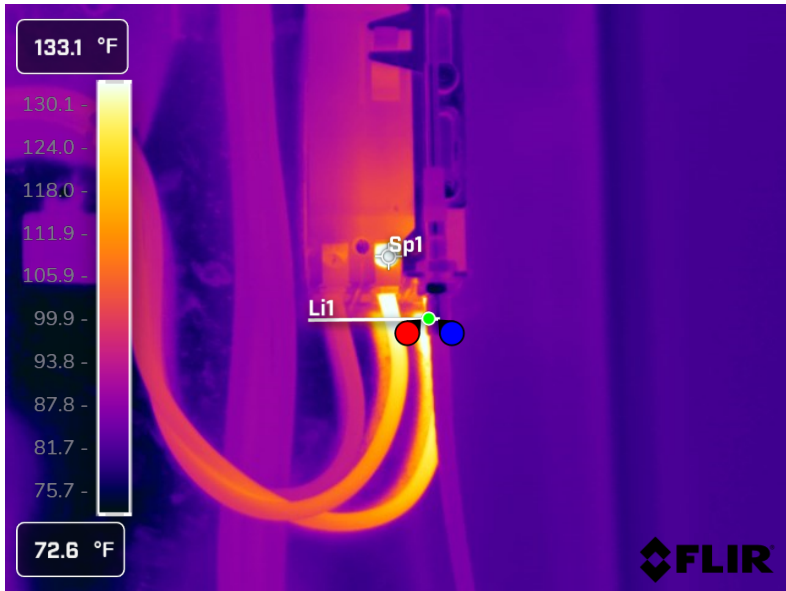
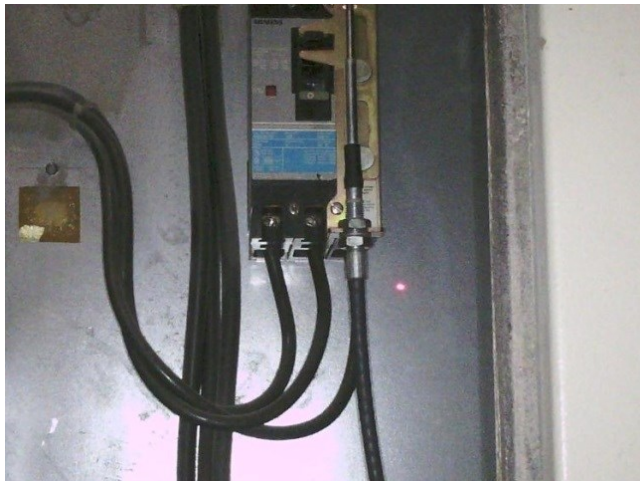
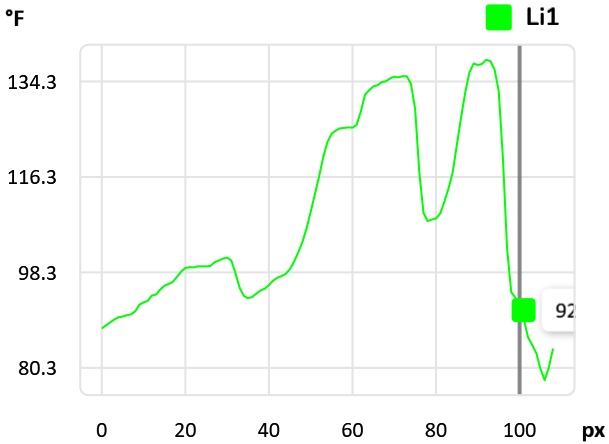
Machine Chest Pump 3A VFD-MCP1

Breaker connections

<b>Li1</b>	
Max	138.4 °F
Avg	108.1 °F
Min	78.0 °F
<b>Sp1</b>	142.8 °F

Connection/lug issues

**CLASS I**

This appears to be a reoccurring issue with these breaker lead connections. If connections are found tight then the issue is likely internally in the breaker itself.
