**Atlantic Dry Ice
Quarterly Infrared Survey Report
May 2024**

All Ammonia Compressor Motor electrical panels were scanned using a FLIR T865 infrared camera. The following report only contains defects that were found during the survey. Below is our classification system for each defect included in this report. If there are any questions or comments, please feel free to contact us at any time.

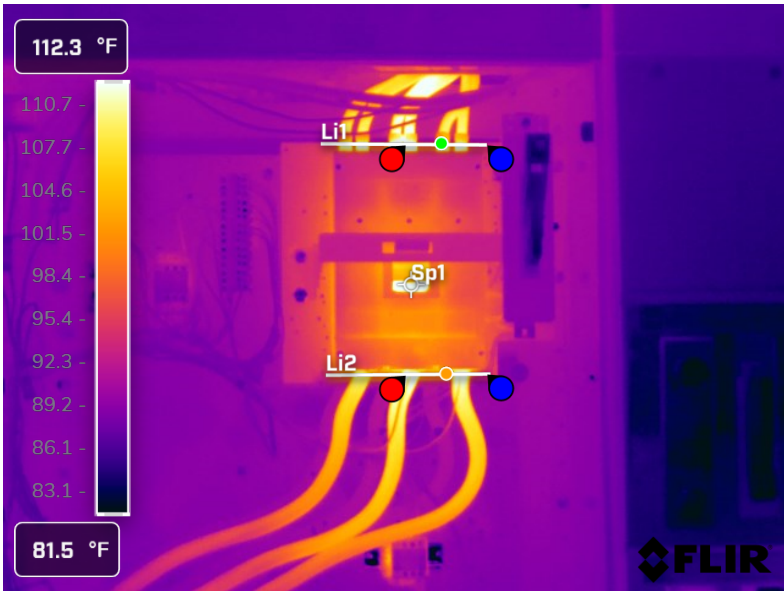
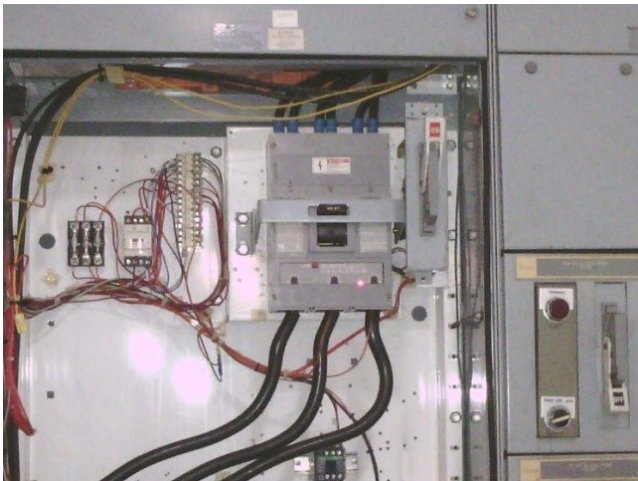
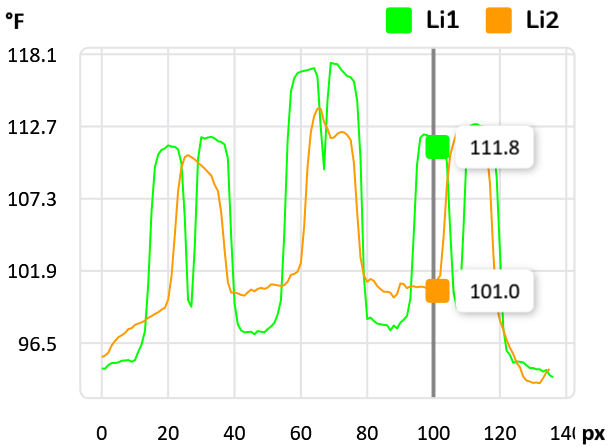
CM-1 Breaker

Li1	
Max	117.5 °F
Avg	104.7 °F
Min	94.0 °F
Li2	
Max	114.1 °F
Avg	103.0 °F
Min	93.5 °F
Sp1	
	121.4 °F

None

N/A

No issues to note this survey.

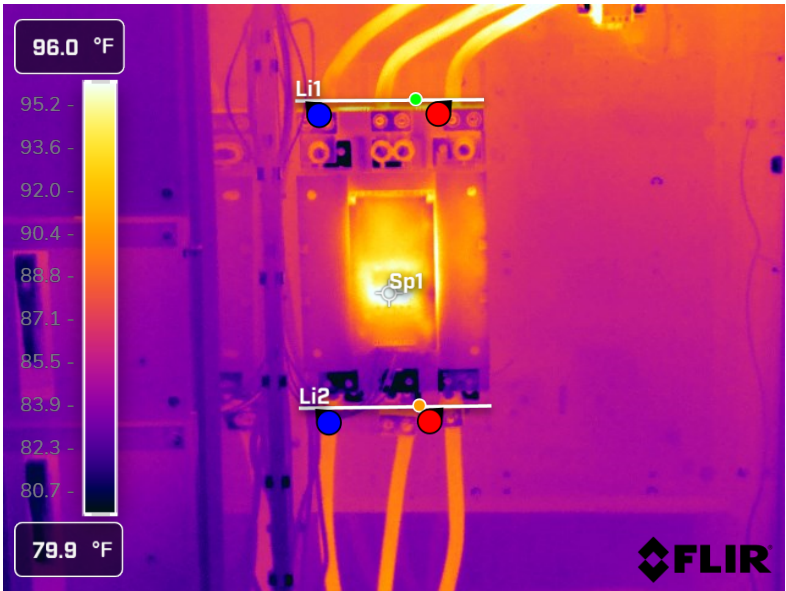
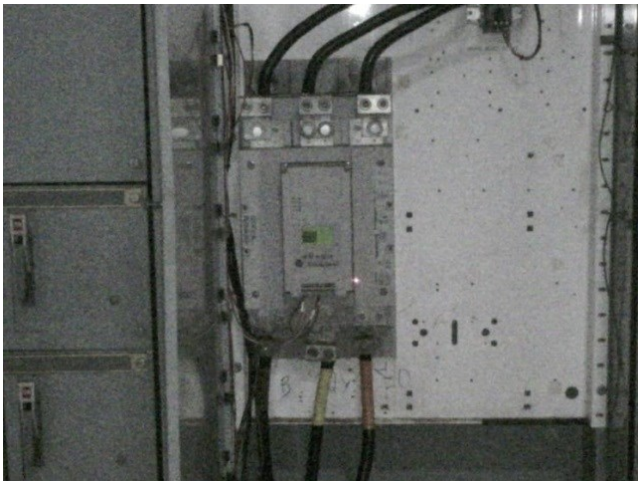
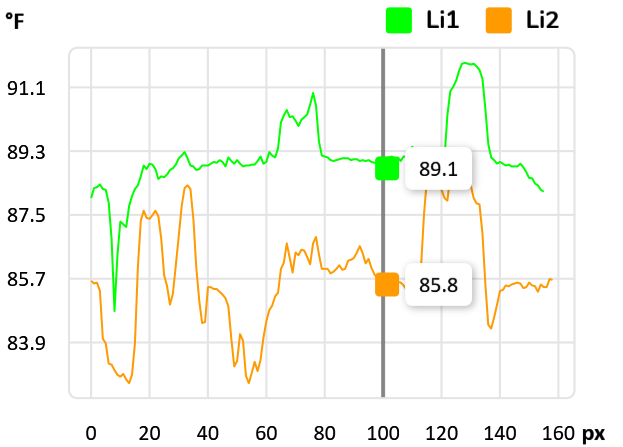
CM-1 Starter

Li1	
Max	91.8 °F
Avg	89.2 °F
Min	84.8 °F
Li2	
Max	88.8 °F
Avg	85.9 °F
Min	82.8 °F
Sp1	98.9 °F

None

N/A

No issues to note this survey.

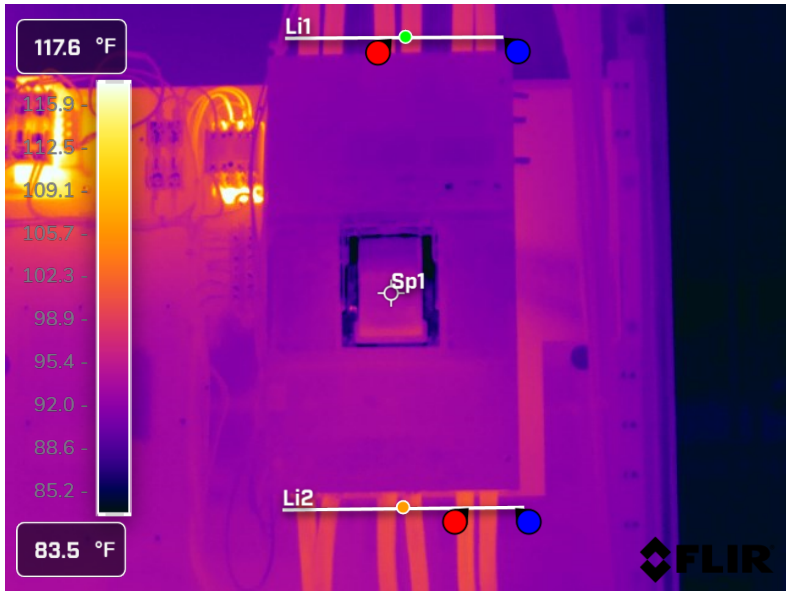
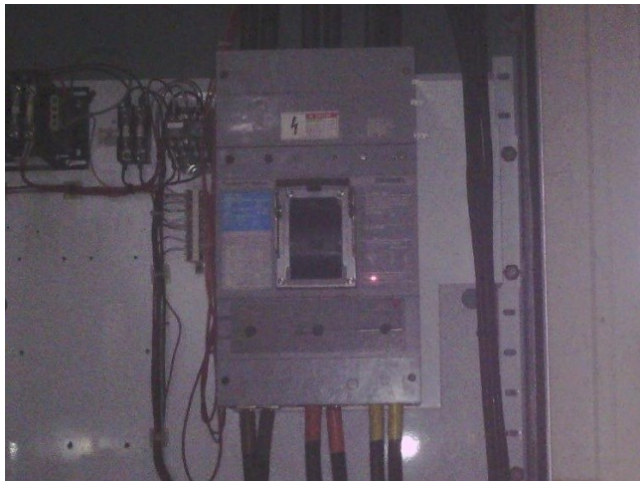
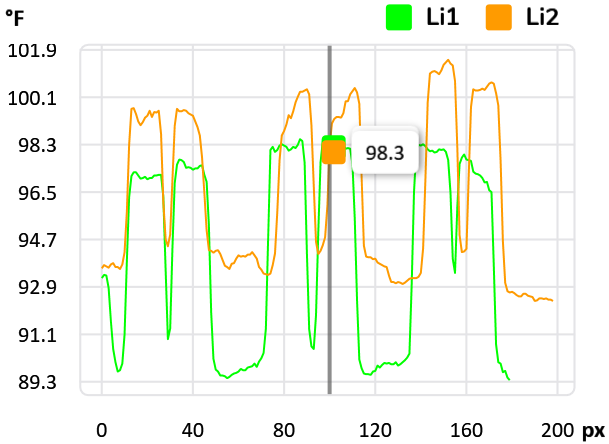
CM-2 Breaker

Li1	
Max	98.5 °F
Avg	94.5 °F
Min	89.4 °F
Li2	
Max	101.6 °F
Avg	96.4 °F
Min	92.4 °F
Sp1	93.9 °F

None

N/A

There are no issues to note this survey.

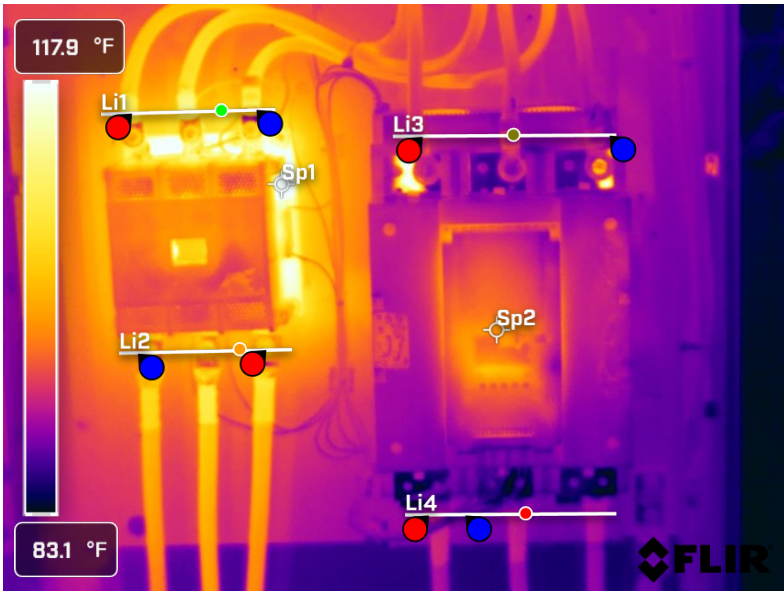
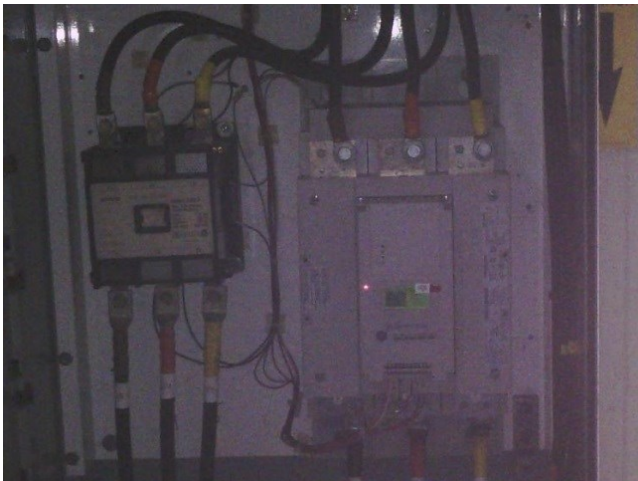
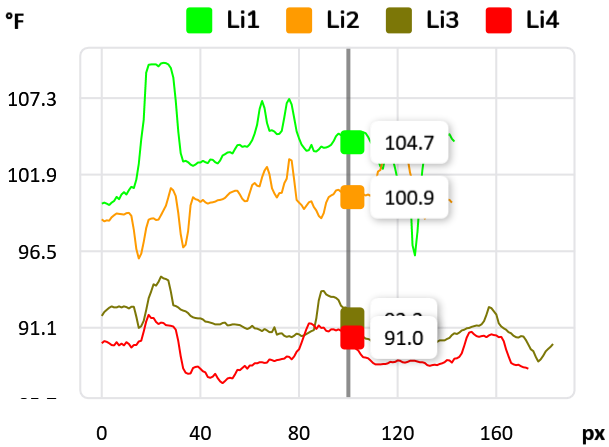
CM-2 Contactor/Starter

Li1	
Max	109.8 °F
Avg	103.9 °F
Min	96.2 °F
Li2	
Max	104.3 °F
Avg	100.3 °F
Min	96.0 °F
Li3	
Max	94.7 °F
Avg	91.3 °F
Min	88.8 °F
Li4	
Max	92.0 °F

None

N/A

There are no issues to note this survey.

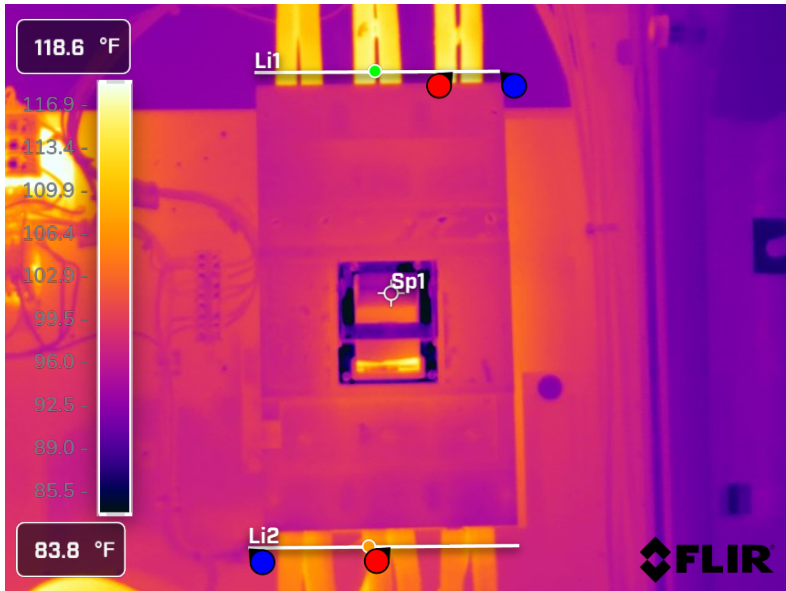
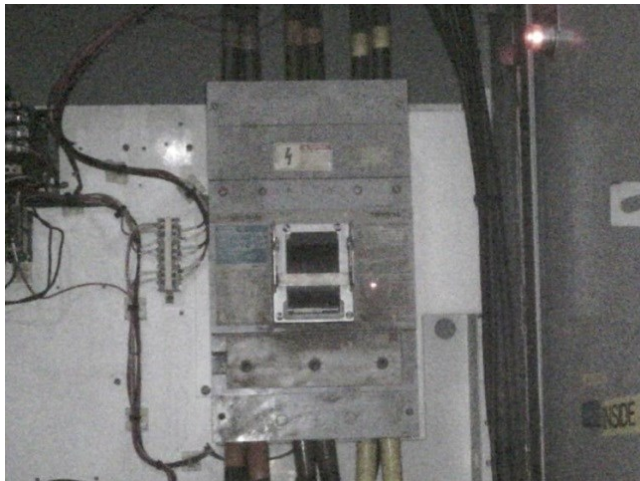
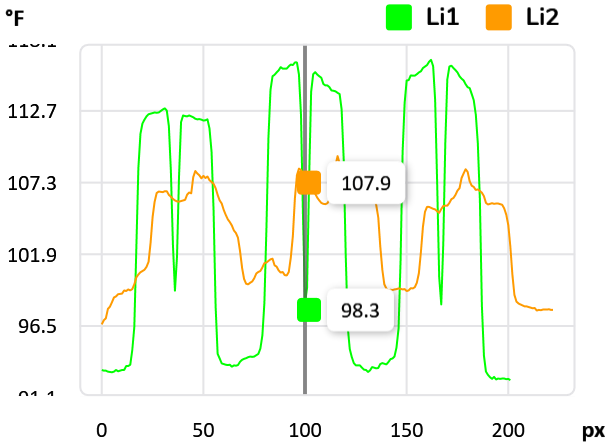
CM-3 Breaker

Li1	
Max	116.6 °F
Avg	104.6 °F
Min	92.4 °F
Li2	
Max	109.3 °F
Avg	103.5 °F
Min	96.6 °F
Sp1	
	96.7 °F

None

N/A

There are no issues to note this survey.

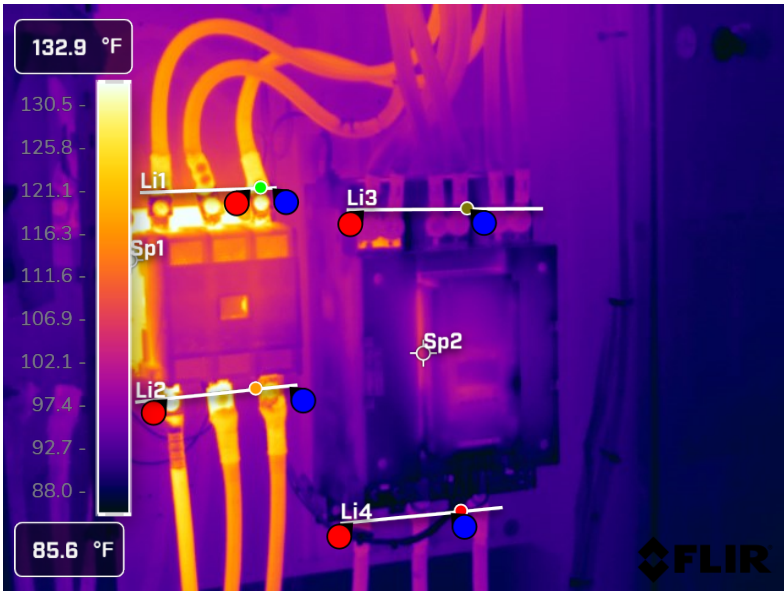
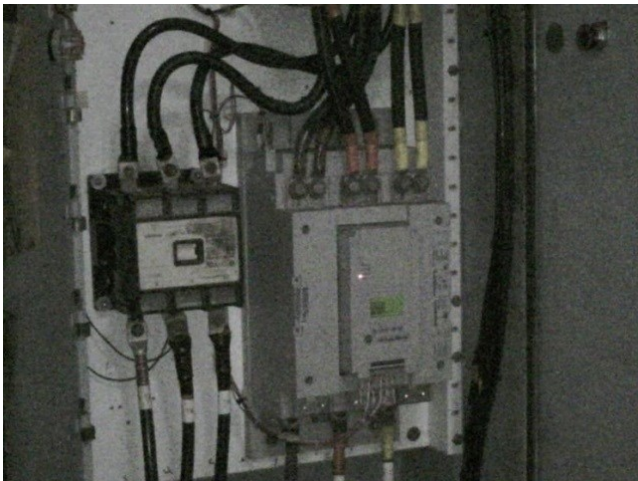
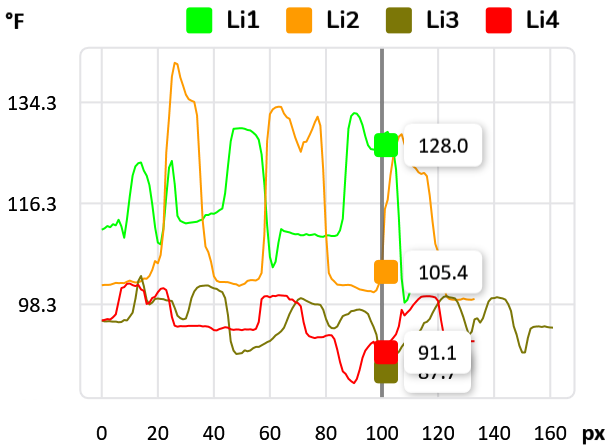
CM-3 Contactor/Starter

Li1	
Max	132.4 °F
Avg	117.0 °F
Min	98.6 °F
Li2	
Max	141.4 °F
Avg	112.7 °F
Min	99.2 °F
Li3	
Max	103.4 °F
Avg	95.8 °F
Min	86.7 °F
Li4	
Max	102.0 °F

None

N/A

There are no issues to note this survey.
