USG Greenville, MS
May 2024
Infrared Survey Report

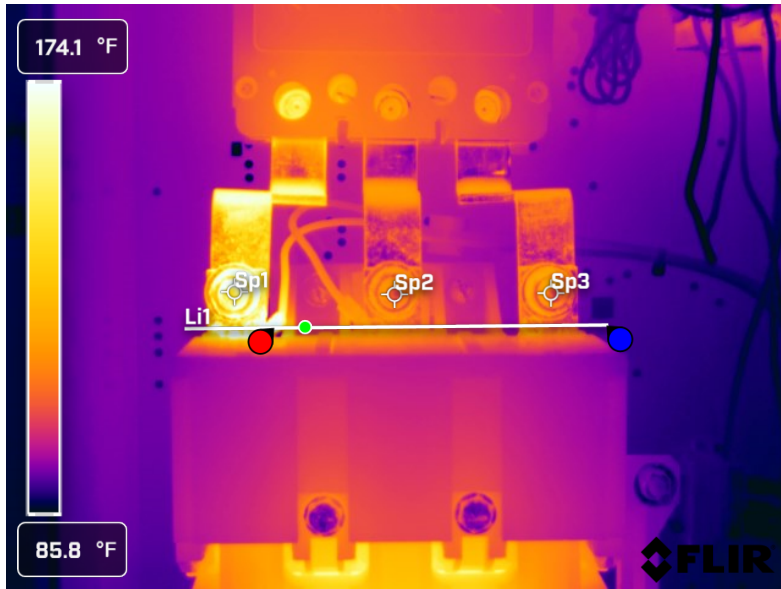
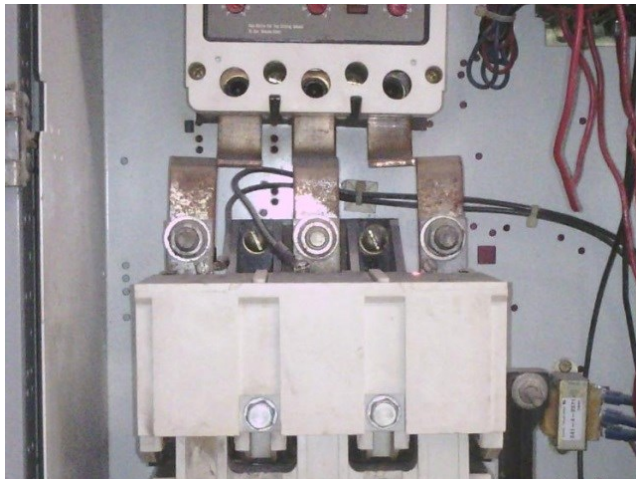
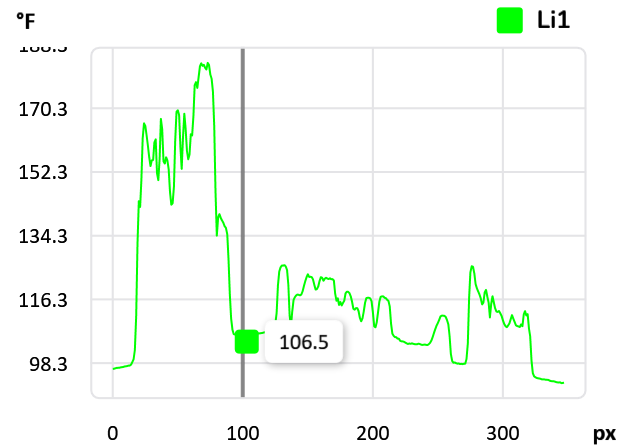
MCC-10B1 M2248 Expander 7 DC Fan

Buss/Lead Connection

Li1	
Max	183.2 °F
Avg	119.4 °F
Min	92.7 °F
Sp1	158.7 °F
Sp2	108.2 °F
Sp3	111.5 °F

Faulty Connection

CLASS II

The A phase connection has an issue. It may be the small lead wire that has the connection issue but may also be the copper buss jumper connection. Check connections ensuring a clean and tight connection.

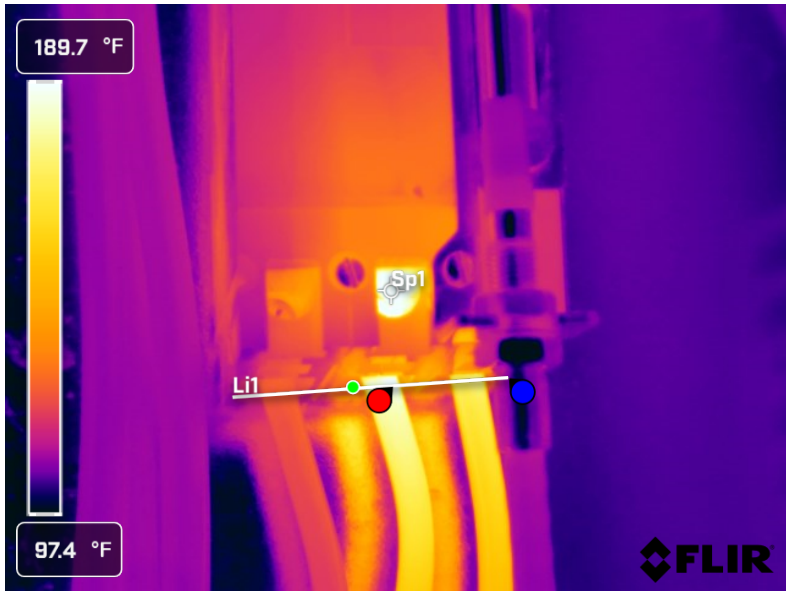
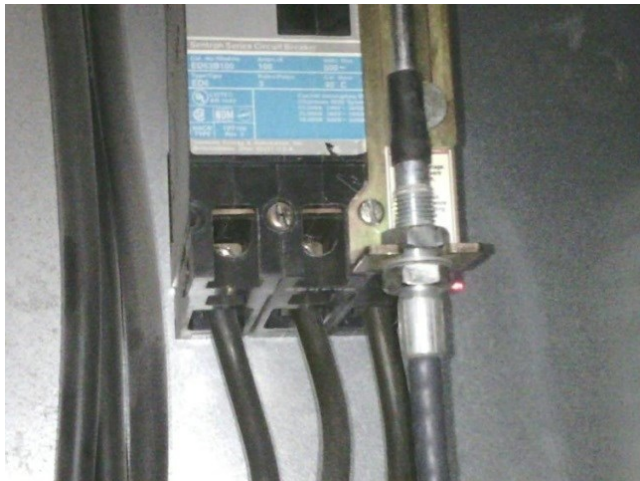
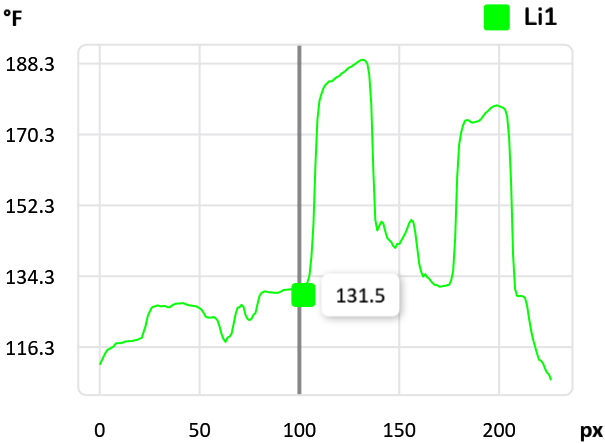
Machine Chest Pump 3A

Breaker

Li1	
Max	189.3 °F
Avg	141.1 °F
Min	108.0 °F
Sp1	206.2 °F

Breaker connections

CLASS II

This is a recheck and still shows an issue. This is likely an internal breaker issue. Inpsect and replace breaker if needed.
