**Greenville, MS  
September 2024  
Infrared Survey Report**

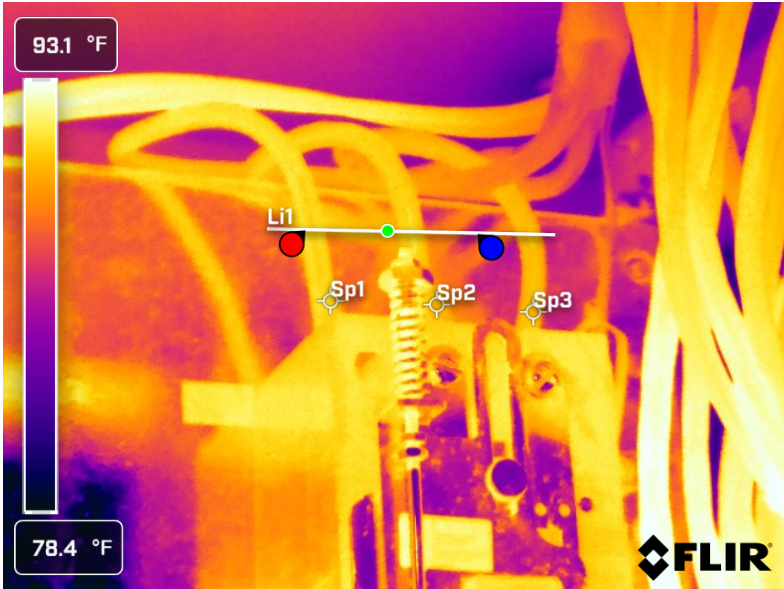
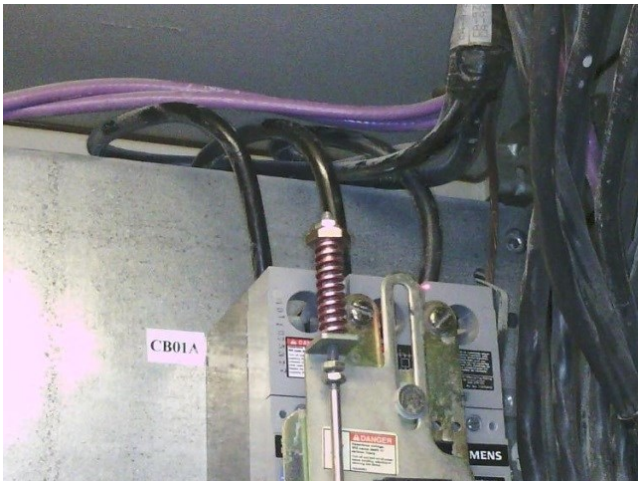
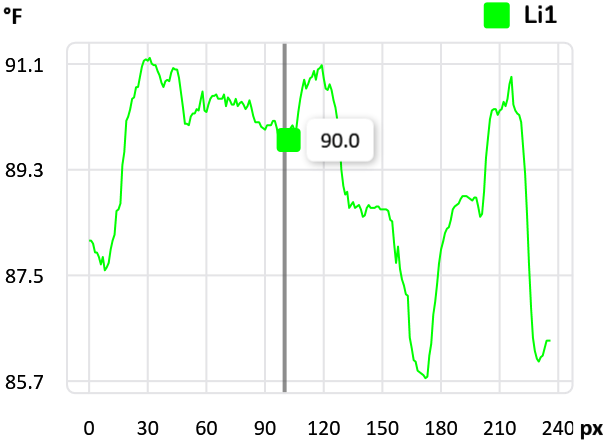
VFD Panel D

Breaker

Li1	
Max	91.2 °F
Avg	89.3 °F
Min	85.8 °F
Sp1	91.0 °F
Sp2	90.1 °F
Sp3	90.4 °F

None

N/A

Recheck shows no issues.

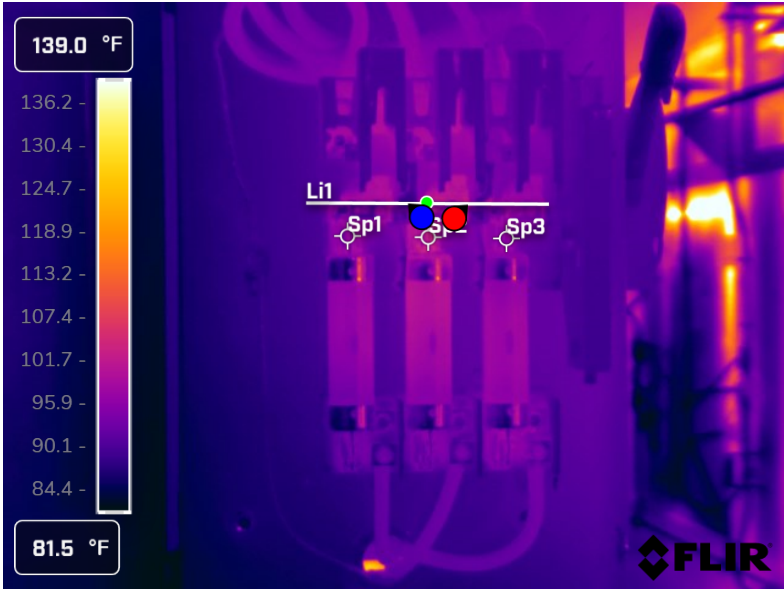
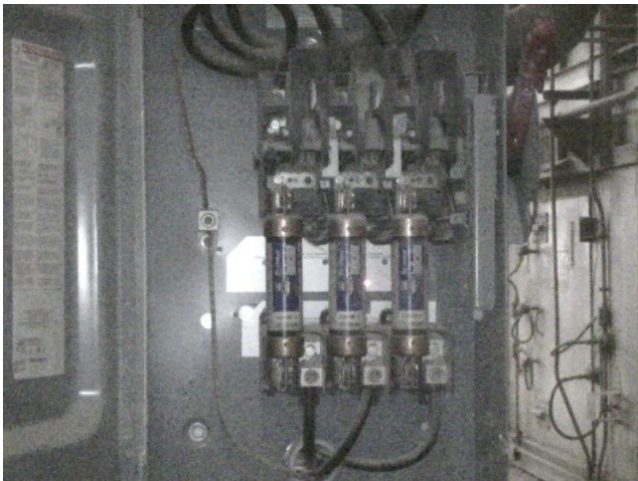
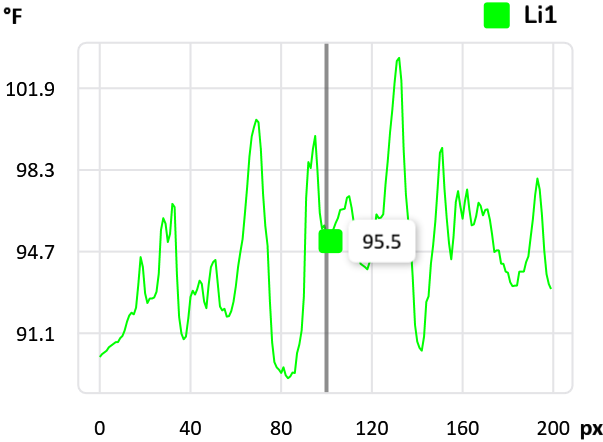
IHEI Oven

Disconnect switch

Li1	
Max	103.3 °F
Avg	94.6 °F
Min	89.2 °F
Sp1	99.4 °F
Sp2	103.0 °F
Sp3	97.5 °F

None

N/A

Recheck shows no issues.

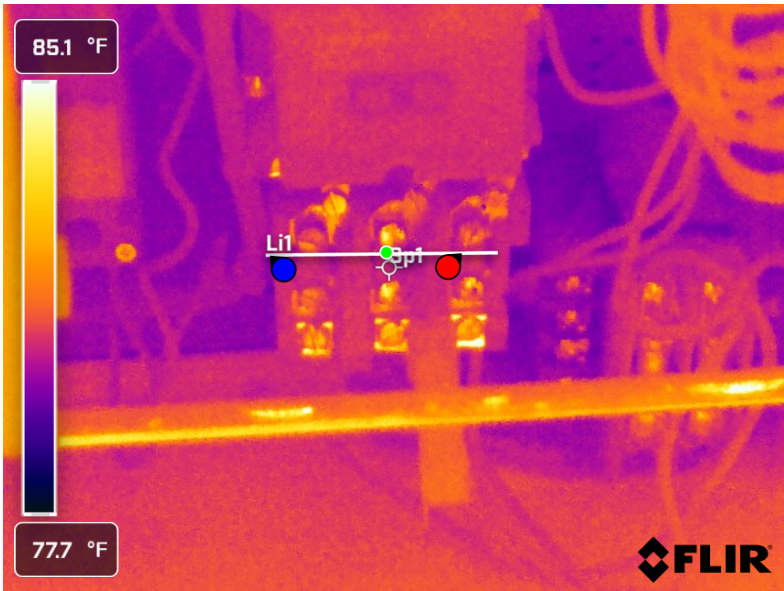
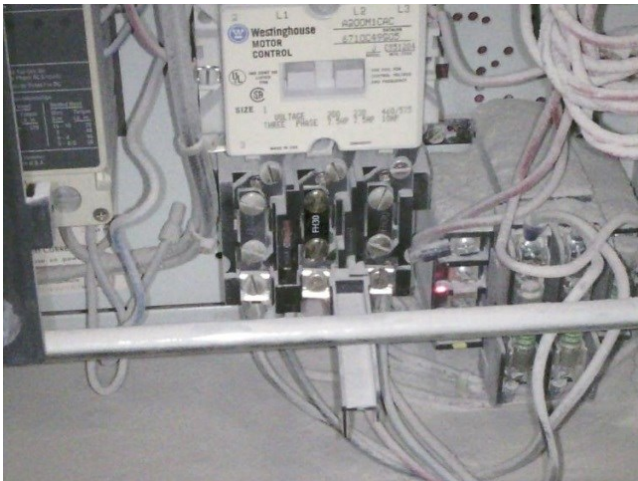
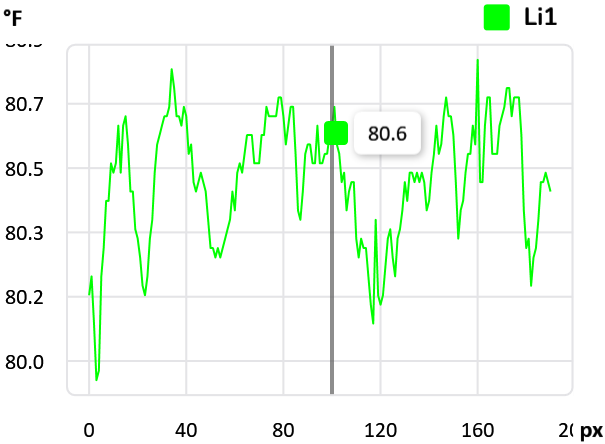
MCC 9B1 M0134 South 2 x 4 hopper conveyor

Thermal overload

Li1	
Max	80.8 °F
Avg	80.5 °F
Min	79.9 °F
Sp1	80.4 °F

None

N/A

Recheck shows no issues.

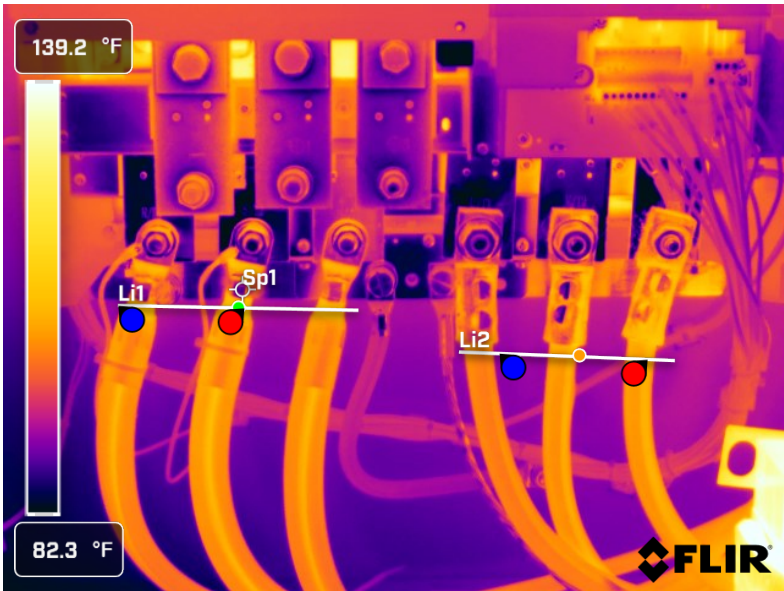
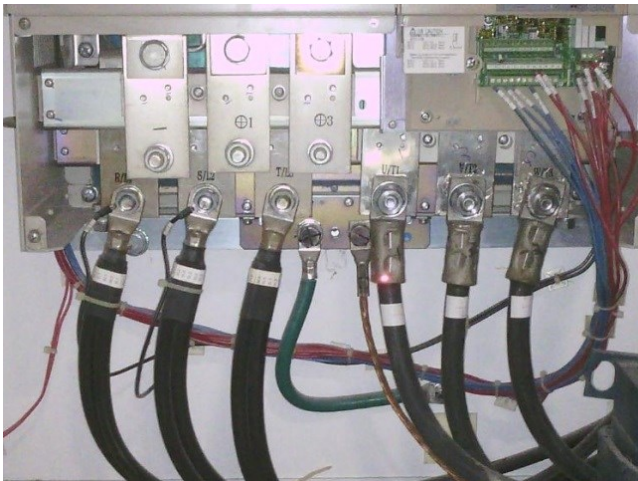
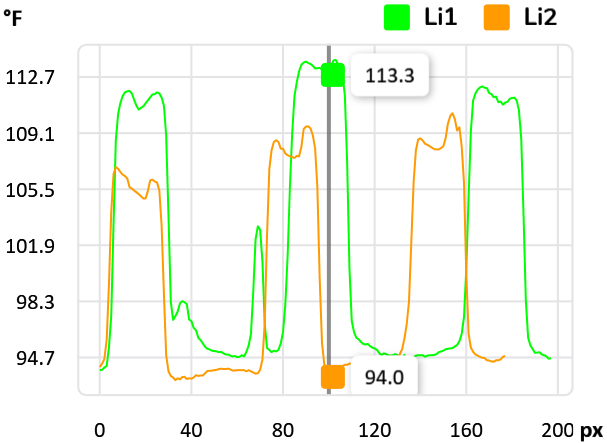
Vacuump Pump #1 VFD

Lead connections

<b>Li1</b>	
Max	113.8 °F
Avg	101.8 °F
Min	93.9 °F
<b>Li2</b>	
Max	110.4 °F
Avg	99.5 °F
Min	93.3 °F
<b>Sp1</b>	89.2 °F

None

N/A

Recheck shows no issues.

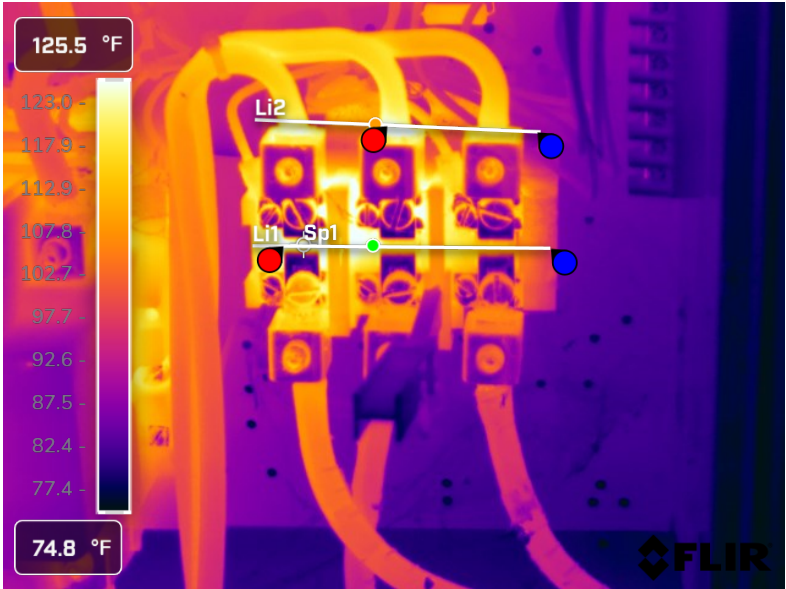
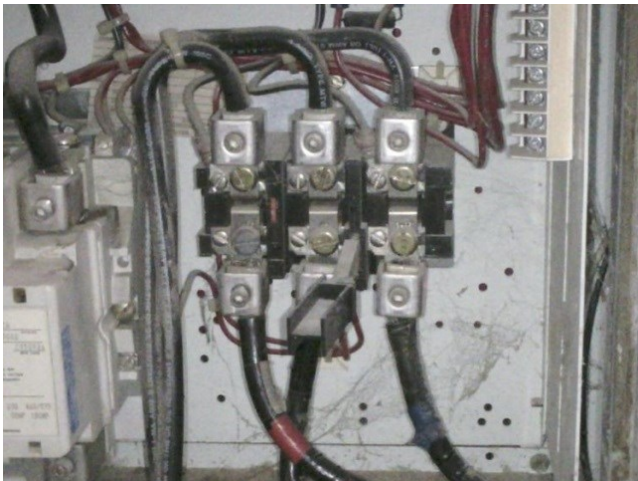
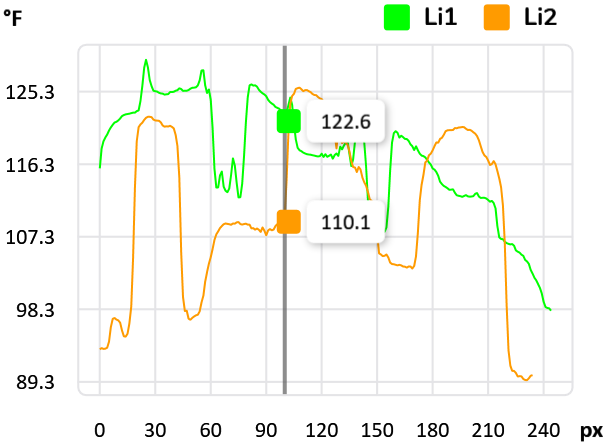
MCC 7C1 M1377 #3 White Water Pump

Lead connections

<b>Li1</b>	
Max	129.3 °F
Avg	117.1 °F
Min	98.2 °F
<b>Li2</b>	
Max	125.8 °F
Avg	111.0 °F
Min	89.5 °F
<b>Sp1</b>	126.2 °F

None

N/A

Recheck shows no issues.

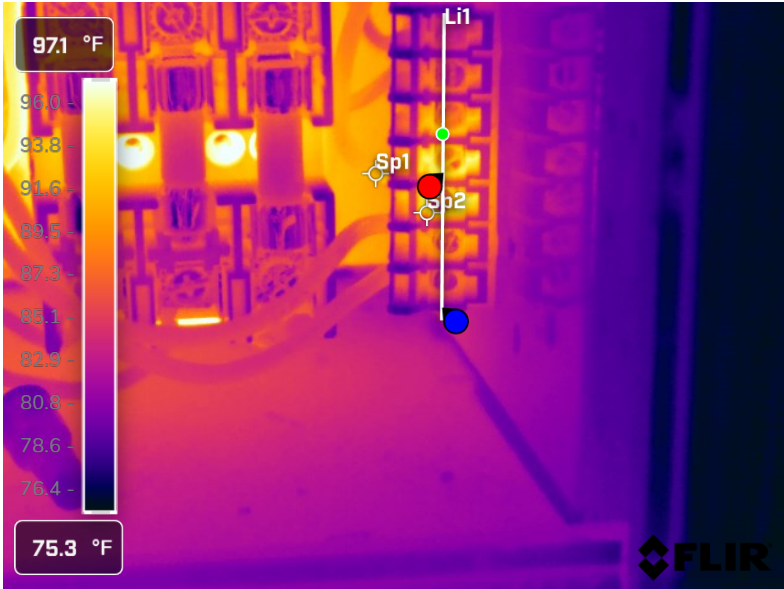
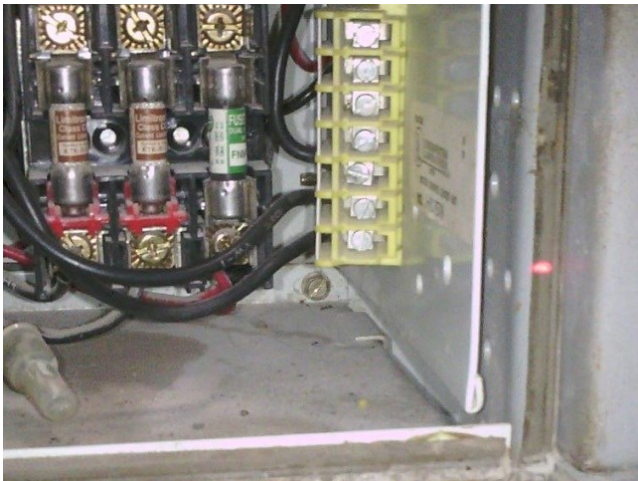
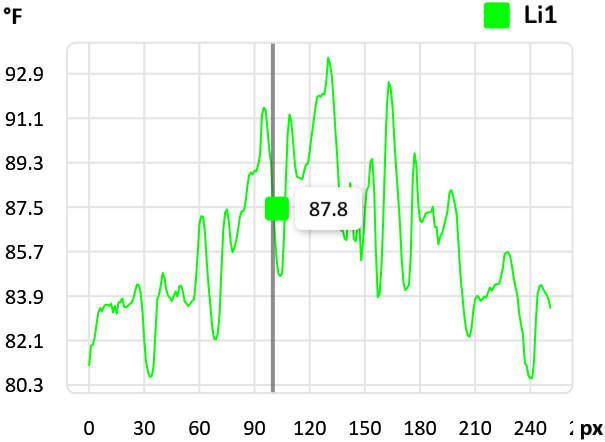
MCC 7C1 M1369 Wet End Coating Tank Agitator

Terminal connections

Li1	
Max	93.6 °F
Avg	86.0 °F
Min	80.6 °F
Sp1	91.1 °F
Sp2	90.9 °F

None

N/A

Recheck shows no issues.

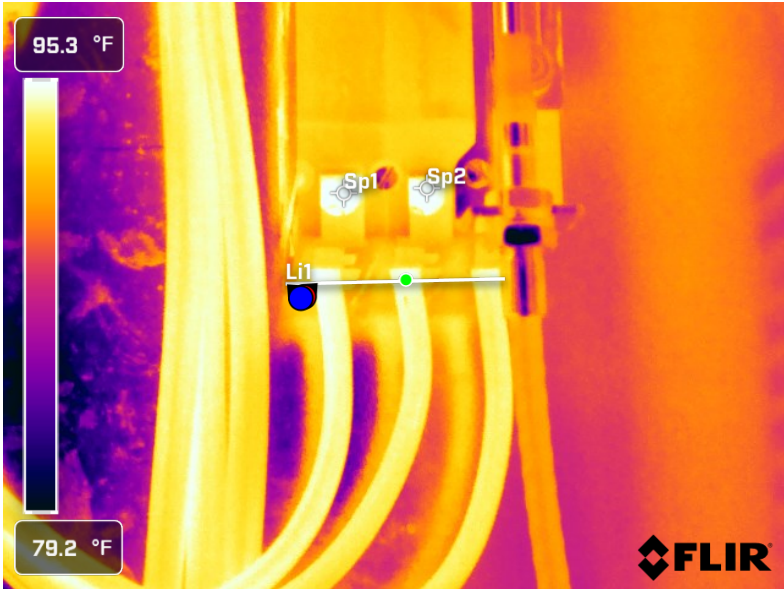
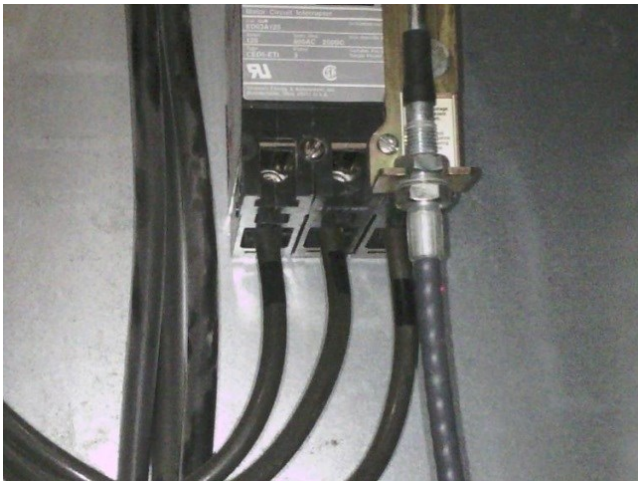
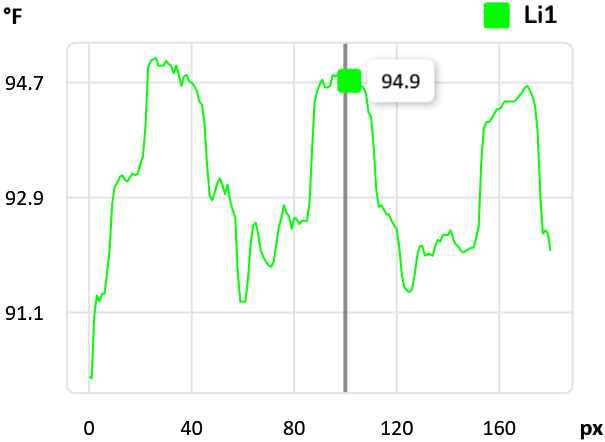
Machine Chest Pump 3A VFD Panel

Breaker

Li1	
Max	95.1 °F
Avg	93.2 °F
Min	90.1 °F
Sp1	95.9 °F
Sp2	95.3 °F

None

N/A

Recheck shows no issues.
