★ *SOUTHLAND CASINO HOTEL* ★

West Memphis, AR
2024 Infrared Survey Report

October 9, 2024

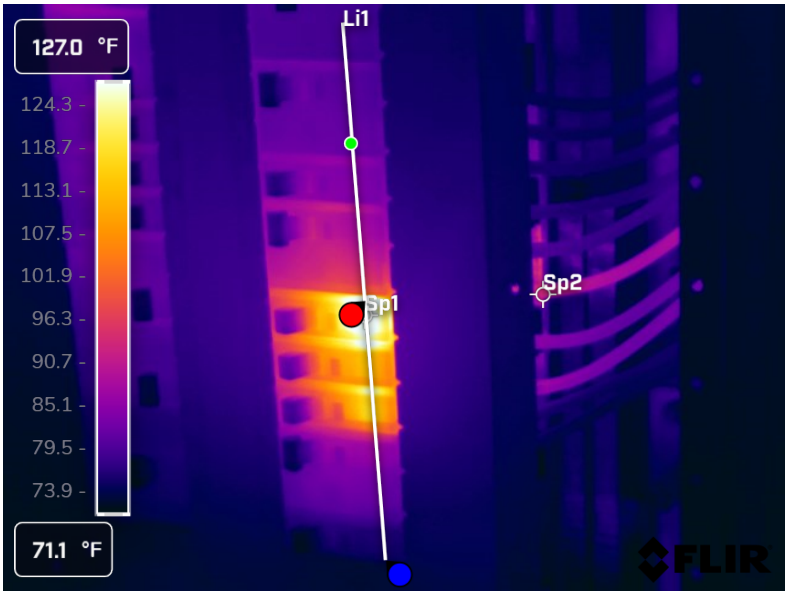
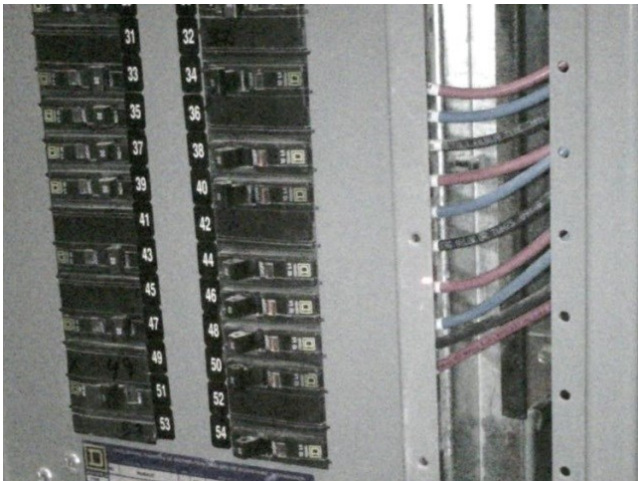
LCS1 E-3

Breaker circuit 44

Li1	
Max	139.5 °F
Avg	94.0 °F
Min	74.7 °F
Sp1	133.7 °F
Sp2	93.9 °F

Overloaded circuit

CLASS II

IR image shows heat on breaker 44. Amps were checked and found to have 22 amps on 20 amp breaker. Wire size will allow for 30 amp breaker. It is recommended to swap out breaker to 30 amp breaker if possible.

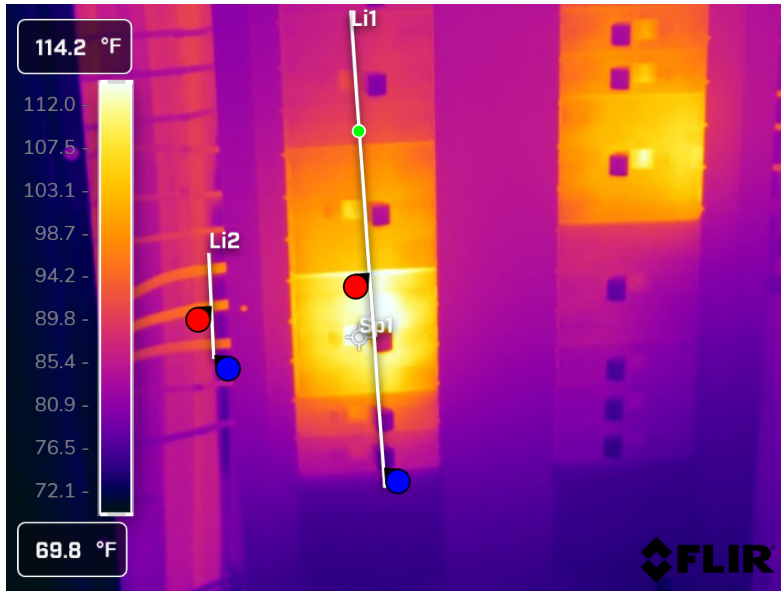
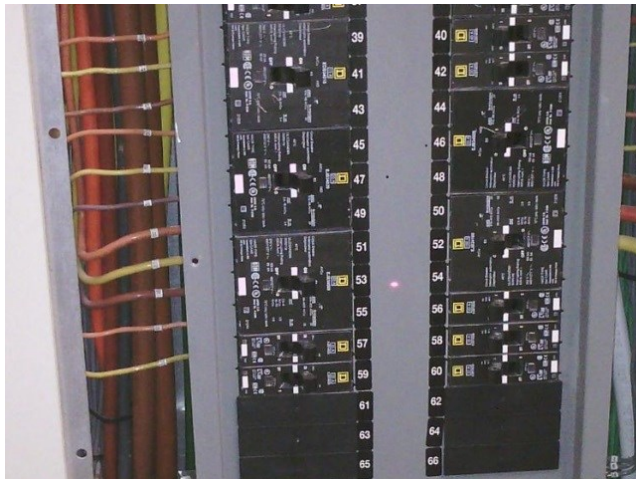
HNP1 F-1

Breaker circuit 51-55

Li1	
Max	114.8 °F
Avg	96.7 °F
Min	77.5 °F
Li2	
Max	98.4 °F
Avg	89.4 °F
Min	84.3 °F
Sp1	120.6 °F

Faulty breaker

CLASS II

IR image shows delta-T on 3 phase breaker 51-55. Amp reading was performed and circuits appeared to have no load. Breaker may have internal faults. Plans should be made to inspect/change breaker as scheduling allows.

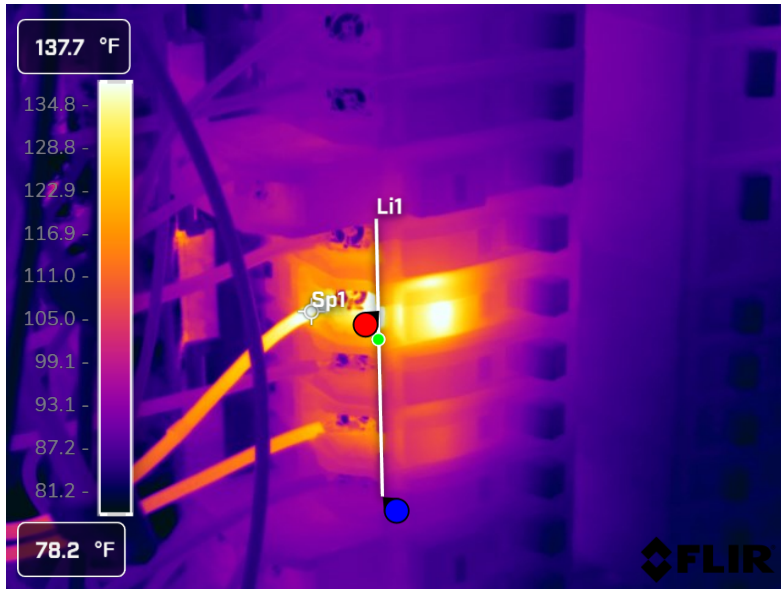
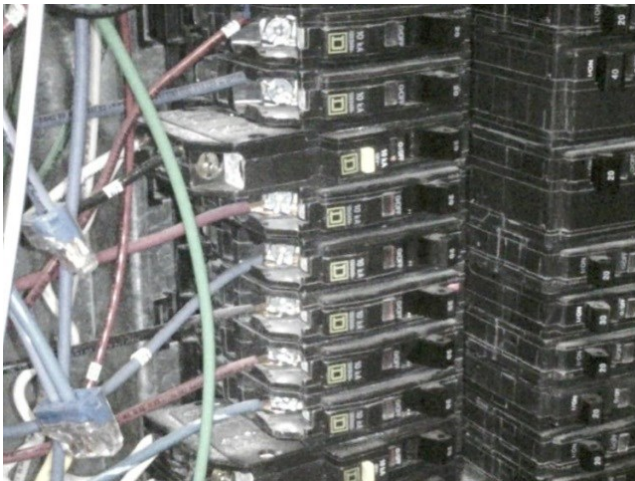
LNK1 E-1

Breaker circuit 71

Li1	
Max	153.3 °F
Avg	111.8 °F
Min	95.0 °F
Sp1	140.9 °F

Overloaded circuit

CLASS II

Breaker 71 has high delta-T. Connections was found to be tight. Amps were checked and circuit is overloaded. Breaker had 22 amps an 20 amp breaker. Upsize breaker to 30 amps if applicable.

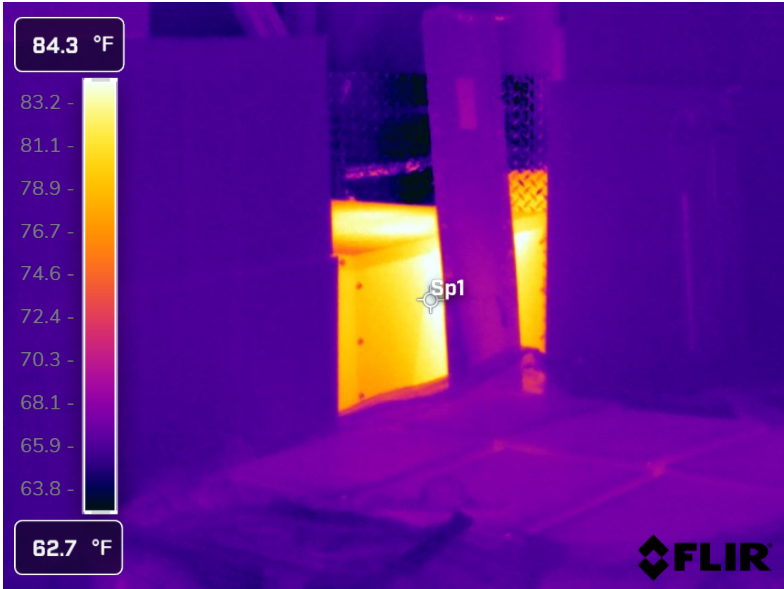
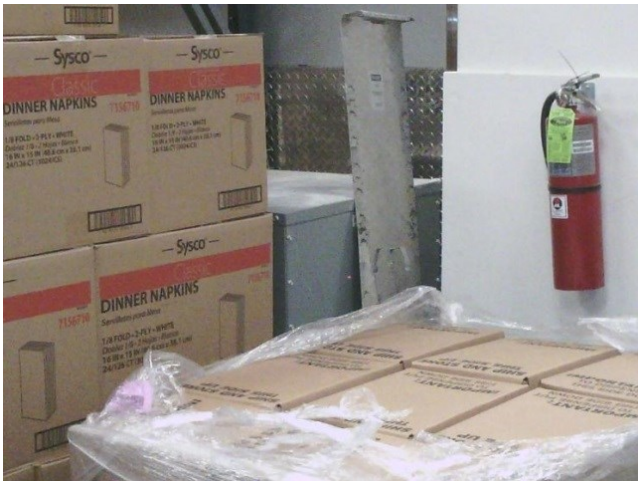
TLNK D-1

Sp1	84.7 °F
-----	---------

Covered Transformer

CLASS II

This transformer was found to be covered by materials. No excessive heat to mention; however, this is a violation of NFPA 70E code. Materials should be cleared away from the transformer asap.

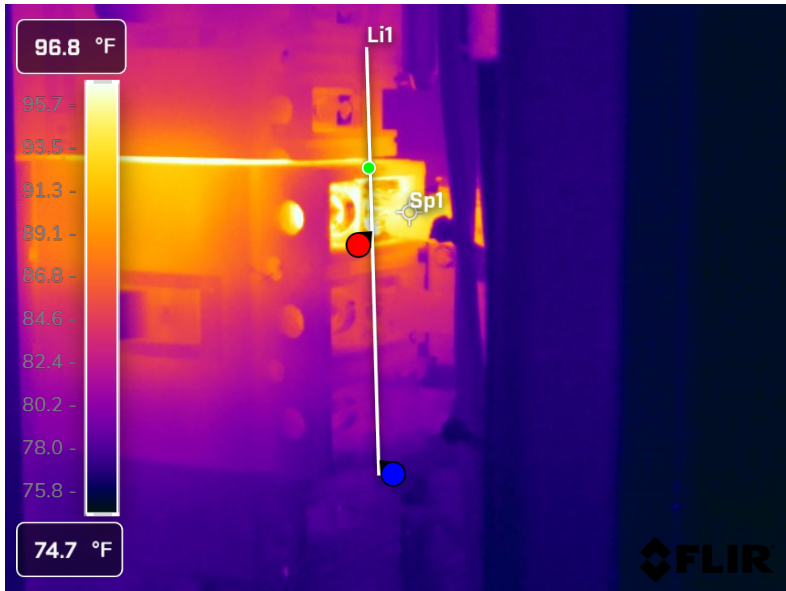
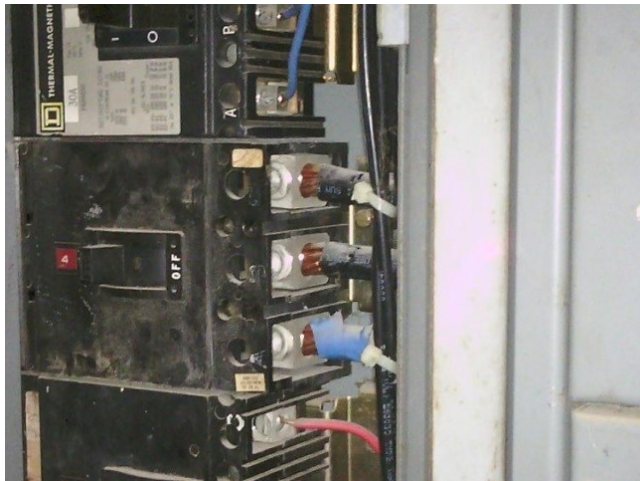
MSB W-1

2N/VA

Li1	
Max	99.3 °F
Avg	85.6 °F
Min	77.9 °F
Sp1	95.0 °F

Connection/lug issue

CLASS I

Image shows characteristics of a loose connection. Ensure connection is clean and tight. Ensure lug is not loose internally.
