LR Field Services

AC Inspection as Found

AC Inspection - Rev. 2

Description: 150 HP WEG

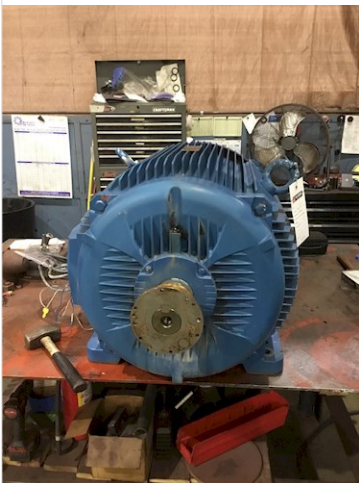
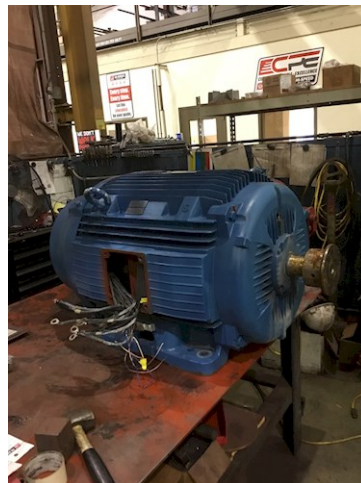
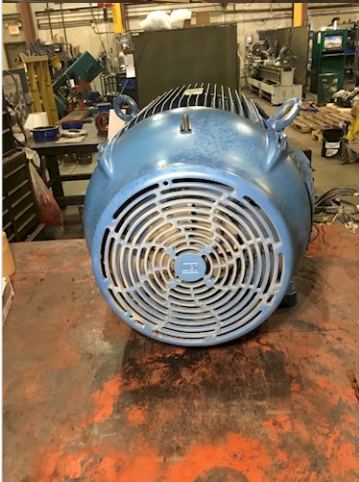
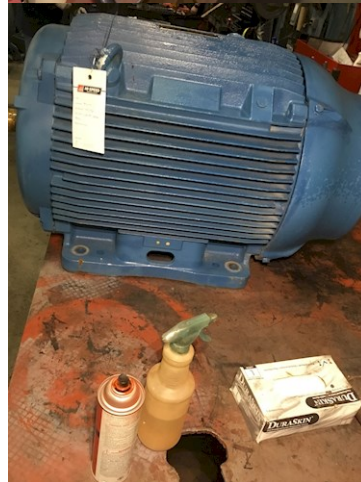
3. Photos of all six sides of the machine.

4. Describe the Overall Condition of the Equipment as Received
Serviceable

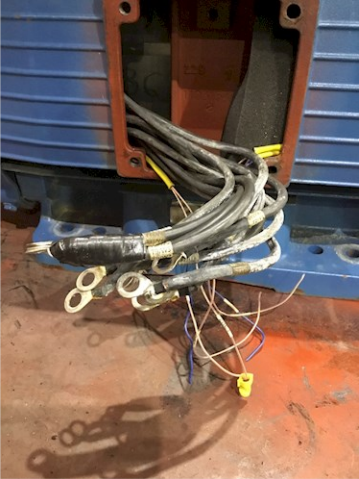
10. Assembled Shaft End Play	0 inches
11. Air Gap Variation <10%	
12. Lead Condition	(P) Pass

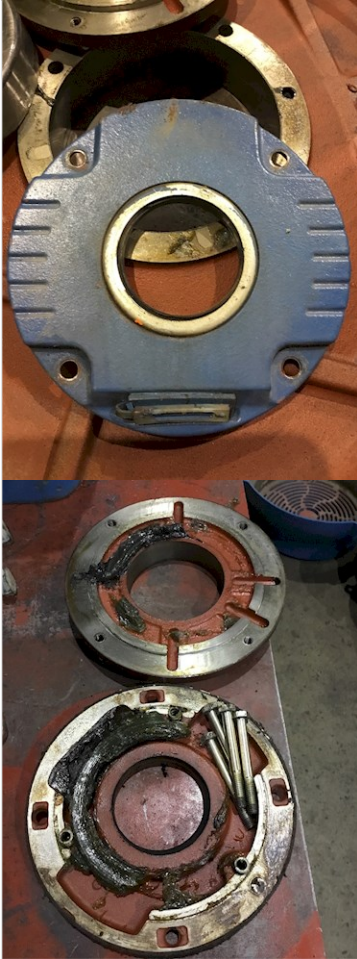
Drive End Bearing Cap
pass

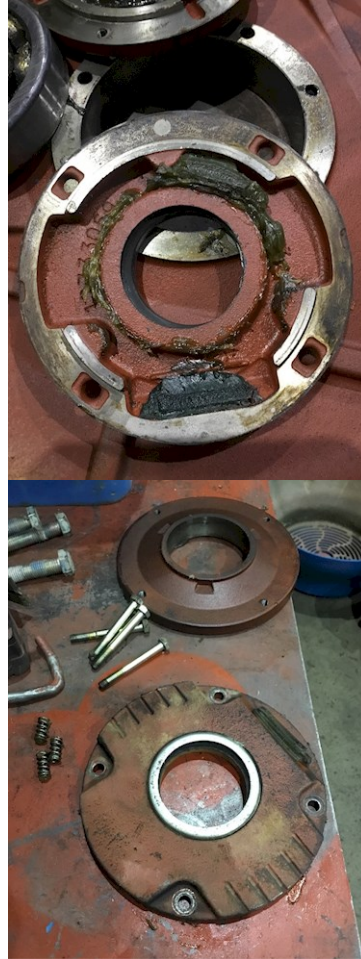
Opposite Drive End Bearing Cap
pass

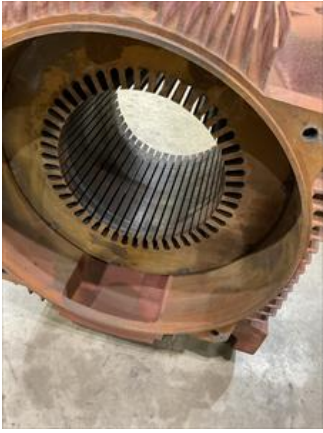
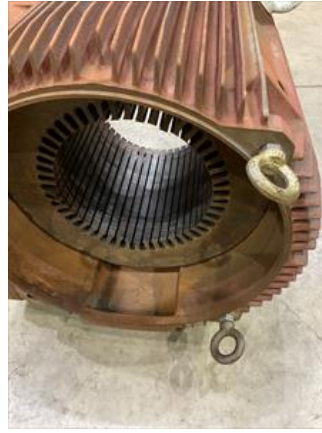
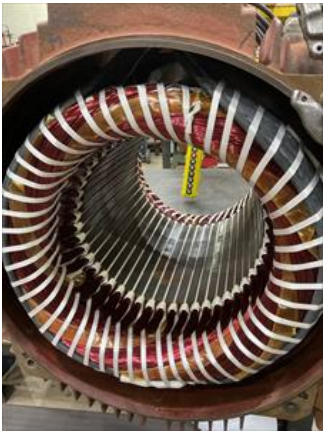
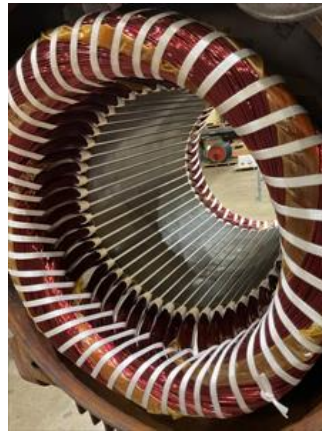
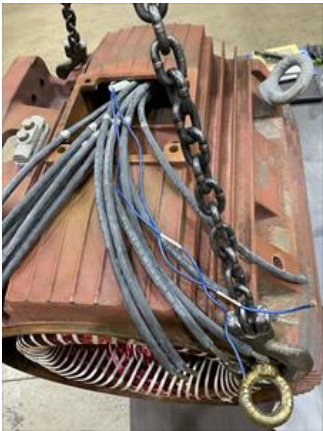
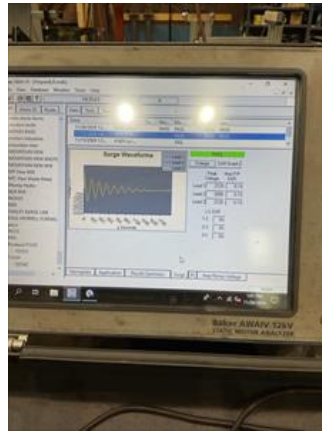
Water leaked into stator windings from improperly sealed connection box. Motor showed signs of being single phased because of 2 groups of coils being overheated. see pictures.

Rewind stator & sleeve ode housing fit
