AC Inspection as Found

Reynolds Metals company

Location: LITTLE ROCK MOTOR SHOP

Description: 75HP MARATHON

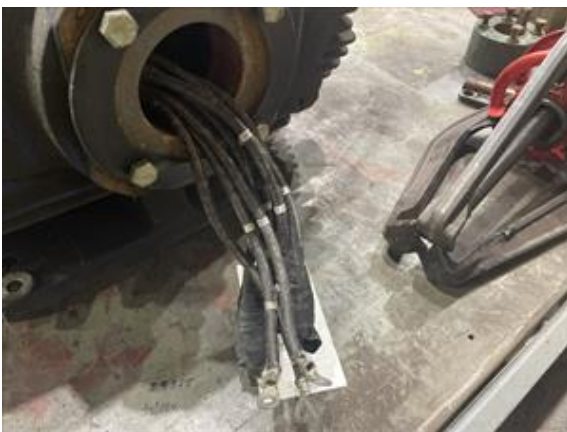
P69

6.	Does Shaft Turn Freely?	(Y) Yes
7.	Does the shaft require T.I.R in Lathe to identify additional repairs?	(No) No
8.	Does Shaft Have Visible Damage?	(No) No
9.	Assembled Shaft Runout	0.001 Inches
10.	Assembled Shaft End Play	0 inches
11.	Air Gap Variation <10%	n/a
12.	Lead Condition	(P) Pass

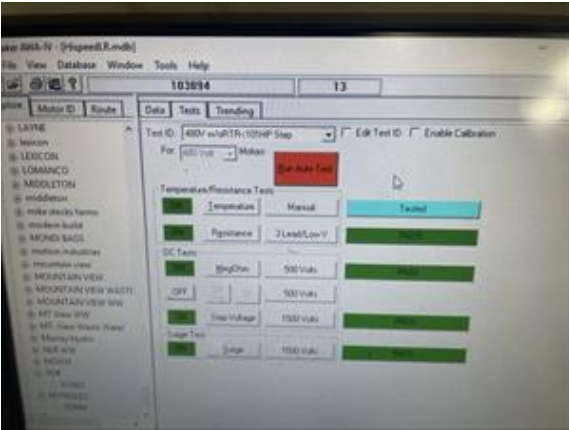
18.	Broken or Missing Components	Na	
Initial Electrical Inspection			
19.	Insulation Resistance/Megger	Megohms	
20.	Winding Resistance	1-2 1-3 2-3	
	Pass		
21.	Perform Surge Test	(P) Pass	P57

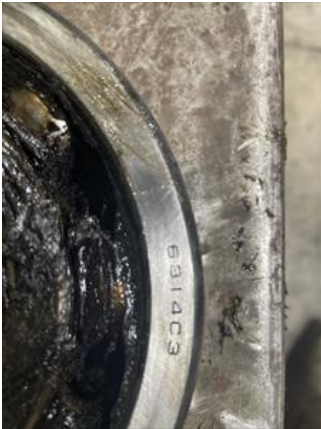
P32

33. Drive End Bearing Condition

Replace

*Bearings 6314 & 6312 2Z/C3 bearings
Sleeve ODE housing fit*

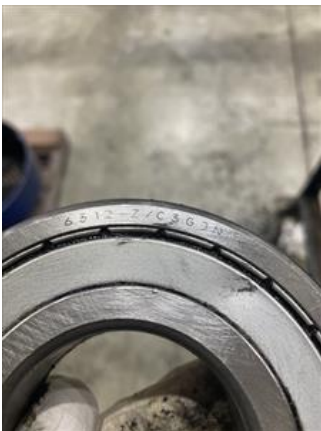
P99

35. Opposite Drive End Bearing Number-
6312

41. Opposite Drive End Bearing Condition

☐ Replace

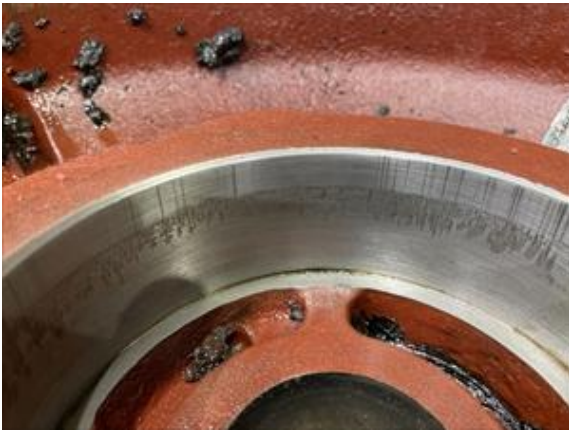
*Excessive wear*

62. Opposite Drive End - Endbell Bearing Fit Condition **(F) Fail**

67. Failure locations

Bearings, and ODE housing

68. Root cause of failure

*Contaminated grease***Dynamic Balance Report**

ODE housing fit

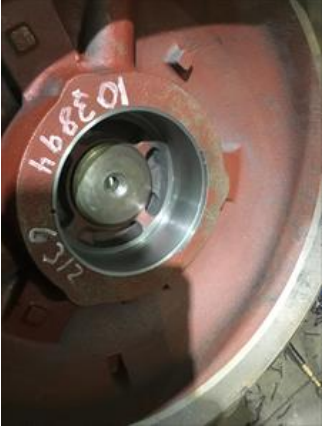
73. Drive End - Endbell Bearing Fit Post Repair			
0 Degrees	60 Degrees	120 Degrees	
74. Opposite Drive End - Endbell Bearing Fit Post Repair P19			
0 Degrees	60 Degrees	120 Degrees	
5.1184	5.1184	5.1184

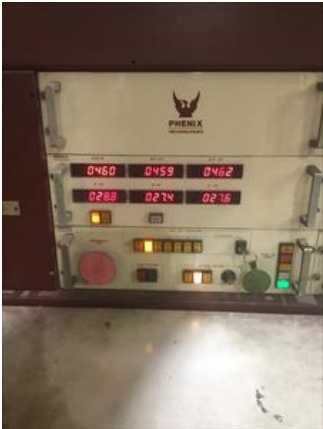
81.	Assembled Shaft Endplay	0 inches	
82.	Assembled Shaft Runout	0.002 inches	
83.	Test Run Voltage	P56	
	Volts	Volts	Volts
	460	4599	462

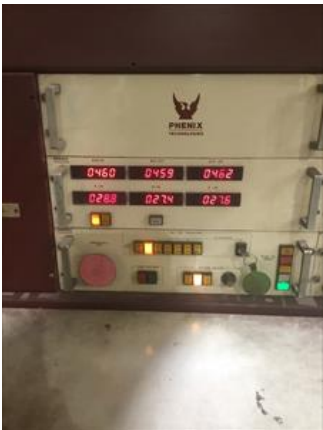
84.	Test Run Amperage	P65	
	Amps	Amps	Amps
	28.8	27.4	27.6
