AC Inspection as Found

AC Inspection - Rev. 2

Description: ROOTS BLOWER

Hi-Speed Job Number: 103920

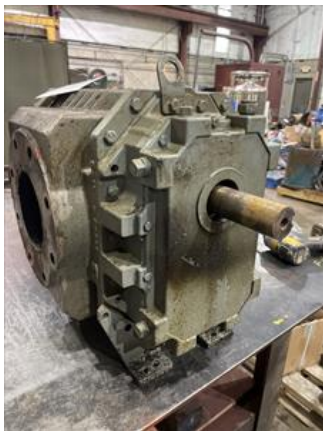
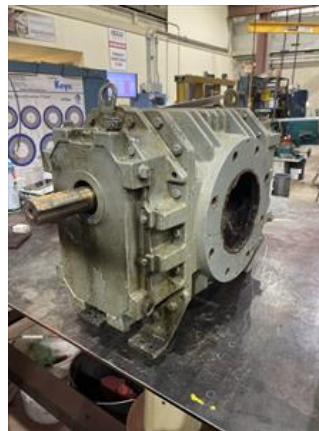
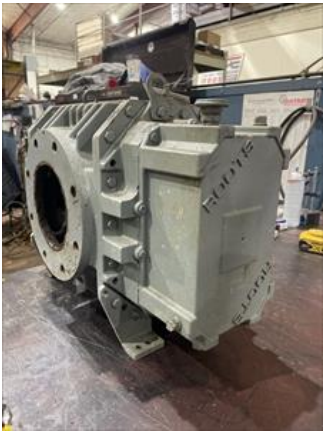
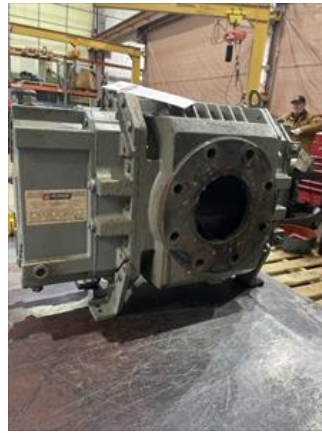
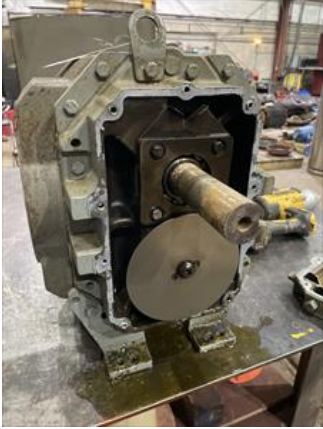
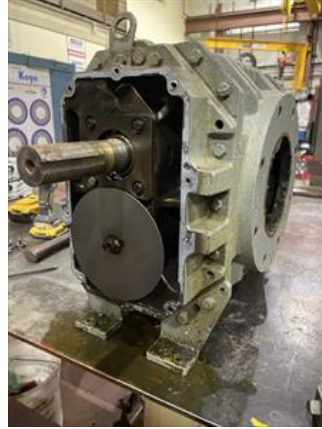
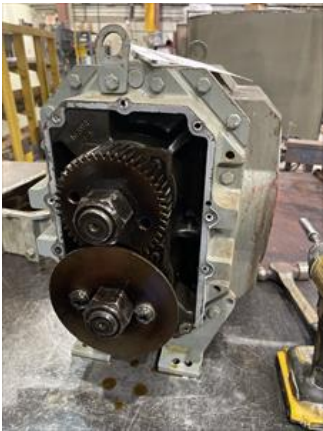
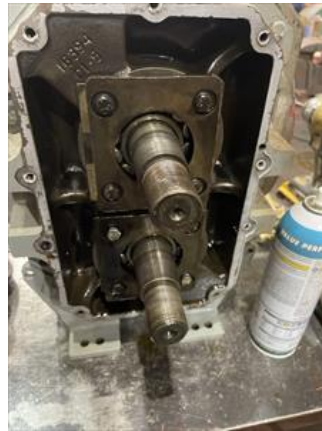
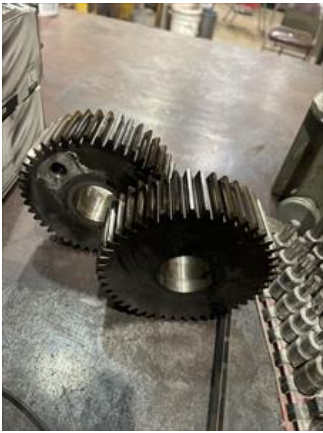
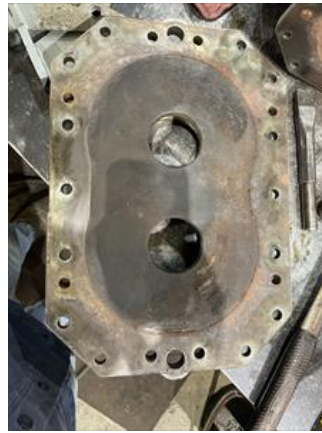
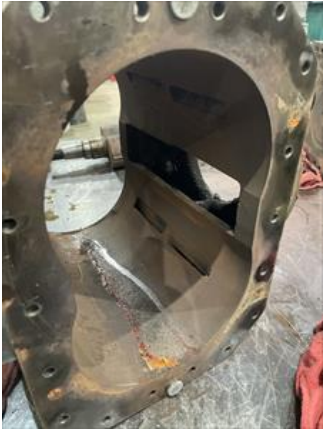
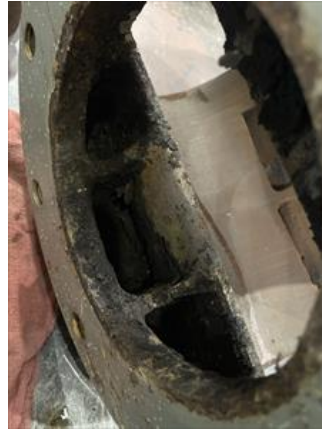
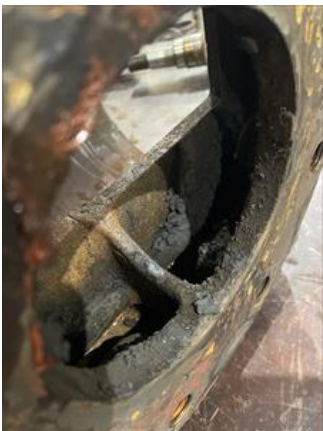
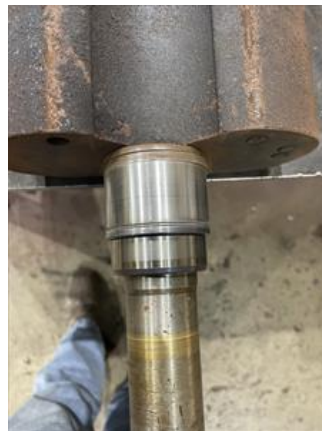
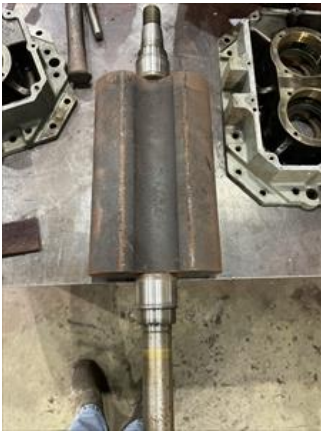
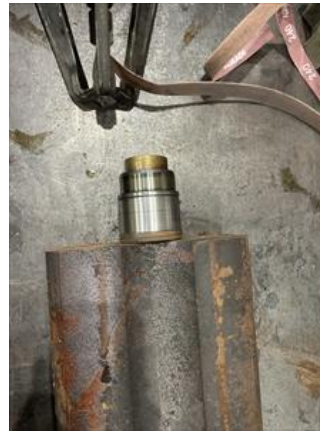
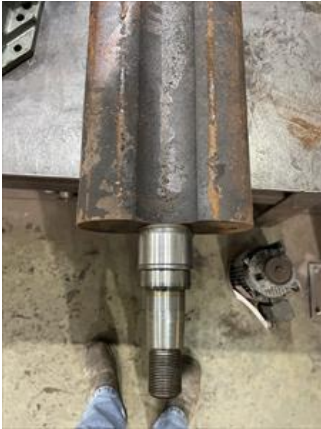
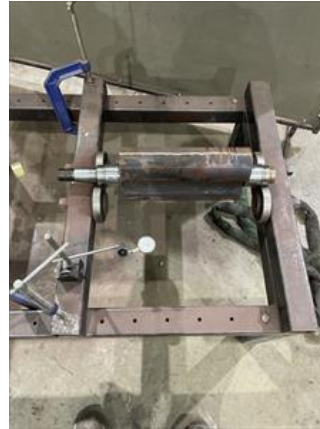
P45

*Dirty and rusted
Need bearings, seals and machine 3 housings*

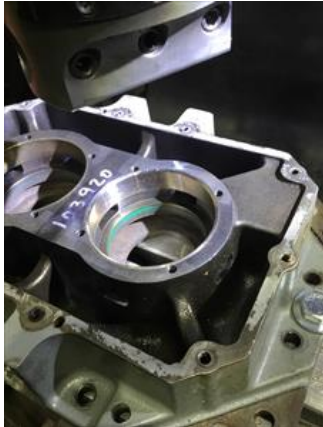
72.	Drive End - Endbell Bearing Fit Post Repair			P5
	0 Degrees	60 Degrees	120 Degrees	
	3.5436	3.5436	3.5436

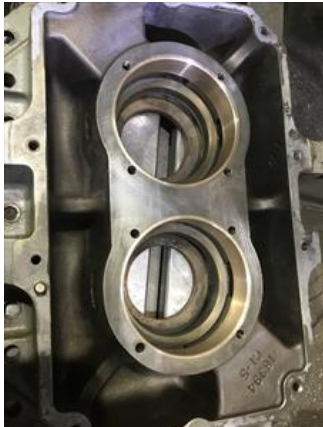
73.	Opposite Drive End - Endbell Bearing Fit Post Repair			P19
	0 Degrees	60 Degrees	120 Degrees	
	3.5435	3.5435	3.5434	
	3.5436, 3.5437, 3.5437
