AC Inspection as Found

Arauco-Malvern MDF (10298)

AC Inspection - Rev. 2

Description: 60 HP RELIANCE

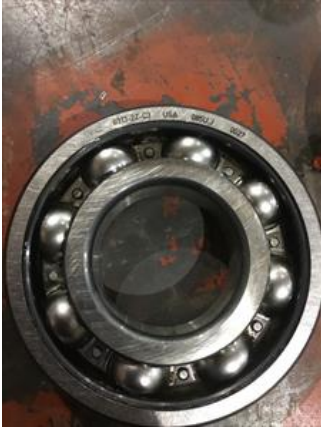
25. Drive End Bearing Brand

fag

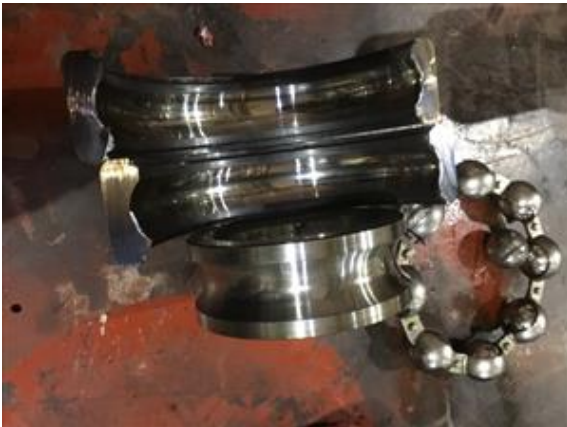
32. Drive End Bearing Condition

Contamination

Excessive wear and contamination

45.	Number of Rotor Bars	47
46.	Rotor Condition	pass
47.	List the Parts needed for the Repair Below 6313x2 J-box cover and bolts Aegis ring- 2.9992	
48.	Signature of Technician that Disassembled Motor	Cw

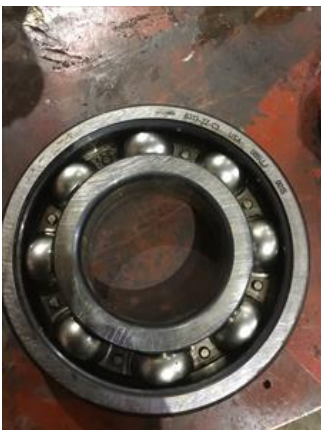
33. Opposite Drive End Bearing Brand

fag

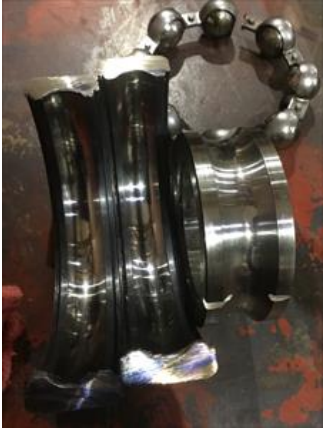
38.	Opposite Drive End Bearing Insulation or Grounding Device?	
39.	Opposite Drive End Wavy Washer/Snap-Ring Other Retention Device?	wavy washer
40.	Opposite Drive End Bearing Condition	P118
<div> <div></div> <div>Contamination</div> </div>

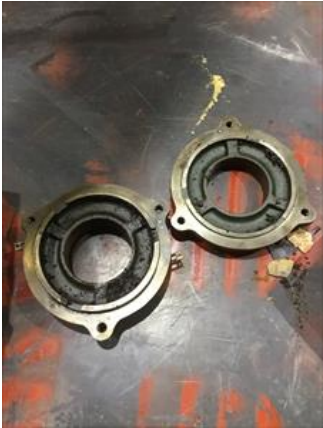
</div>			
58.	Drive End - Endbell Bearing Fit		
	0 Degrees	60 Degrees	120 Degrees
	<div>Excessive lip worn into fit</div>

59.	Drive End - Endbell Bearing Fit Condition		(F) Fail
60.	Opposite Drive End - Endbell Bearing Fit		
	0 Degrees	60 Degrees	120 Degrees
	<div>5.5117-5.5123-5.5115</div>

61.	Opposite Drive End - Endbell Bearing Fit Condition		(F) Fail
	<div>Egg shaped</div>		
62.	Bearing Cap Condition		P52
	Drive End Bearing Cap	Opposite Drive End Bearing Cap

63.	End Bell Air Seal Fits		
	Drive End Air Seal	Opposite Drive End Air Seal	
64.	List Machine Work Needed Below		
	<i>DE end bell Beaty fit</i>

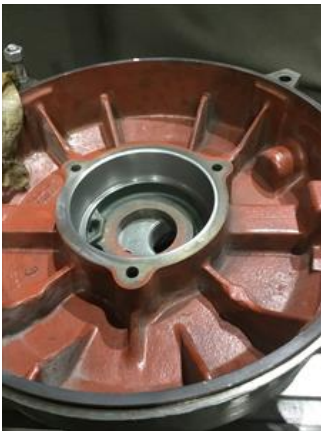
80. Drive End - Endbell Bearing Fit Post Repair

5.5122

5.5121

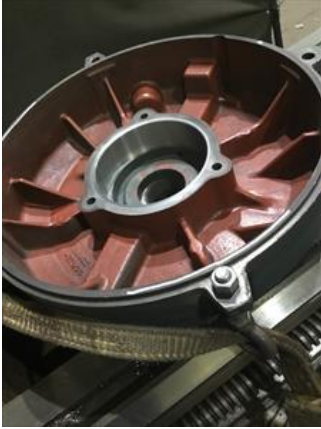
81. Opposite Drive End - Endbell Bearing Fit Post Repair

5.512
