## AC Inspection as Found

### AC Inspection - Rev. 2

Location: LR MOTORSHOP  
Serial Number: 1PC31042AA600FB4  
Description: 45.0 KW SIEMENS

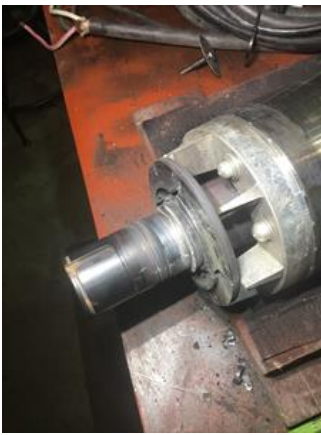
<input checked="" type="radio"/>	6. Does Shaft Turn Freely?	(N) No	
<input checked="" type="radio"/>	7. Does the shaft require T.I.R in Lathe to identify additional repairs?	(Yes) Yes	P16

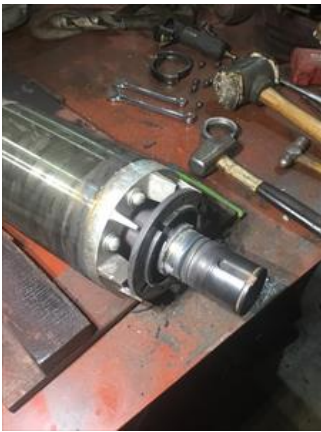
8. Does Shaft Have Visible Damage?	(Yes) Yes	P26
------------------------------------	-----------	-----

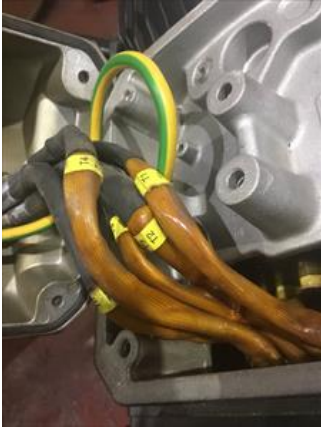
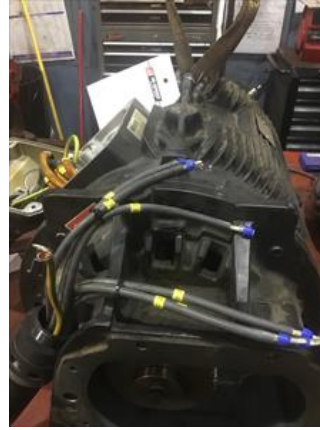
9. Assembled Shaft Runout	Inches
<input checked="" type="checkbox"/> Unable to perform due to locked up shaft	
10. Assembled Shaft End Play	inches
11. Air Gap Variation <10%	no

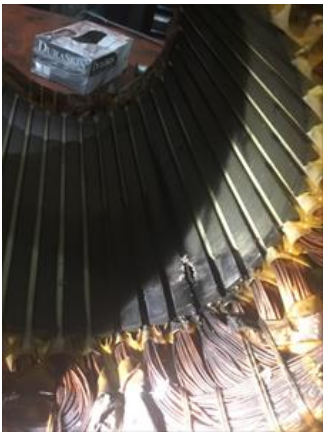
21. Perform Surge Test
- Stator windings blown in slot.*

22. Number of Stator Slots36
23. Stator Conditionrewind
- Recommend core test on stator iron*
24. Stator Thermistors/Ohms
25. Stator Overloads/Ohms

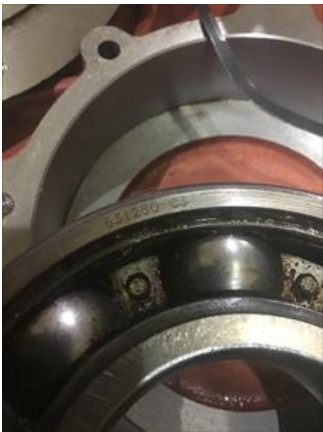
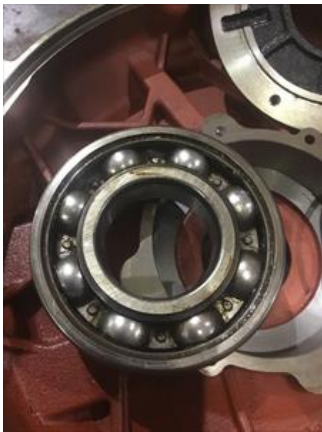
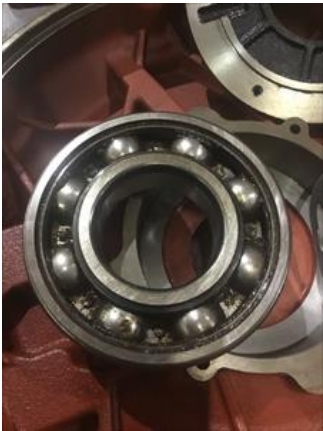
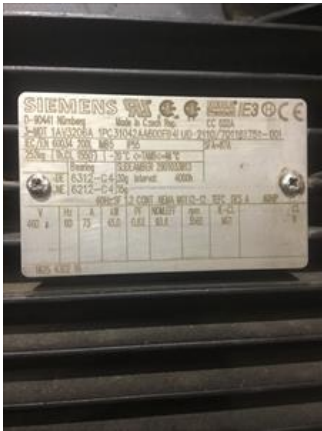
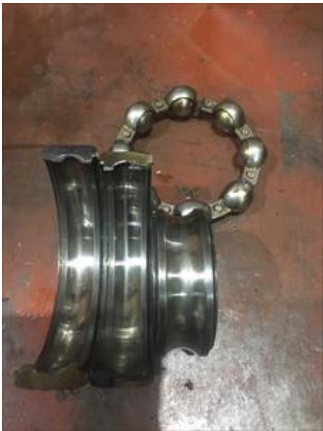
27. Drive End Bearing Number-  
Motor name plate requires a C4 fit.

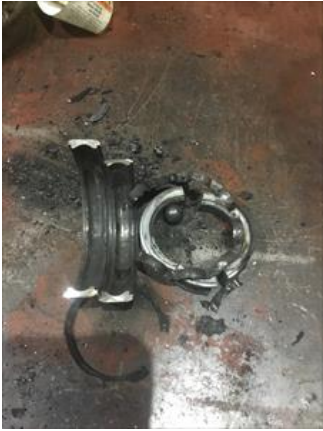
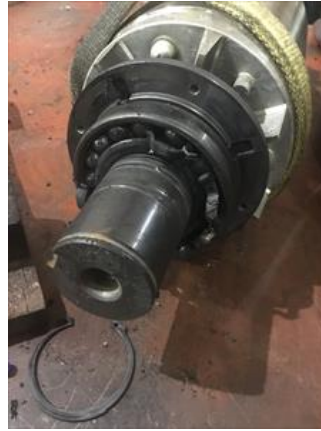
33.	Drive End Bearing Condition	replace	
34.	Opposite Drive End Bearing Brand	un-readable	
35.	Opposite Drive End Bearing Number-	un-readable	
	<i>Requires a C4 fit.</i>		
36.	Opposite Drive End Bearing Qty.	1	P103

68.	Root cause of failure		
	ODE bearing cage suffered catastrophic failure. This caused the rotor to impact the stator iron and windings causing the motor to fail. The DE bearing was a C3 fit instead of the nameplate required C4 fit. The ODE bearing was destroyed and un-readable, but the race was welded to the shaft fit.		
<b>Dynamic Balance Report</b>

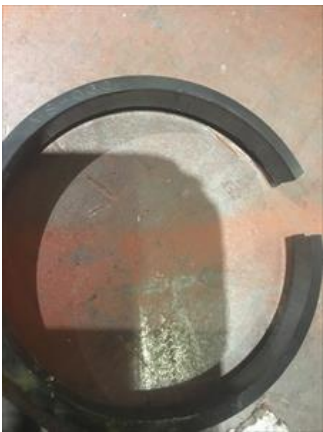
37.	Opposite Drive End Bearing Type	(Ball) Ball Bearing	
38.	Opposite Drive End Lubrication Type	(Grease) Grease Lubricated	
39.	Opposite Drive End Bearing Insulation or Grounding Device?	none	
40.	Opposite Drive End Wavy Washer/Snap-Ring Other Retention Device?	snap ring	
41.	Opposite Drive End Bearing Condition	catastrophic cage failure	
42.	Drive End Seal	VS-060	P120

64.	End Bell Air Seal Fits		
	Drive End Air Seal	Opposite Drive End Air Seal	
	pass	fail	
65.	List Machine Work Needed Below		
	1) Re-sleeve ODE housing bearing fit. 2) Repair ODE housing air seal / shaft opening 3) Repair ODE shaft bearing journal, and bearing shoulder. 4) Remove welded on ODE bearing cap and repair shaft opening cracks.
