AC Inspection as Found

Baptist Medical Center (10043)

AC Inspection - Rev. 2

Description: 100 HP BALDOR

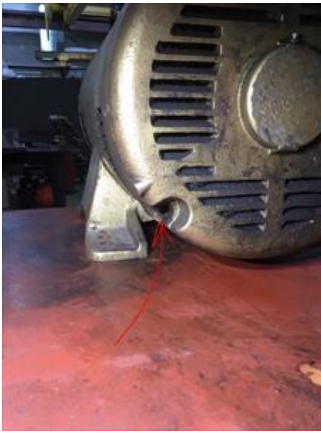
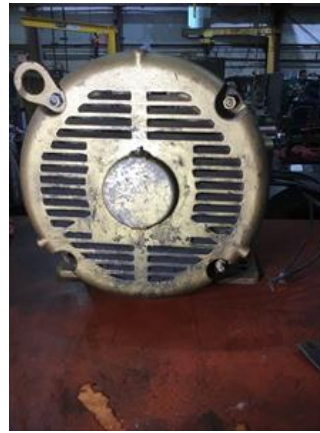
Missing mount bolt

17. Broken or Missing Components **missing end bell mount bolt**

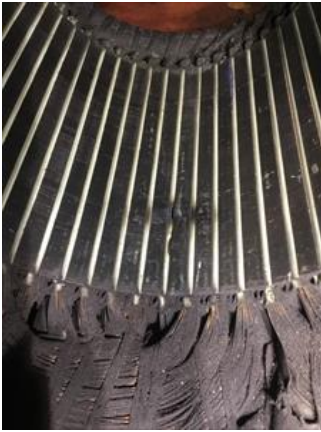
P84

22. Stator Condition

rewind

Shorted in slots

Stator windings shorted between slots.

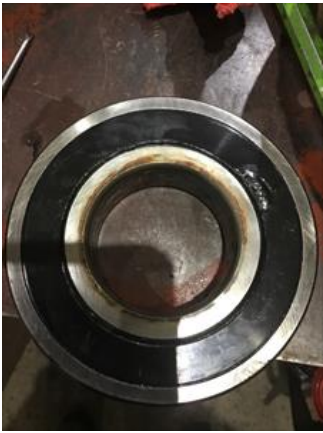
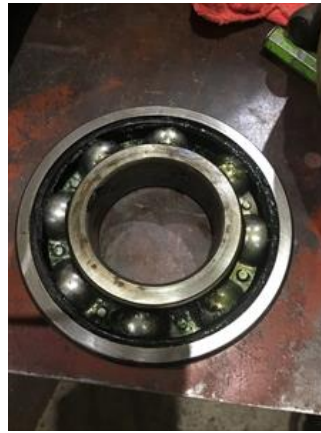
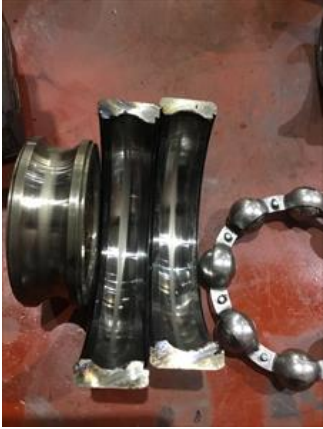
Frosting

32. Drive End Bearing Condition	replace	
---------------------------------	---------	--

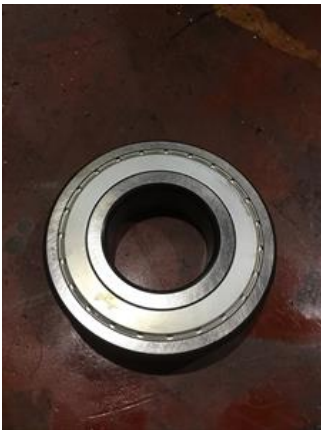
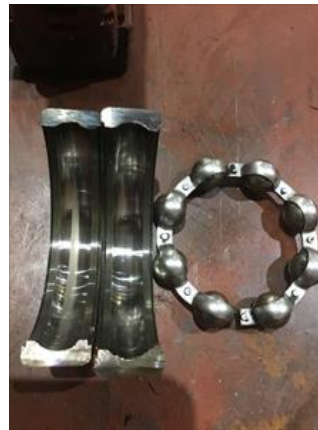
Frosting

40. Opposite Drive End Bearing Condition

replace

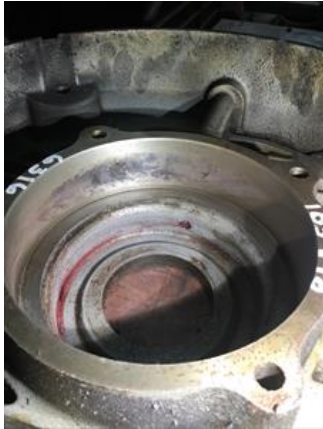
57.	Shaft Air Seal Fits		
	Drive End Air Seal	Opposite Drive End Air Seal	
	pass	pass	
Mechanical Fits- Bearing Housings			
58.	Drive End - Endbell Bearing Fit		P2
	0 Degrees	60 Degrees	120 Degrees
	<div>Bad. Excessive wear.</div> <div>

</div>		
59.	Drive End - Endbell Bearing Fit Condition		(F) Fail
	<div>Excessive wear and pitting</div>		
60.	Opposite Drive End - Endbell Bearing Fit		
	0 Degrees	60 Degrees	120 Degrees
	5.1182	5.1181	5.1181
61.	Opposite Drive End - Endbell Bearing Fit Condition		(P) Pass
62.	Bearing Cap Condition		
	Drive End Bearing Cap	Opposite Drive End Bearing Cap	
	fail	na	
	<div>Cracked</div> <div><div>

Repair cracked DE bearing cap
Re-sleeve DE housing fit

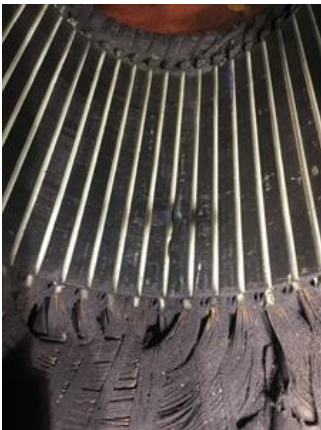
P18

*Windings in slot.
D.E bearing cap cracked
Sleeve D.E housing fit
Both bearings show frosting. Aegis measurement 3.7364*
