AC Inspection as Found
DEWITT MUNICIPAL WATERWORKS
428 COURT SQUARE

AC Inspection - Rev. 2

Location: LR MOTOR SHOP
Serial Number: C1983937
Description: PUMP FOR EVALUATION NO DATA

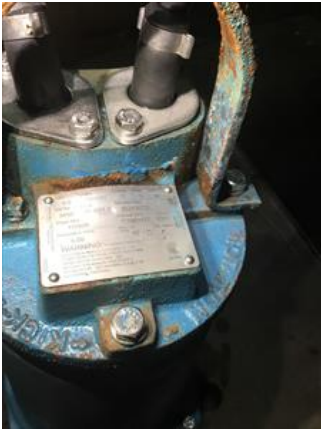
P37

2. Nameplate Picture

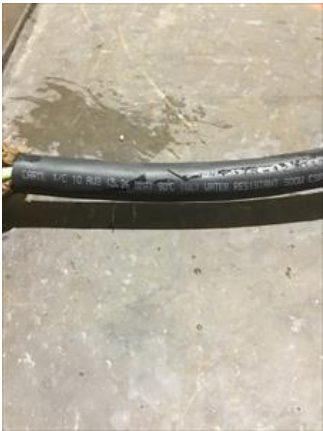
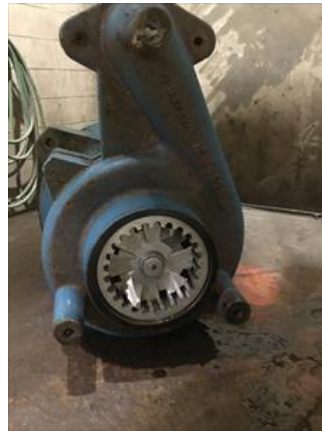
Sensor cord. 3C 14awg 30ft long

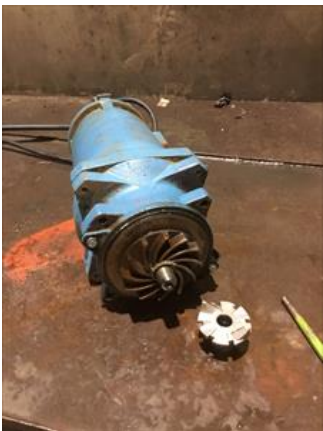
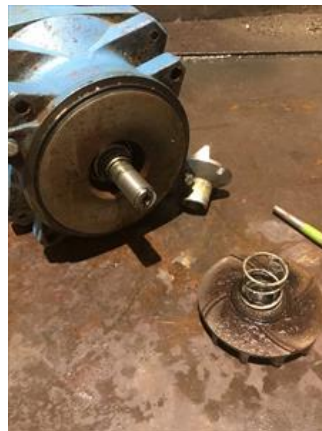
4C 10awg. 30ft long

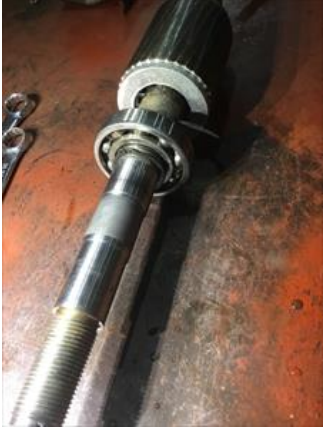
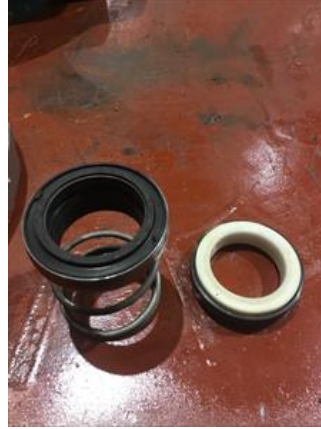
Outer seal O.D 1.7560
Shaft diameter: 1.1255
Carbon ceramic

Outer seal surface has wear.

65.	End Bell Air Seal Fits		
	Drive End Air Seal	Opposite Drive End Air Seal	
66.	List Machine Work Needed Below <i>Polish seal surface on D.E</i>		
67.	Technician		Terrence Holland

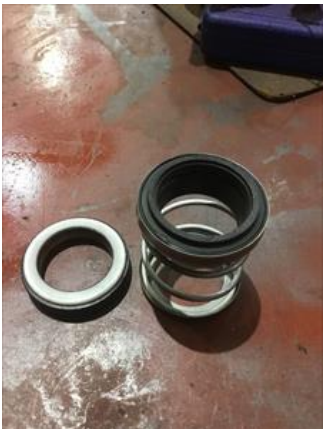
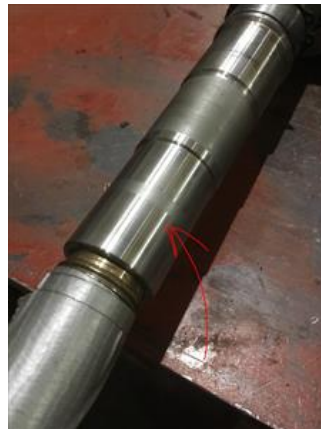
Inner seal OD: 1.8825
Shaft diameter: 1.2502

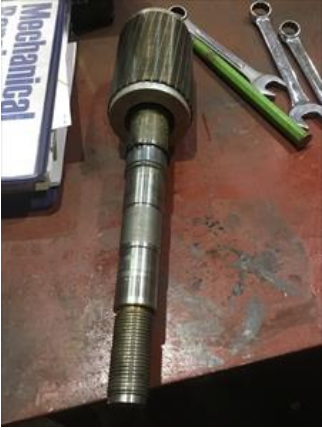
8.	Does Shaft Have Visible Damage?	(No) No	P26

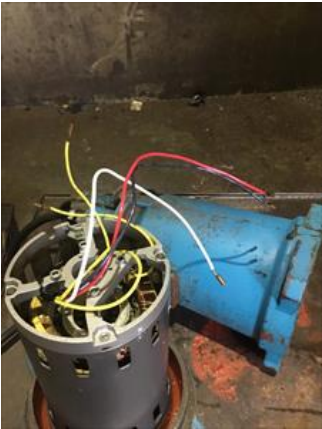
9.	Assembled Shaft Runout	Inches	
10.	Assembled Shaft End Play	inches	
11.	Air Gap Variation <10%		
	A		
12.	Lead Condition	(P) Pass	P69

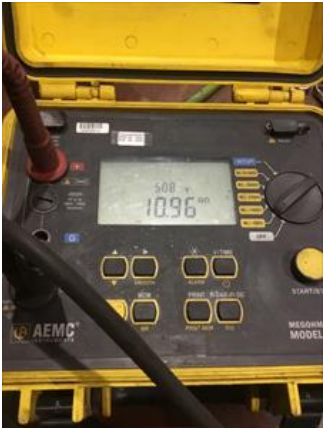
21.	Winding Resistance		
	1-2	1-3	2-3
	0	0	0.9
● 22.	Perform Surge Test	(NA) Not Applicable	
23.	Number of Stator Slots	24	
24.	Stator Condition	rewind	
25.	Stator Thermistors/Ohms		
26.	Stator Overloads/Ohms

68.	Failure locations <i>Windings show open between leads 1&2, & leads 1&3. Both bearings show water contamination.</i>		
69.	Root cause of failure <i>Seal failure allow water to saturate the stator windings.</i>		
Dynamic Balance Report

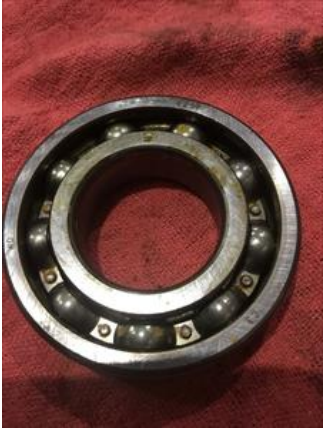
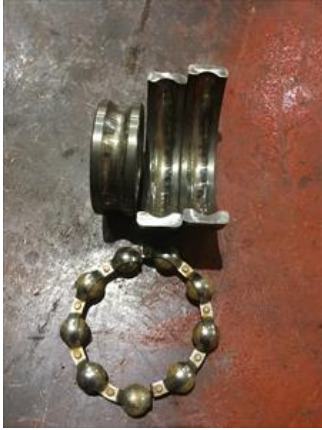
Mechanical Inspection			P32
27. Drive End Bearing Brand	WD		
28. Drive End Bearing Number-	6207 C3		
<div>

</div>			
29. Drive End Bearing Qty.	1		
30. Drive End Bearing Type	(Ball) Ball Bearing		
31. Drive End Lubrication Type	(Oil) Oil Lubricated		
32. Drive End Bearing Insulation or Grounding Device?	none		
33. Drive End Wavy Washer/Snap-Ring Other Retention Device?	snap ring		
34. Drive End Bearing Condition	replace		
35. Opposite Drive End Bearing Brand	CU		P92
<div>

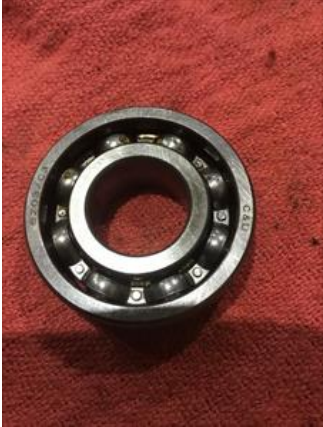
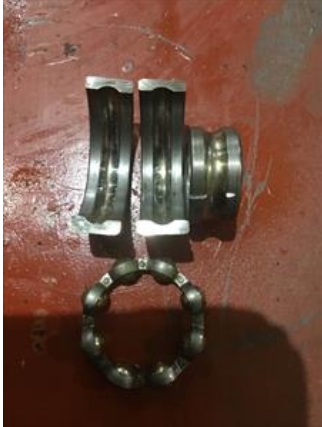
37. Opposite Drive End Bearing Qty.	1	
38. Opposite Drive End Bearing Type	(Ball) Ball Bearing	
39. Opposite Drive End Lubrication Type	(Oil) Oil Lubricated	
40. Opposite Drive End Bearing Insulation or Grounding Device?		
41. Opposite Drive End Wavy Washer/Snap-Ring Other Retention Device?	wavy washer	
42. Opposite Drive End Bearing Condition	replace	
43. Drive End Seal	Outer seal	P120

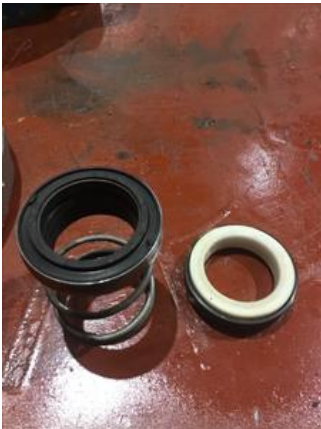
Seal O.D 1.7560 Shaft I.D 1.1255 Carbon ceramic

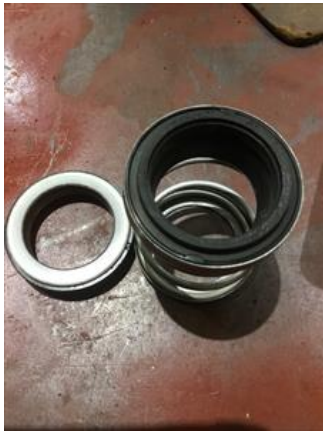
44. Opposite Drive End Seal	Inner seal	P123

Seal O.D 1.8825 Shaft I.D 1.2502 Carbon ceramic
