AC Inspection as Found

FUTURE FUEL CHEMICAL

Location: LR MOTOR SHOP

Description: 75 HP BALDOR

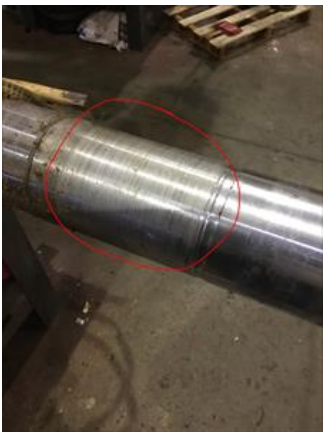
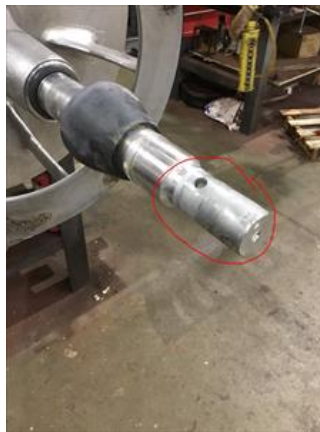
P26

| | 8. Does Shaft Have Visible Damage? | (Yes) Yes |

Bushing ride area

Propeller ride area

66.	List Machine Work Needed Below		
	DE end bell bearing fit, bushing, bushing shaft fit, and propeller shaft fit, and bore propeller for new shaft fit

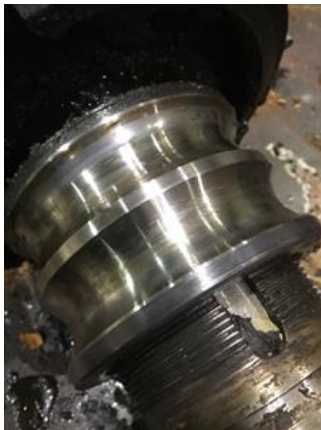
P82

34. Drive End Bearing Condition

Contamination

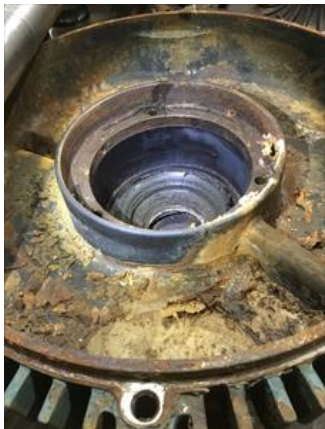
59.	Shaft Air Seal Fits		
	Drive End Air Seal	Opposite Drive End Air Seal	
Mechanical Fits- Bearing Housings <div> <div></div> </div>			
60.	Drive End - Endbell Bearing Fit		
	0 Degrees	60 Degrees	120 Degrees
	<div>Excessive wear</div>

61.	Drive End - Endbell Bearing Fit Condition (F) Fail		
62.	Opposite Drive End - Endbell Bearing Fit		
	0 Degrees	60 Degrees	120 Degrees
	<div>5.5129-5.5127-5.5128</div>

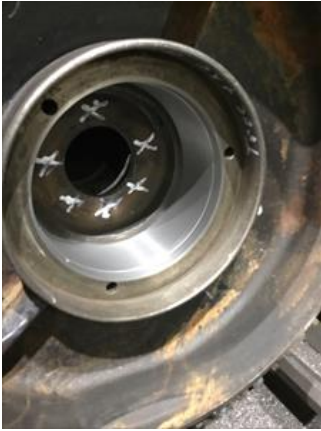
P5

90. Drive End - Endbell Bearing Fit Post Repair

6.6938

6.6939

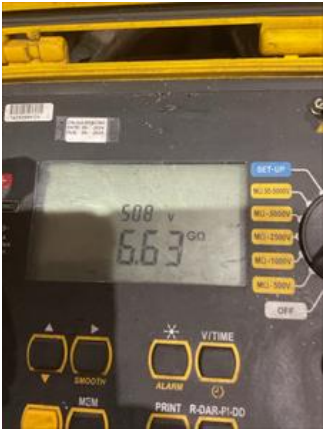
P31

97. Final Insulation Resistance Test

6,630 Megohms

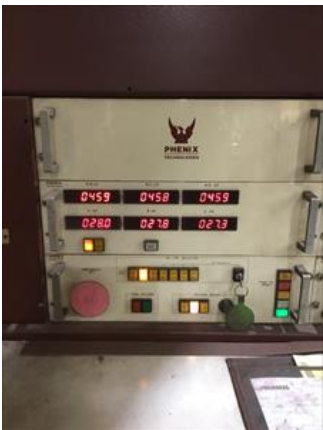
P55

100. Test Run Voltage

459

458

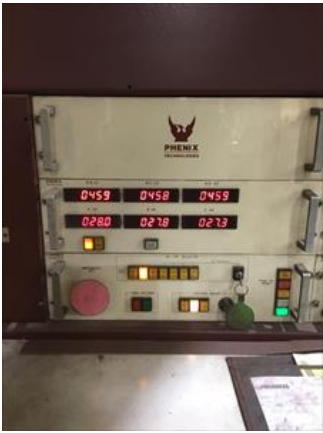
P65

101. Test Run Amperage

28

27.8

27.3
