AC Inspection as Found

Tyson Foods (10914)

AC Inspection - Rev. 2

Description: 5 HP PUMP
GOULDS WATER TECHNOLOGY

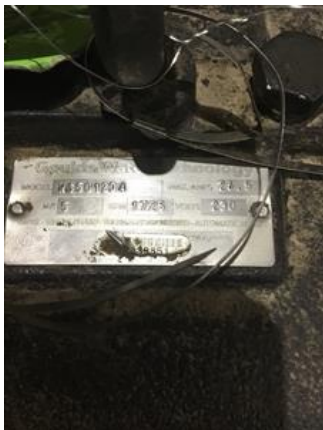
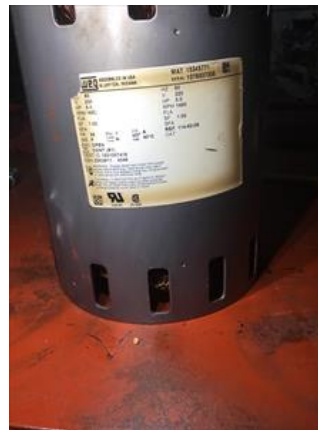
2. Nameplate Picture WEG P37

Sn: 1076937356

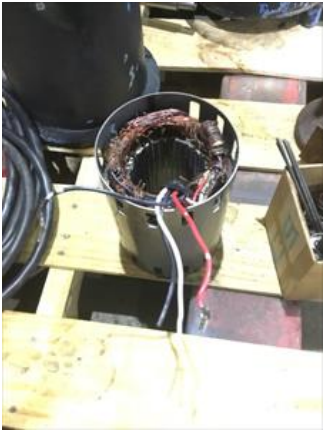
10.	Air Gap Variation <10%		
● 11.	Lead Condition	(F) Fail	P69

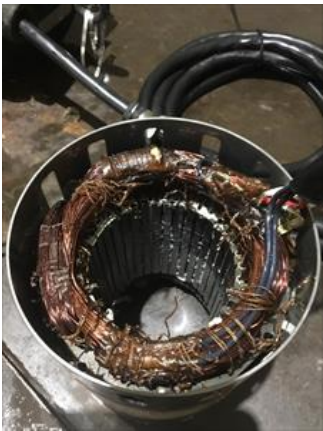
12.	Lead Length	10 Inches	
● 13.	Does it have Lugs?, If so what is the Stud Size?	(No) No	
■	Terminals		
14.	Lead Numbers		
■	Not numbered		
15.	Frame Condition	pass	
16.	Fan Condition		
● 17.	Does motor have internal fan?	(No) No	
18.	Broken or Missing Components	none	
Initial Electrical Inspection			📷
19.	Insulation Resistance/Megger	Megohms	
■	Rewind		
20.	Winding Resistance		
	1-2	1-3	2-3
■	Rewind		
● 21.	Perform Surge Test	(F) Fail	P57

Terrence Holland	
Root Cause of Failure		
67.	Failure locations <i>Windings</i> <i>D.E. housing fit</i>	
68.	Root cause of failure <i>Outer seal failure due to excessive debris, allowed water to penetrate the stator windings causing shorted windings.</i>	
Dynamic Balance Report		
69.	Rotor Weight and Balance Grade	
	Rotor Weight	Balance Grade
70.	Initial Balance Readings	
	Drive End	Opposite Drive End
71.	Final Balance Readings	
	Drive End	Opposite Drive End
72.	Technician	
Rewind		
73.	Core Test Results - Watts loss per Pound	
	Pre-Burnout	Post Burnout
74.	Core Hot Spot Test	
	Pre-Burnout	Post-Burnout
75.	Post Rewind Electrical Test- Insulation Resistance	
76.	Post Rewind Polarization Index	
77.	Post Rewind Winding Resistance	
	1-2	1-3 2-3
78.	Post Rewind Surge Test	
79.	Post Rewind Hi-Pot	
80.	Technician	
Mechanical Fits- Bearing Housings - Post Repair

48. List the Parts needed for the Repair Below <i>Rewind stator. Replace bearings: 6206Z & 6204Z</i> <i>Replace both capacitors and O-rings plus power cord grommet</i> <i>Inner seal: Carbon-Ceramic with viton elastomer OD 1.7575: ID 1.1250</i> <i>Outer seal: Tungsten with viton elastomer: OD 1.7575: ID 1.1250</i>

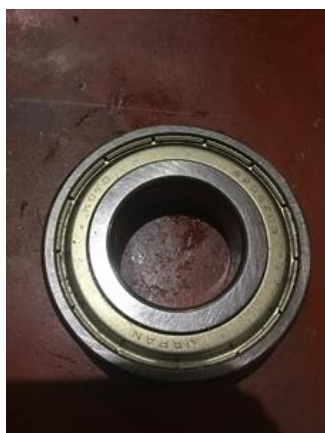
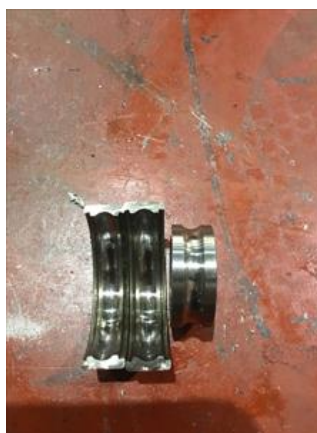
33. Drive End Bearing Condition

replace

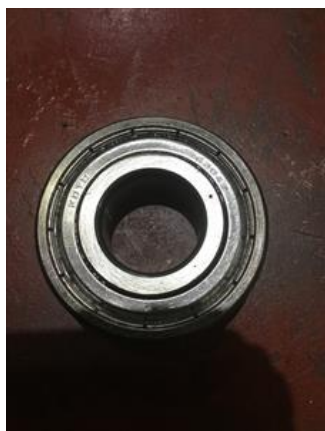
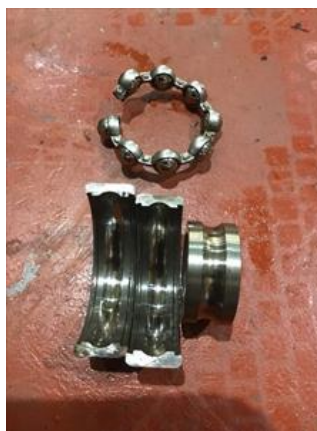
41. Opposite Drive End Bearing Condition

replace
