AC Inspection as Found

Tyson Foods (10914)

AC Inspection - Rev. 2

Description: 5 HP PUMP
GOULDS WATER TECHNOLOGY

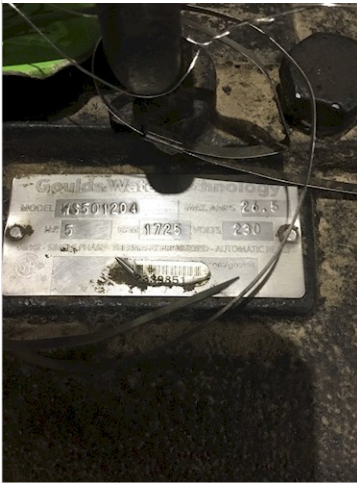
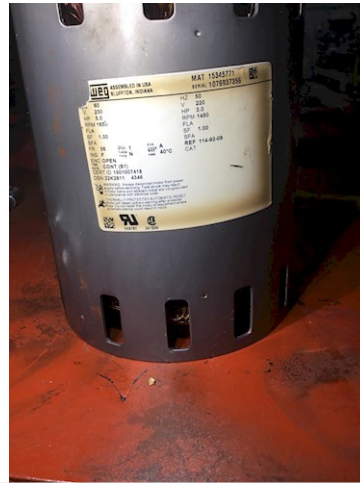
2. Nameplate Picture

WEG

Sn: 1076937356

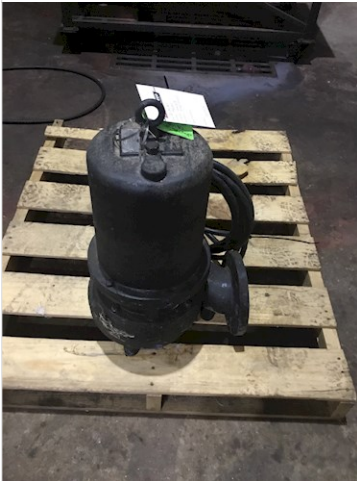
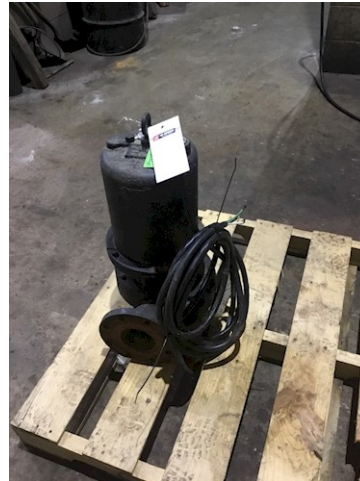
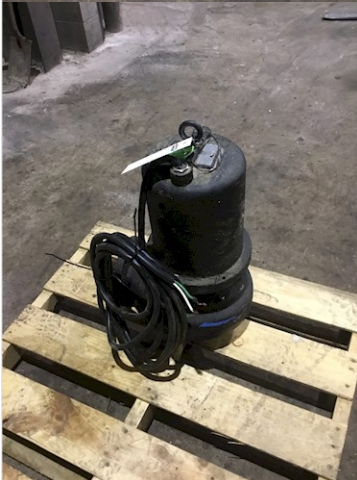
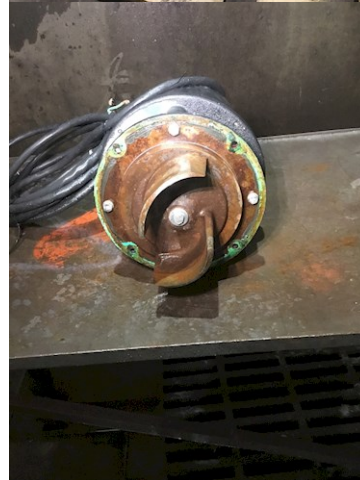
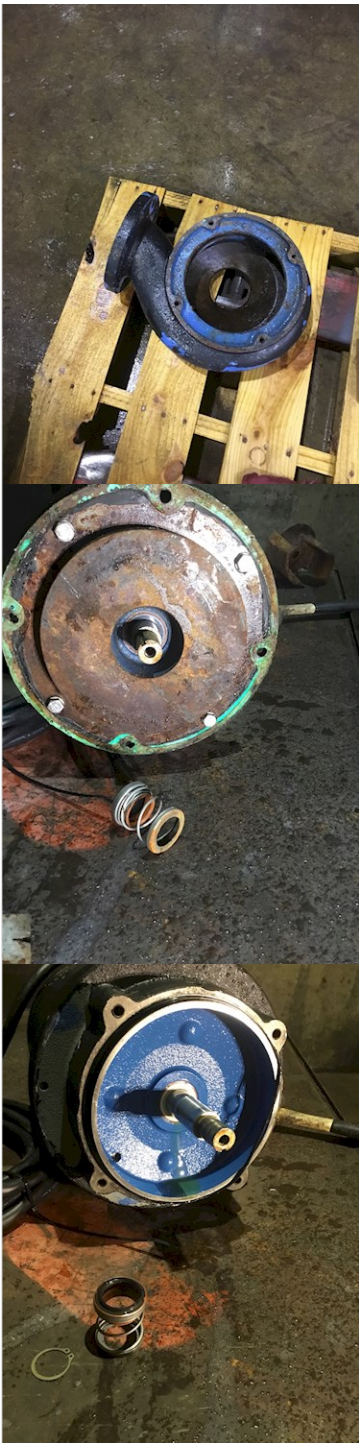
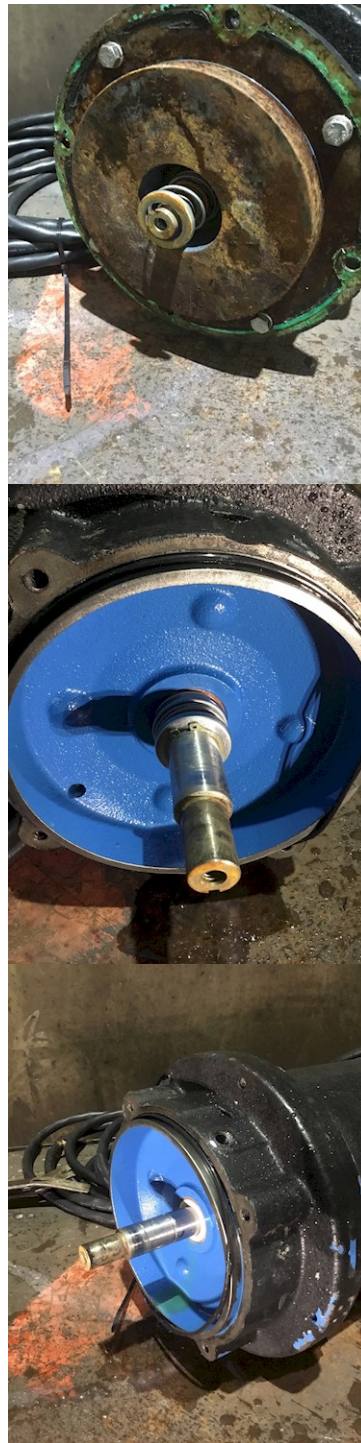
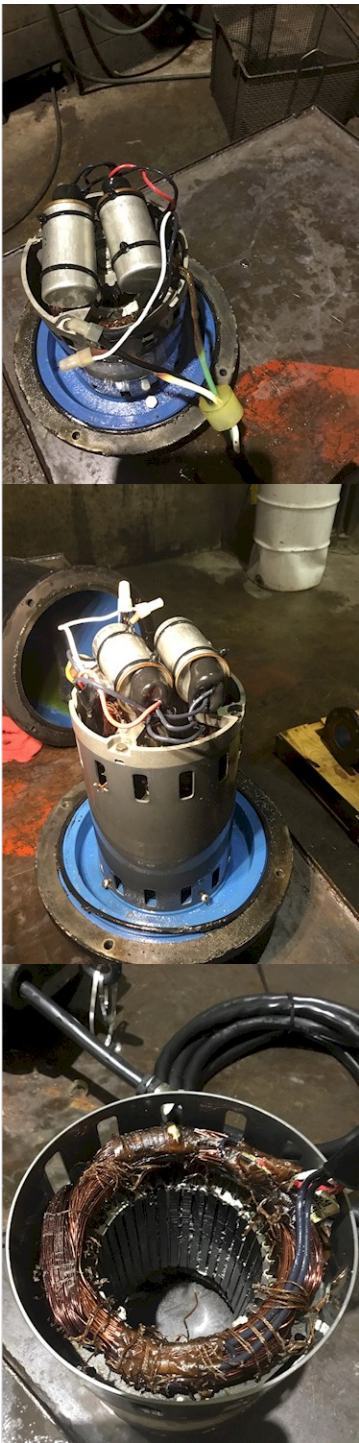
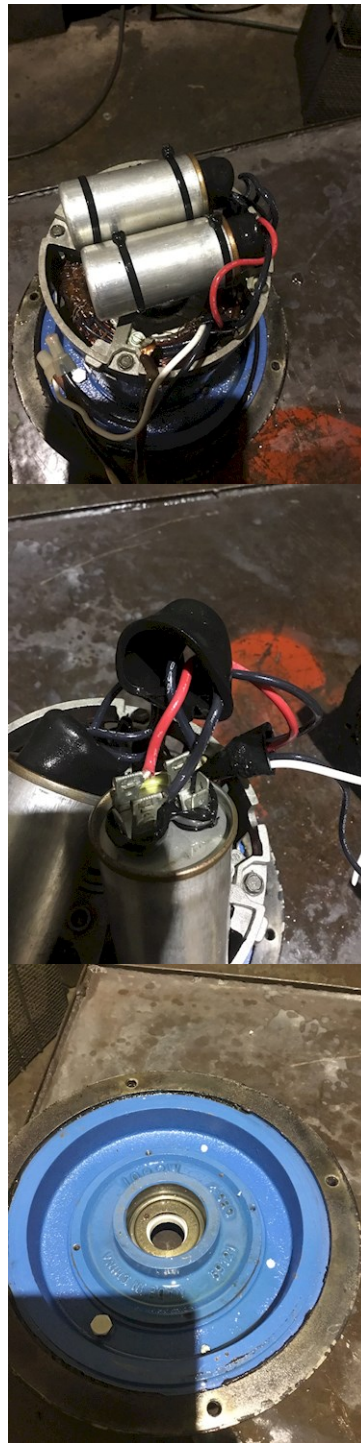
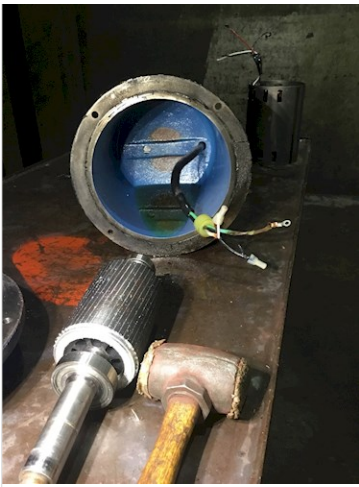
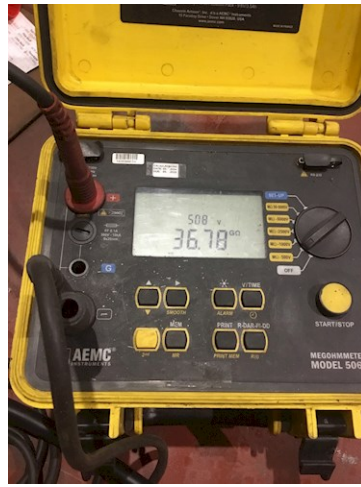
3. Photos of all six sides of the machine.

4. Describe the Overall Condition of the Equipment as Received
Debris has impeller locked up.

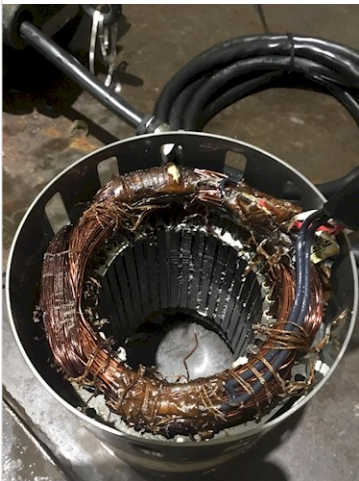
21. Perform Surge Test

(F) Fail

23. Stator Condition rewind

67.	Failure locations <i>Windings</i> <i>D.E. housing fit</i>		
68.	Root cause of failure <i>Outer seal failure due to excessive debris, allowed water to penetrate the stator windings causing shorted windings.</i>		
Dynamic Balance Report

46.	Number of Rotor Bars	48
47.	Rotor Condition	pass
48.	List the Parts needed for the Repair Below <i>Rewind stator. Replace bearings: 6206Z & 6204Z</i> <i>Replace both capacitors and O-rings plus power cord grommet</i> <i>Inner seal: Carbon-Ceramic with viton elastomer OD 1.7575: ID 1.1250</i> <i>Outer seal: Tungsten with viton elastomer: OD 1.7575: ID 1.1250</i>

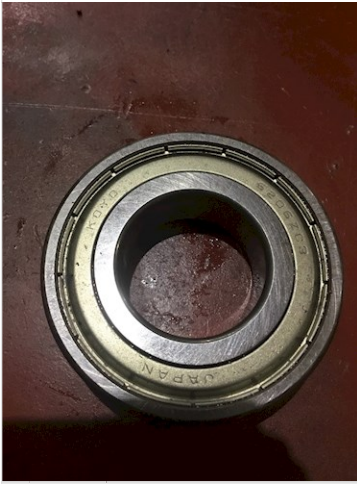
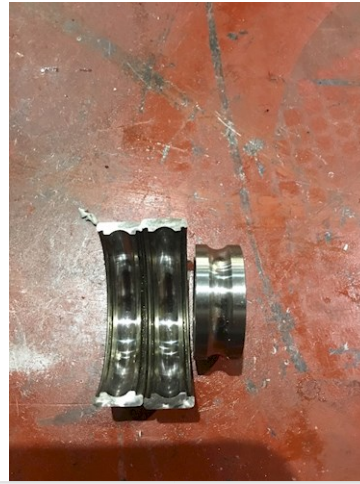
replace

59.	Drive End - Endbell Bearing Fit	
	0 Degrees	120 Degrees
	2.442	2.4421
60.	Drive End - Endbell Bearing Fit Condition	(F) Fail
61.	Opposite Drive End - Endbell Bearing Fit	
	0 Degrees	120 Degrees

64.	End Bell Air Seal Fits		
	Drive End Air Seal	Opposite Drive End Air Seal	
65.	List Machine Work Needed Below <i>D.E. Housing fit</i>		
66.	Technician		Terrence Holland

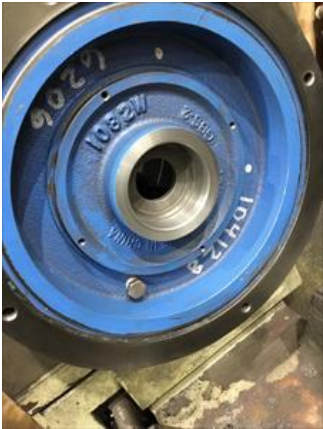
81.	Drive End - Endbell Bearing Fit Post Repair		P5
	0 Degrees	60 Degrees	120 Degrees
	2.4413	2.4413	2.4413

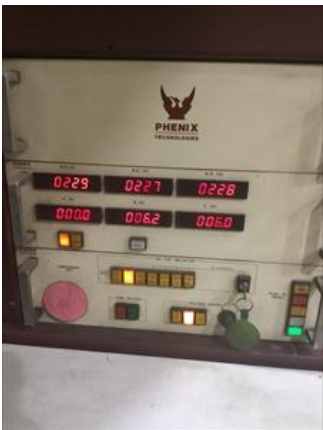
88.	Final Insulation Resistance Test	Megohms	
89.	Assembled Shaft Endplay	0 inches	
90.	Assembled Shaft Runout	0.002 inches	
91.	Test Run Voltage		
	Volts	Volts	Volts
	227	228

No load

92.	Test Run Amperage		
	Amps	Amps	Amps
	6.2	6
