AC Inspection as Found

Riceland Foods (11100-RLF)

AC Inspection - Rev. 2

Description: 50HP US 1770 RPM

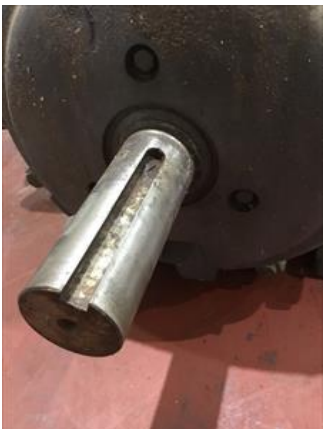
5. Does Shaft Turn Freely? **(N) No**
Fan assembly rubbing against dented in fan cover.

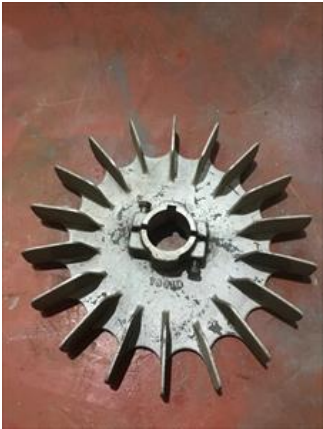
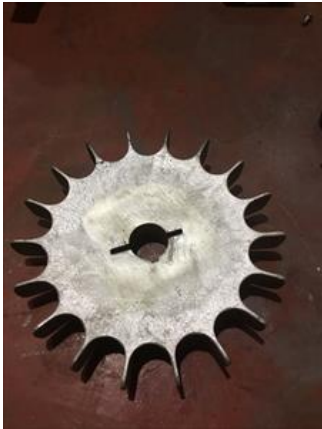
17. Does motor have internal fan?	(No) No
18. Broken or Missing Components	none
Fan cover is dented but can be straightened.

45. Growler Test	(Pass) Pass	
46. Number of Rotor Bars	56	
47. Rotor Condition	pass	
48. List the Parts needed for the Repair Below	211 & 311 2RS bearings Remove multiple dents from fan cover and replace grease overload tube. Recondition motor	
49. Signature of Technician that Disassembled Motor	Terrence Holland

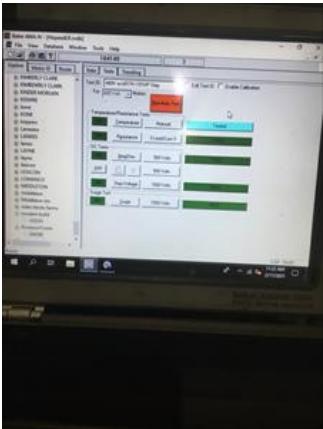
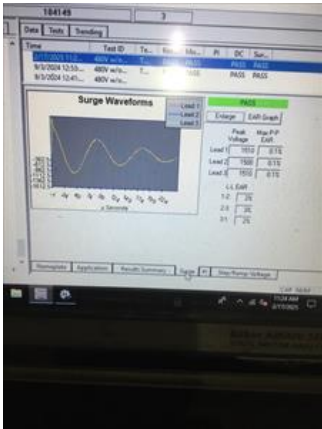
21. Perform Surge Test

(P) Pass

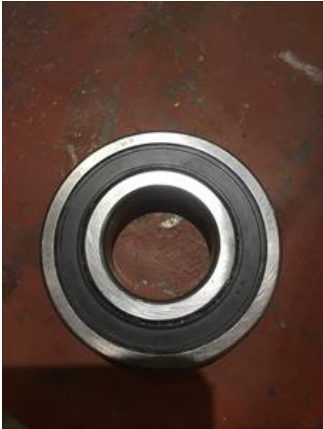
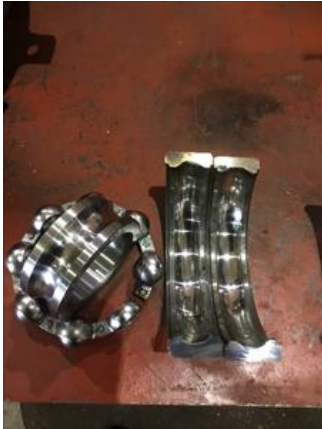
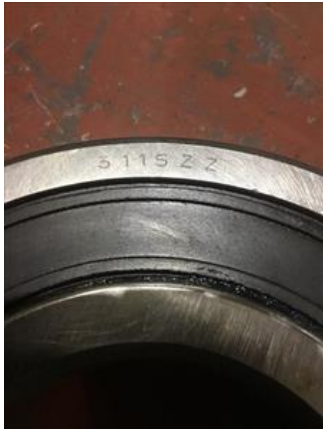
26. Drive End Bearing Brand

28. Drive End Bearing Qty.	1
29. Drive End Bearing Type	(Ball) Ball Bearing
30. Drive End Lubrication Type	(Grease) Grease Lubricated
31. Drive End Bearing Insulation or Grounding Device?	none
32. Drive End Wavy Washer/Snap-Ring Other Retention Device?	none
33. Drive End Bearing Condition	replace
34. Opposite Drive End Bearing Brand	MRC

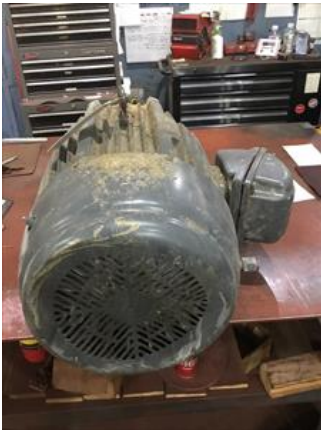
68. Root cause of failure

Fan cover

Fan cover was dented inward which allowed the fan to rub against the cover
