AC Inspection as Found

Sage V Foods

AC Inspection - Rev. 2

Description: 25 HP SCHAEFFLER

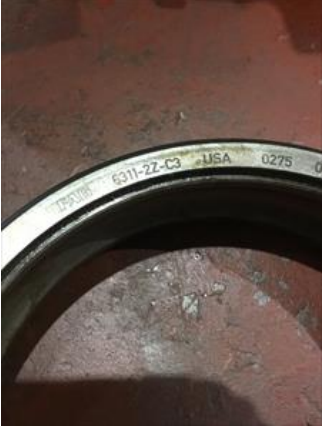
26.	Drive End Bearing Brand	FAG	P12

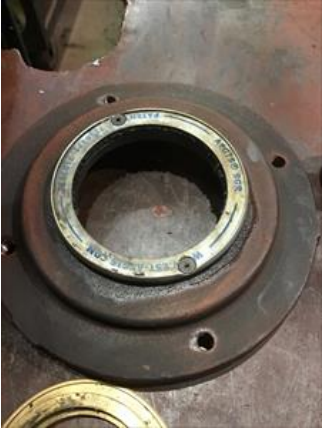
27.	Drive End Bearing Number-	6311 2Z/C3	
28.	Drive End Bearing Qty.	1	
29.	Drive End Bearing Type	(Ball) Ball Bearing	
30.	Drive End Lubrication Type	(Grease) Grease Lubricated	
31.	Drive End Bearing Insulation or Grounding Device?	Aegis ring	P64

*6309&6311 2Z/C3 bearings.
Replace ODE housing with broken off ear.
Replace aegis ring: shaft measurement is 2.7140
Rewind stator and replace in pro seal on DE housing.*

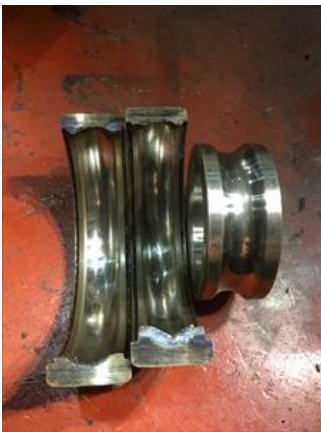
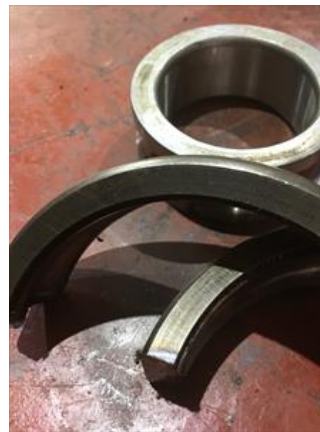
35. Opposite Drive End Bearing Number-

6309 2Z/C3
