AC Inspection as Found

Sage V Foods

AC Inspection - Rev. 2

Description: 25 HP SCHAEFFLER

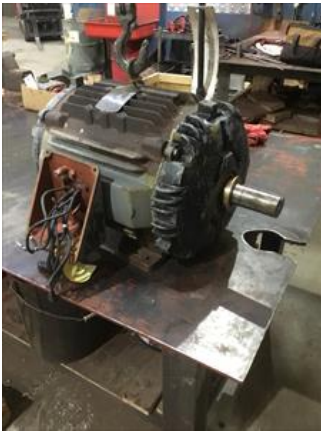
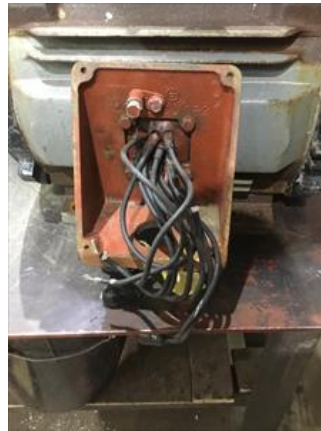
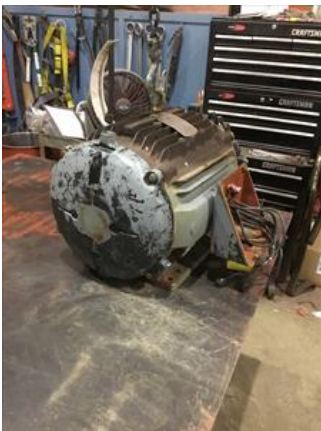
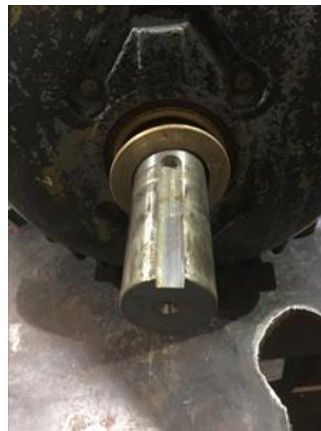
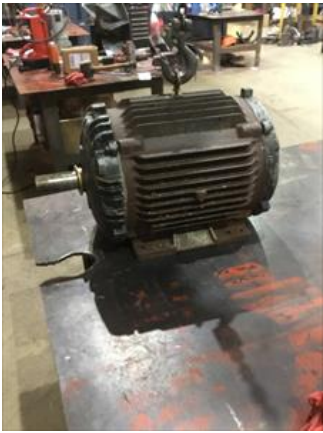
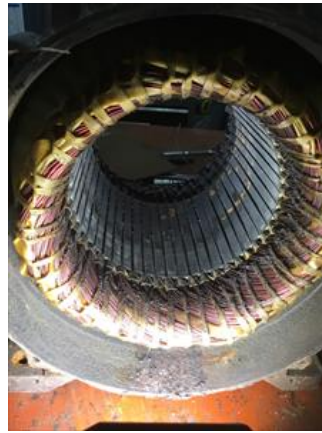
3. Photos of all six sides of the machine.

4. Describe the Overall Condition of the Equipment as Received

Dirty/rusted

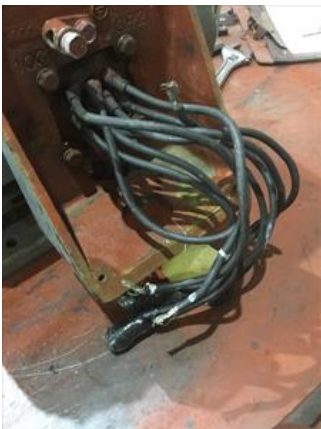
5. Does Shaft Turn Freely?	(Y) Yes	
6. Does the shaft require T.I.R in Lathe to identify additional repairs?	(No) No	
7. Does Shaft Have Visible Damage?	(No) No	
8. Assembled Shaft Runout	Inches	
9. Assembled Shaft End Play	0 inches	
10. Air Gap Variation <10%		
11. Lead Condition	(P) Pass	P69

12. Lead Length	12 Inches	
13. Does it have Lugs?, If so what is the Stud Size?	(No) No	
14. Lead Numbers	1-9	
15. Frame Condition	pass	
16. Fan Condition	(N) NA	
17. Does motor have internal fan?	(No) No	
18. Broken or Missing Components	ODE housing	
Has mount bolt hole broken off

6309&6311 2Z/C3 bearings.
Replace ODE housing with broken off ear.
Replace aegis ring: shaft measurement is 2.7140
Rewind stator and replace in pro seal on DE housing.

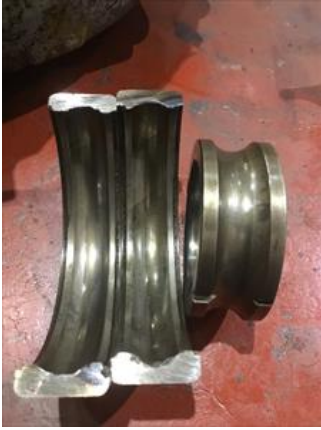
33. Drive End Bearing Condition

water contaminated grease

67.	Failure locations <i>Windings shorted.</i>	
68.	Root cause of failure <i>Excessive water moisture inside stator windings.</i>	
Dynamic Balance Report

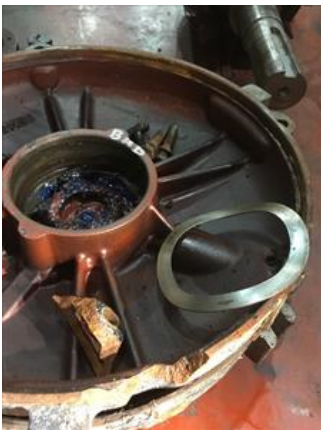
41. Opposite Drive End Bearing Condition

water contaminated grease

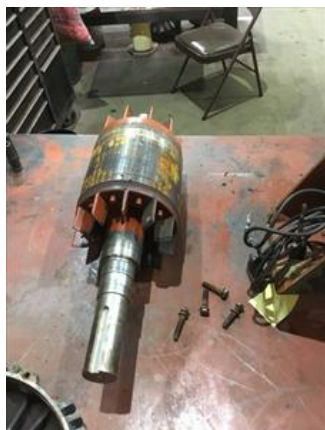
44. Rotor Type/Material

(Squirrel Aluminum) Squirrel
Cage Aluminum Die Cast

45. Growler Test (Pass) Pass

47. Rotor Condition pass

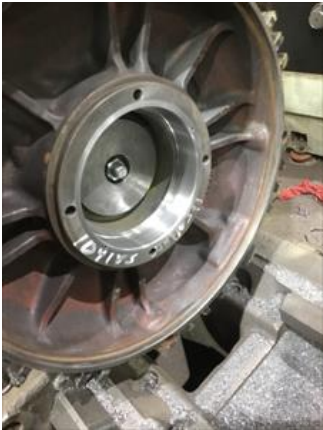
88. Shaft Repair Sign-off			
Mechanical Fits- Bearing Housings - Post Repair			
89. Drive End - Endbell Bearing Fit Post Repair			P5
0 Degrees	60 Degrees	120 Degrees

60.	Drive End - Endbell Bearing Fit Condition	(F) Fail
61.	Opposite Drive End - Endbell Bearing Fit	
	0 Degrees	60 Degrees 120 Degrees
<div> <i>Bad, lip worn in.</i> </div>

65.	List Machine Work Needed Below <i>Machine D.E housing fit. D.E housing fit is oversized</i>	
66.	Technician	Terrence Holland

4.725	4.725	4.725
