## AC Inspection as Found

Riceland Foods  
1200 N Park Ave  
Stuttgart, AR 72160

### AC Inspection - Rev. 2

Description: 200 HP BALDOR

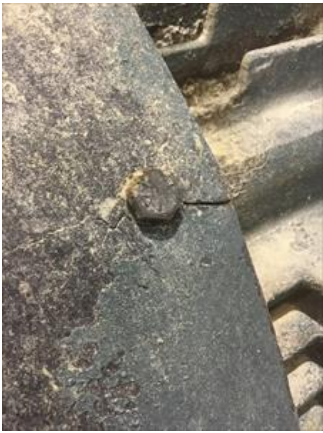
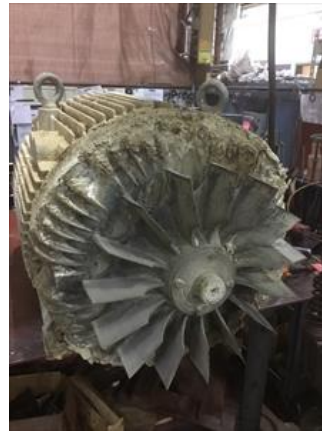
*Small crack in fan cover mount bolt hole*

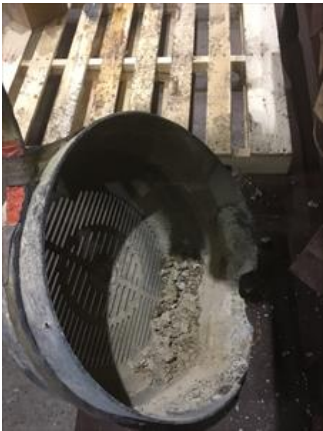
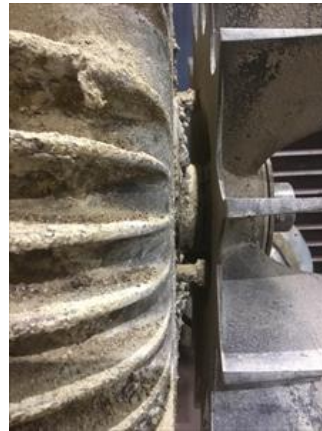
*ODE bearing cap bolts loose. (All of them.)*

Co sign RRW		
Root Cause of Failure			
67.	Failure locations		
	ODE bearing cap bolts. Both bearings have dirty grease.

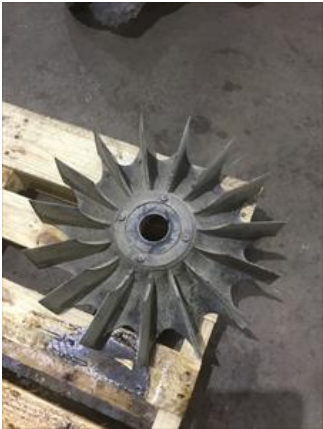
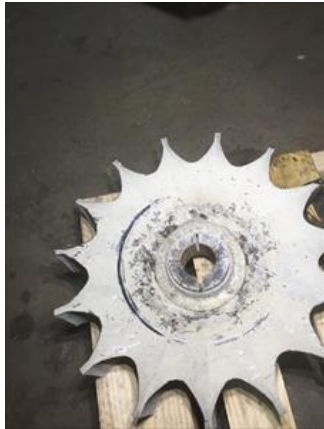
Some wear from loose bearing cap bolts

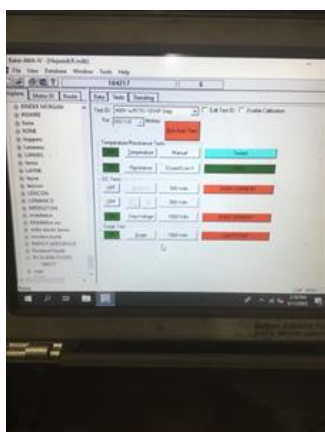
21. Perform Surge Test

(F) Fail

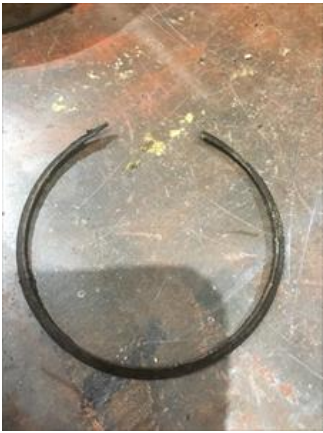
Needs replacing

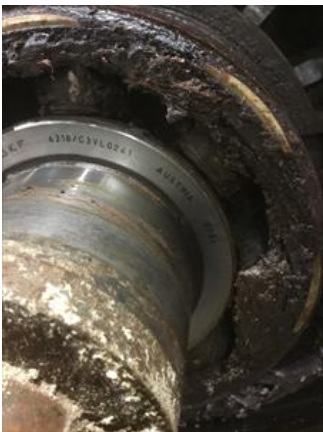
33. Drive End Bearing Condition

replace

Contaminated grease

*D.E bearing #6318 C3 & ODE #6318/C3 VL0241 (ceramic)  
Sleeve both housing fits.  
Repair ODE air gap shaft surface.  
Recommend Aegis grounding ring on DE*

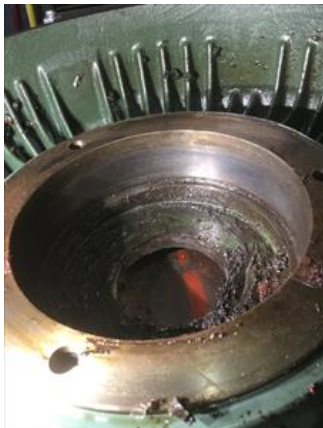
59.	Drive End - Endbell Bearing Fit		
	0 Degrees	60 Degrees	120 Degrees
	See below		
60.	Drive End - Endbell Bearing Fit Condition		(F) Fail P15
	Lip worn in

63.	Bearing Cap Condition		
	Drive End Bearing Cap	Opposite Drive End Bearing Cap	
	pass	pass	
64.	End Bell Air Seal Fits		
	Drive End Air Seal	Opposite Drive End Air Seal	
65.	List Machine Work Needed Below		
	Both end bell housing fits bad. DE shaft bearing journal bad		
66.	Technician		Terrence Holland

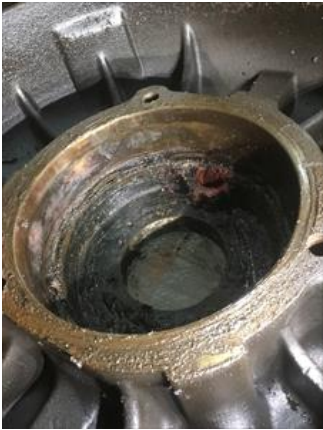
61.	Opposite Drive End - Endbell Bearing Fit		
	0 Degrees	60 Degrees	120 Degrees
	See below		
62.	Opposite Drive End - Endbell Bearing Fit Condition		(F) Fail P39
	Lip worn in

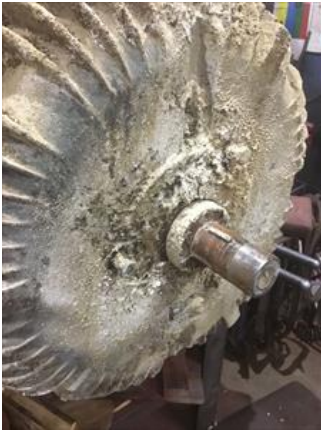
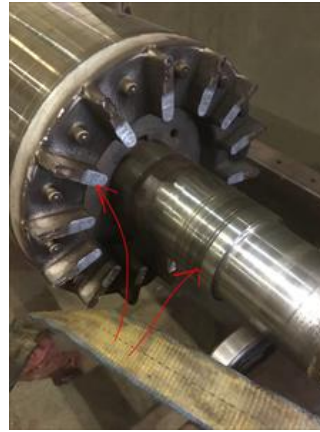
*All ODE bearing cap bolts were completely backed out of the bolt hole threads.*

*After fan removal, the bolts pulled out by hand without being unscrewed.*

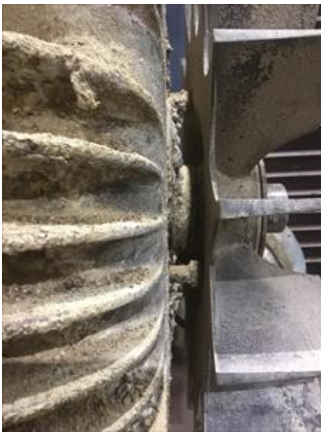
*Bearing cap was free floating inside because of the mount bolts being backed off.*
