AC Inspection as Found
Arkansas Electric Coop. (11681)
17400 highway 365 south
Little Rock, AR 72206

AC Inspection - Rev. 2

Description: 7 1/2 AMETEK

Hi-Speed Job Number: 104252

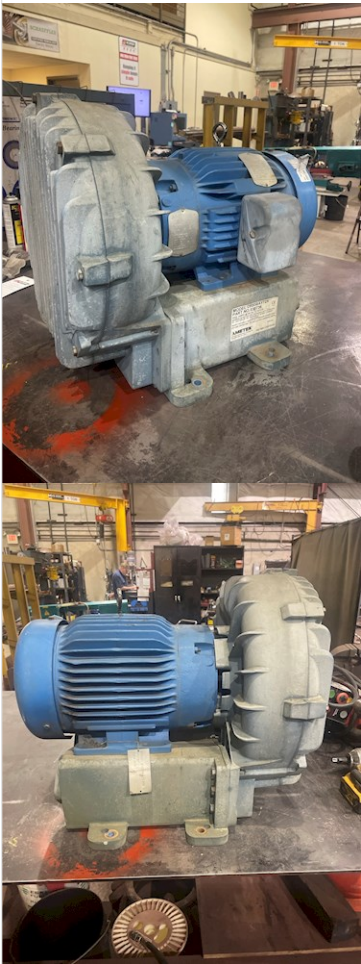
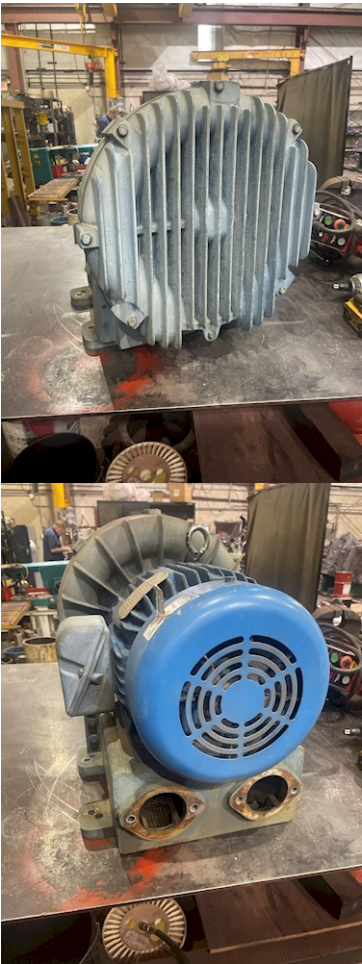
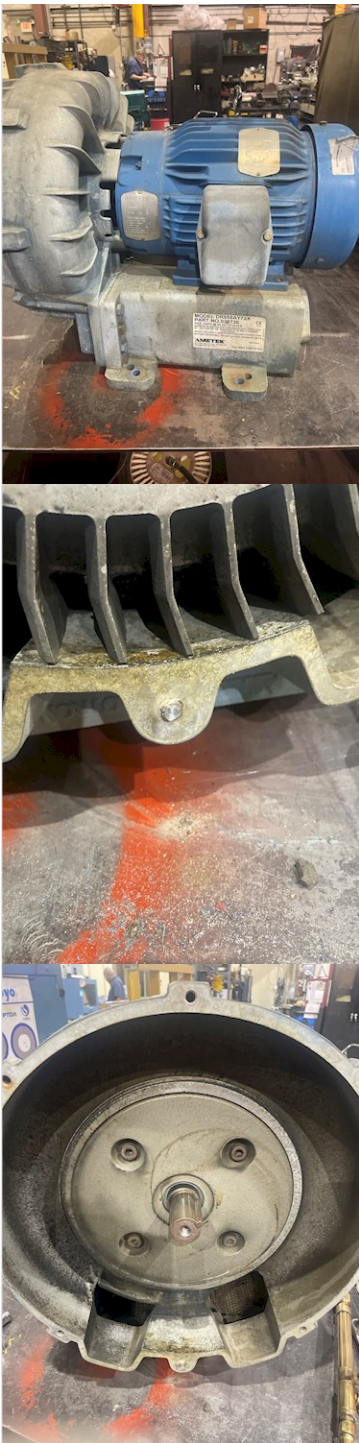
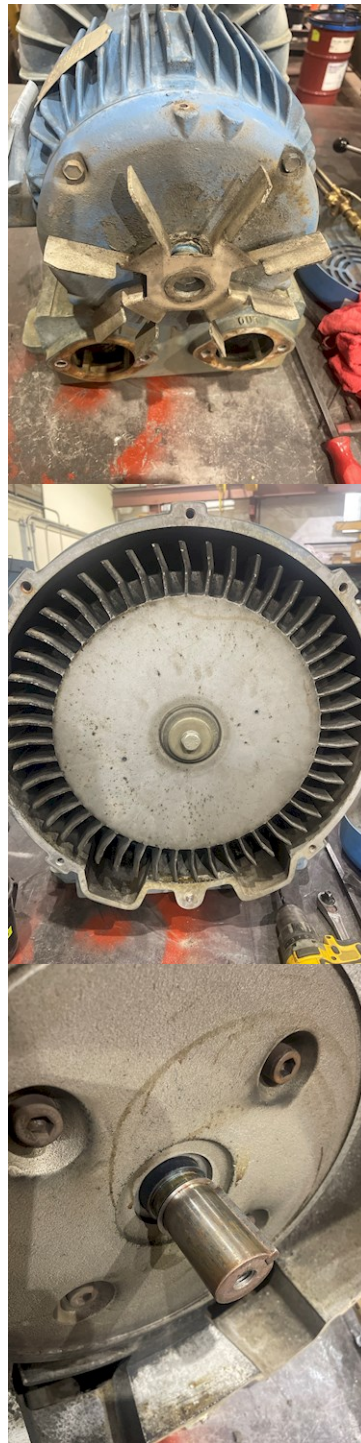
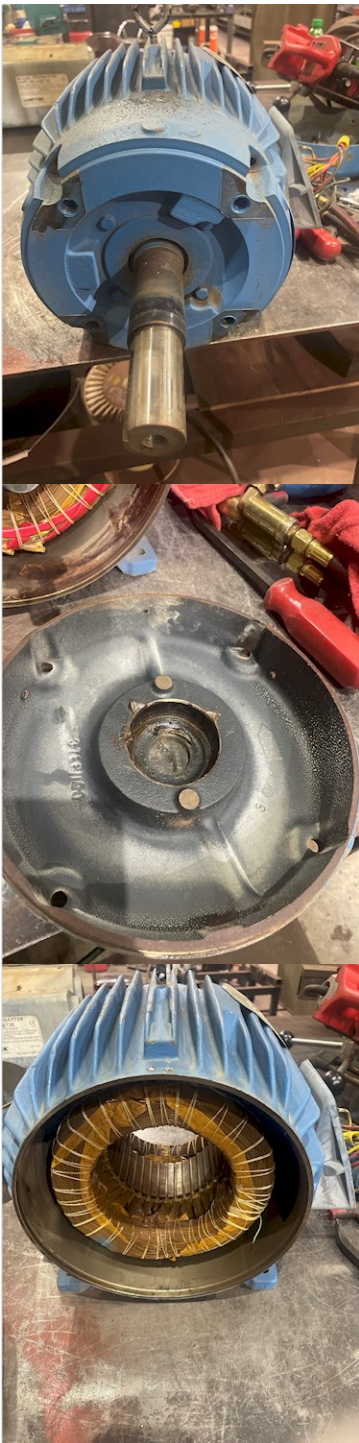
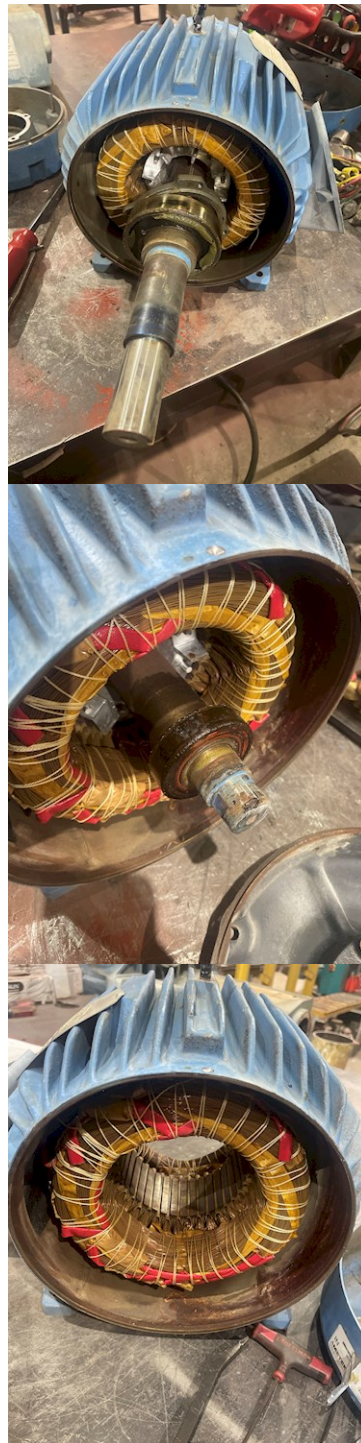
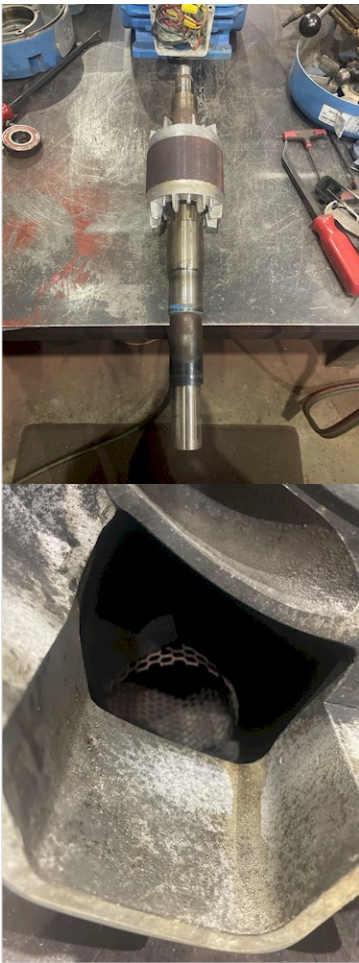
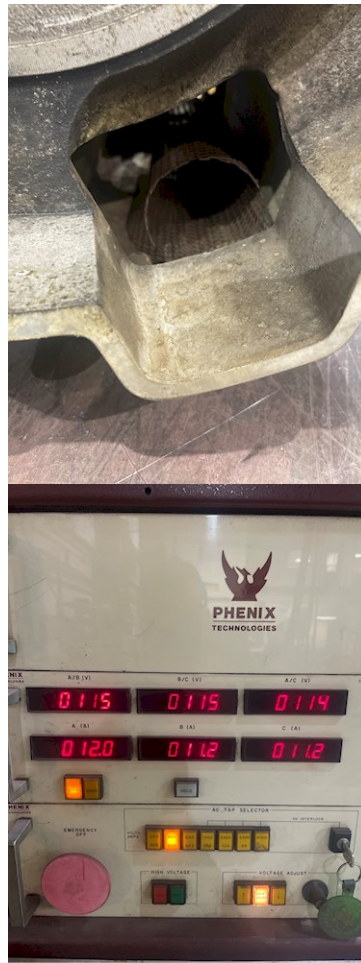
3. Photos of all six sides of the machine.

4.	Describe the Overall Condition of the Equipment as Received	
	<i>Needs bearings, shaft fits repaired and endbell sleeved.</i>	
5.	Distance from the end of the shaft to the Coupling/Sheave	inches
	<i>Has a shoulder</i>

22.	Broken or Missing Components	two broken bolts

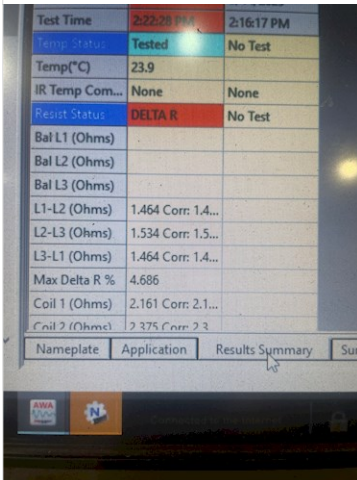
24. Winding Resistance

In pic

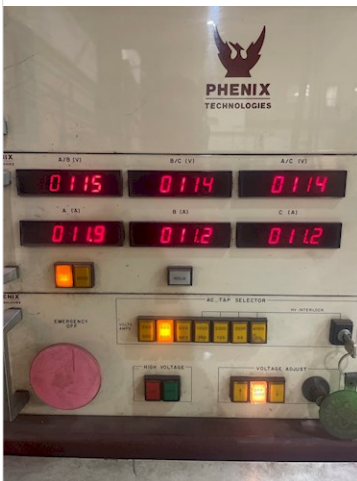
25. Perform Surge Test

(P) Pass

Basket wound. Pulls good amps on test panel

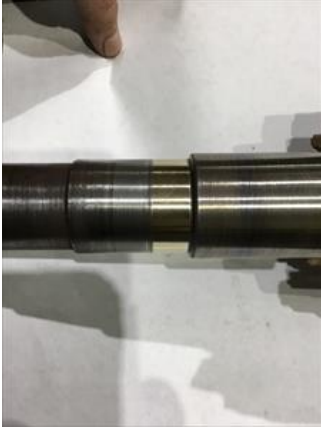
81. Drive End Bearing Shaft Fit Post Repair

1.7722

1.7721

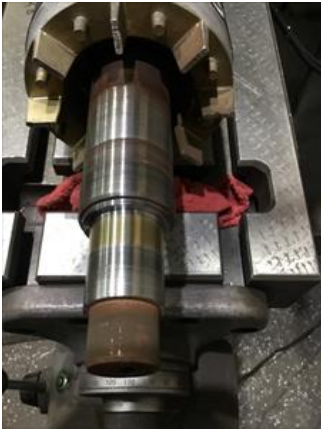
82. Opposite Drive End Bearing Shaft Fit Post Repair

54.	Shaft Runout	0.001 inches
55.	Rotor Runout	
	Drive End Bearing Fit	Rotor Body
		Opposite Drive End Bearing
	Na	
56.	Coupling Fit Closest to Bearing Housing	
	0 Degrees	90 Degrees
	1.3746	1.3746
		120 Degrees
		1.3746
57.	Coupling Fit Closest to the end of the Shaft	
	0 Degrees	60 Degrees
	1.3746	1.3746
		120 Degrees
		1.3746
58.	Drive End Bearing Shaft Fit	
	0 Degrees	60 Degrees
	1.7716	1.7717
		120 Degrees
		1.7717
59.	Drive End Bearing Shaft Fit Condition	(F) Fail
	Undersized	
60.	Opposite Drive End Bearing Shaft Fit	
	0 Degrees	60 Degrees
	1.1812	1.1812
		120 Degrees
		1.1811
61.	Opposite Drive End Bearing Shaft Fit Condition	(F) Fail
	Undersized

1.1815

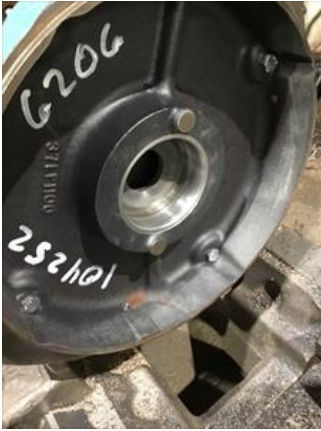
86. Opposite Drive End - Endbell Bearing Fit Post Repair

2.4413

And removed broken bolts

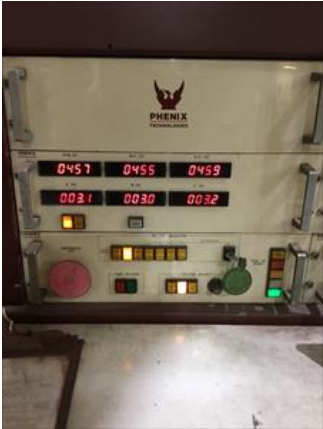
93.	Assembled Shaft Endplay	0 inches	
94.	Assembled Shaft Runout	0.001 inches	
95.	Test Run Voltage	P500	
Volts		Volts	Volts
457		455	459

Without fan

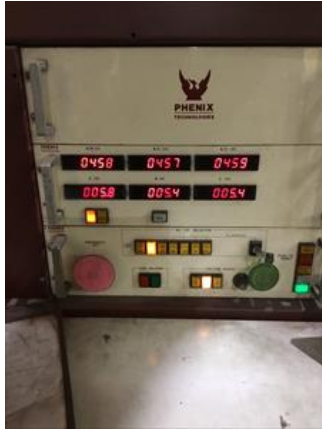
Without fan

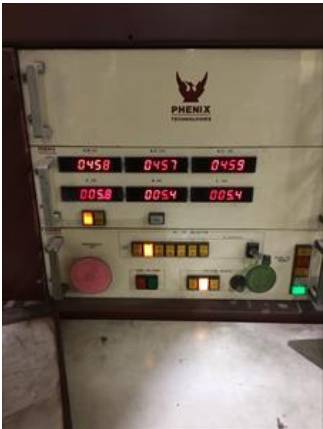
With blower fan/ run

96.	Test Run Amperage	P600	
Amps		Amps	Amps
3.1		3	3.2

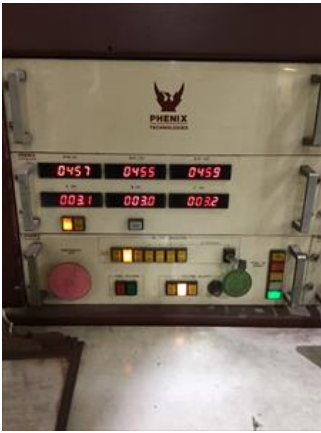
Without fan
