AC Inspection as Found

Reynolds Metals company

AC Inspection - Rev. 2

Description: 7.5 HP Reliance

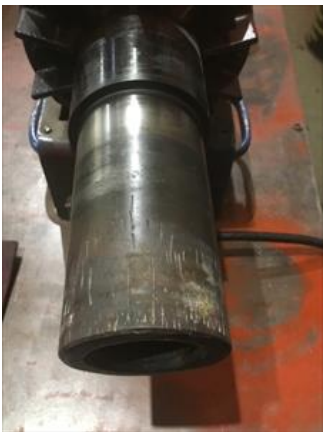
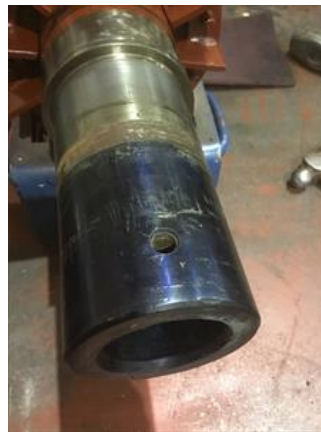
(No) No
7. Does Shaft Have Visible Damage?

Minor scratches on both ends.

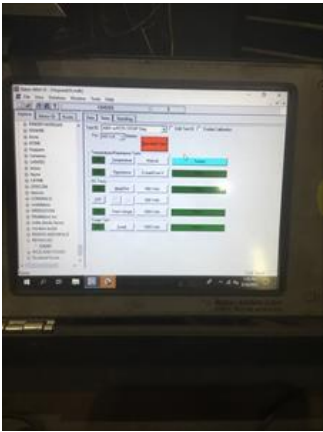
See below			
21.	Perform Surge Test	(P) Pass	P57

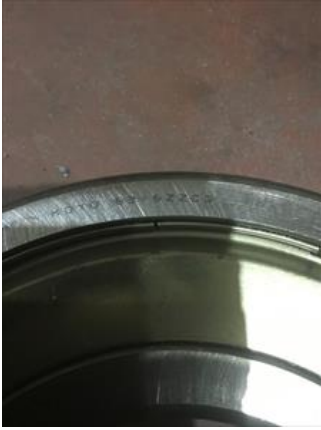
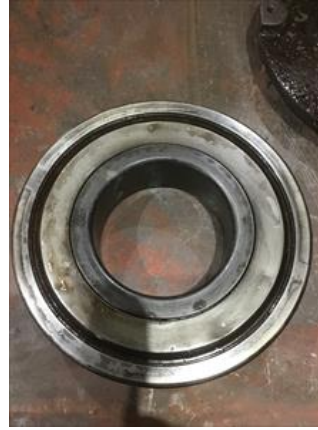
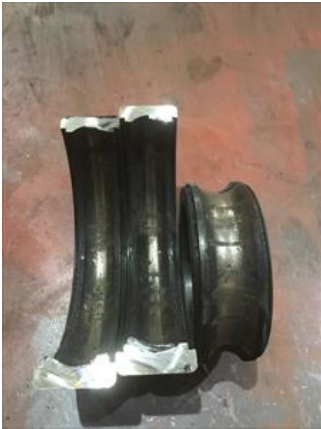
26.	Drive End Bearing Brand	Koyo

28. Drive End Bearing Qty.	1
29. Drive End Bearing Type	(Ball) Ball Bearing
30. Drive End Lubrication Type	(Grease) Grease Lubricated
31. Drive End Bearing Insulation or Grounding Device?	none
32. Drive End Wavy Washer/Snap-Ring Other Retention Device?	none
33. Drive End Bearing Condition	replace
34. Opposite Drive End Bearing Brand	koyo
35. Opposite Drive End Bearing Number-	6316 ZZ C3

67.	Failure locations <i>DE housings fit bad.</i> <i>DE bearing locked up</i>		
68.	Root cause of failure <i>Lack of lubrication on DE bearing, & contaminated grease.</i>		
Dynamic Balance Report

45. Growler Test	(Pass) Pass
46. Number of Rotor Bars	64
47. Rotor Condition	pass
48. List the Parts needed for the Repair Below (2) 6316 ZZ C3	
49. Signature of Technician that Disassembled Motor	Terrence Holland

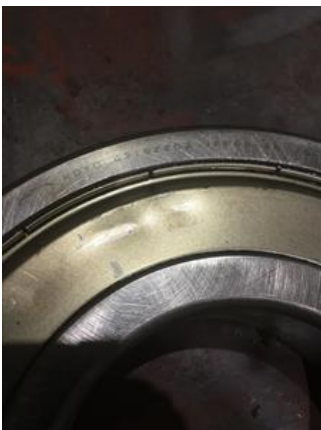
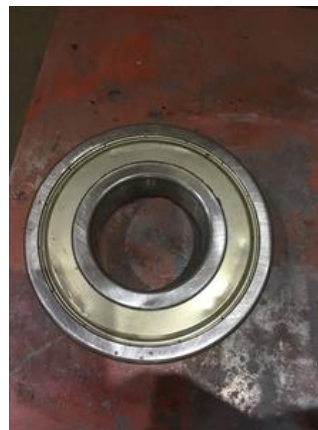
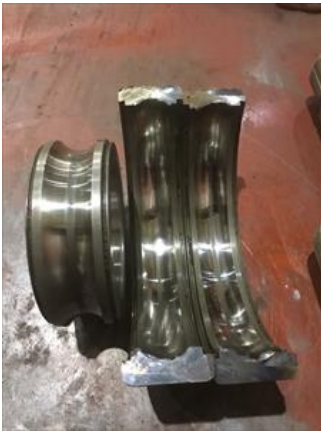
36. Opposite Drive End Bearing Qty.	1
37. Opposite Drive End Bearing Type	(Ball) Ball Bearing
38. Opposite Drive End Lubrication Type	(Grease) Grease Lubricated
39. Opposite Drive End Bearing Insulation or Grounding Device?	none
40. Opposite Drive End Wavy Washer/Snap-Ring Other Retention Device?	none
41. Opposite Drive End Bearing Condition	replace
42. Drive End Seal	none
43. Opposite Drive End Seal	none

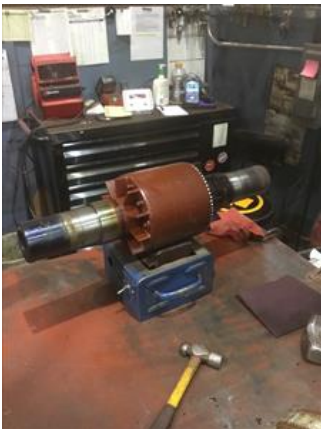
44. Rotor Type/Material	(Squirrel Aluminum) Squirrel Cage Aluminum Die Cast	P3
-------------------------	--	----

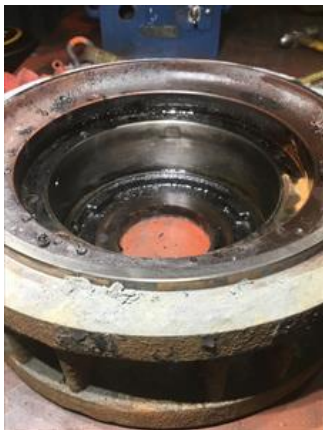
58.	Shaft Air Seal Fits		
	Drive End Air Seal	Opposite Drive End Air Seal	
	pass	pass	
Mechanical Fits- Bearing Housings  			
59.	Drive End - Endbell Bearing Fit	P2	
	0 Degrees	60 Degrees	120 Degrees
<div>  Lip worn in.</div> <div>

60.	Drive End - Endbell Bearing Fit Condition	(F) Fail	
	<div>

64.	End Bell Air Seal Fits		
	Drive End Air Seal	Opposite Drive End Air Seal	
65.	List Machine Work Needed Below <i>D.E housing fit.</i>		
66.	Technician	Terrence Holland
