AC Inspection as Found
ARKANSAS INDUSTRIAL MACHINERY
3804 N. NONA ST
NORTH LITTLE ROCK, AR 72118

AC Inspection - Rev. 2

Location: LR MOTOR SHOP

Description: 250 HP BALDOR

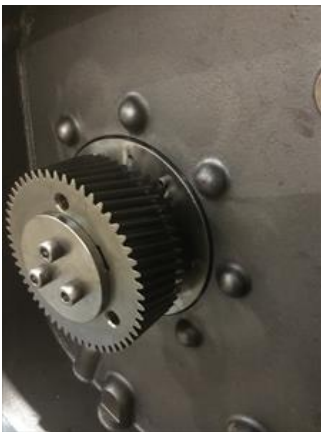
6.	Does Shaft Turn Freely?	(Y) Yes
7.	Does the shaft require T.I.R in Lathe to identify additional repairs?	(No) No
8.	Does Shaft Have Visible Damage?	(No) No
9.	Assembled Shaft Runout	0.007 Inches
10.	Assembled Shaft End Play	0 inches
11.	Air Gap Variation <10%	
12.	Lead Condition	(P) Pass
13.	Lead Length	83 Inches
	6'11"

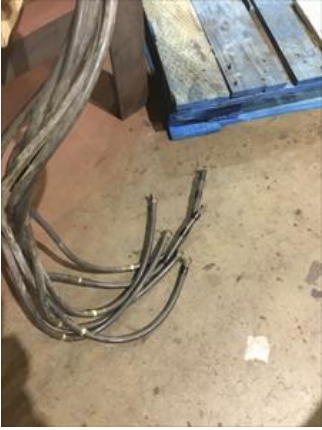
14. Does it have Lugs?, If so what is the Stud Size?	(No) No	P93

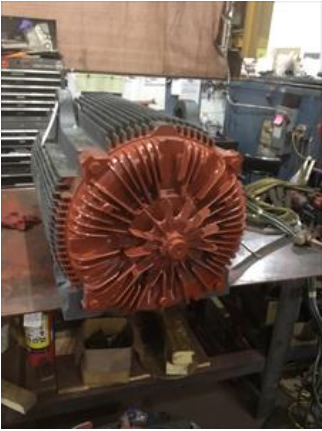
15. Lead Numbers	1-6	
16. Frame Condition	pass	
17. Fan Condition	(P) Pass	
18. Does motor have internal fan?	(No) No	P118

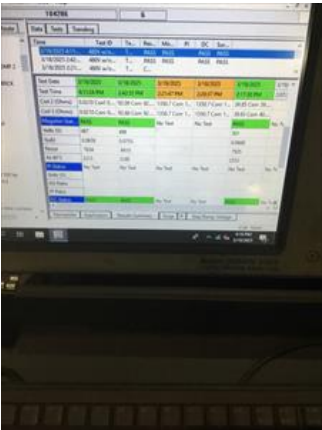
19. Broken or Missing Components	none	
Initial Electrical Inspection		
20. Insulation Resistance/Megger	Megohms	P8

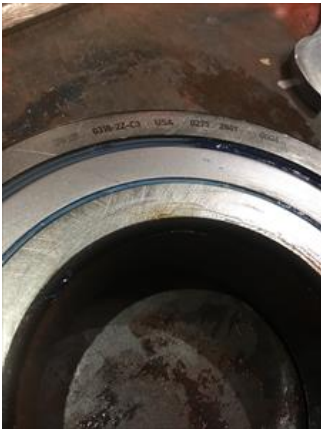
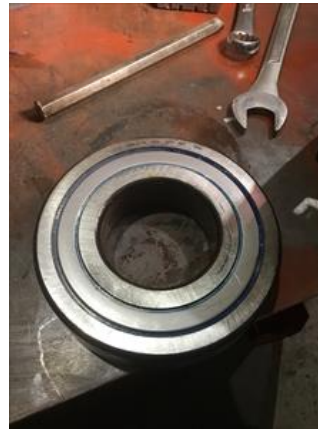
29. Drive End Bearing Qty.	1
30. Drive End Bearing Type	(Roller) Roller Bearing
31. Drive End Lubrication Type	(Grease) Grease Lubricated
32. Drive End Bearing Insulation or Grounding Device?	none
33. Drive End Wavy Washer/Snap-Ring Other Retention Device?	
Snap ring	
34. Drive End Bearing Condition	good
35. Opposite Drive End Bearing Brand	FAG

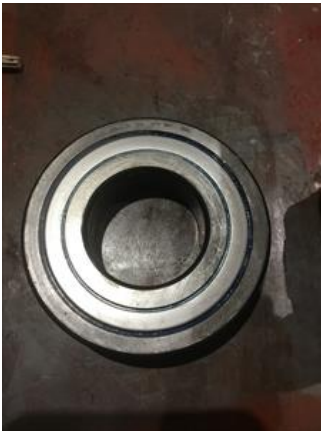
36. Opposite Drive End Bearing Number-	6318-2Z-C3
37. Opposite Drive End Bearing Qty.	1
38. Opposite Drive End Bearing Type	(Ball) Ball Bearing
39. Opposite Drive End Lubrication Type	(Grease) Grease Lubricated
40. Opposite Drive End Bearing Insulation or Grounding Device?	none
41. Opposite Drive End Wavy Washer/Snap-Ring Other Retention Device?	snap ring
42. Opposite Drive End Bearing Condition
