AC Inspection as Found
ARKANSAS INDUSTRIAL MACHINERY
3804 N. NONA ST
NORTH LITTLE ROCK, AR 72118

AC Inspection - Rev. 2

Description: 250 HP BALDOR

Repair Stage: Final

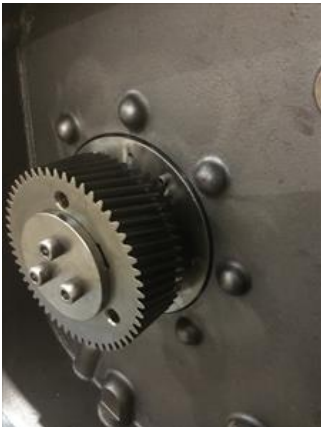
P76

4. Describe the Overall Condition of the Equipment as Received
Serviceable

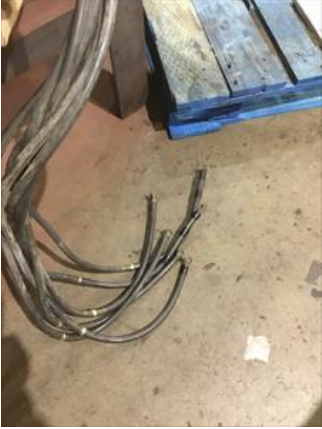
13.	Lead Length	83 Inches	
	6'11"		
14.	Does it have Lugs?, If so what is the Stud Size?	(No) No	P93

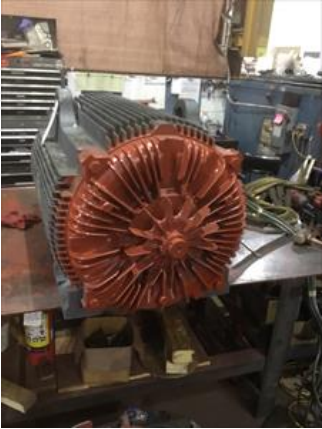
15.	Lead Numbers	1-6	
16.	Frame Condition	pass	
17.	Fan Condition	(P) Pass	
18.	Does motor have internal fan?	(No) No	P118

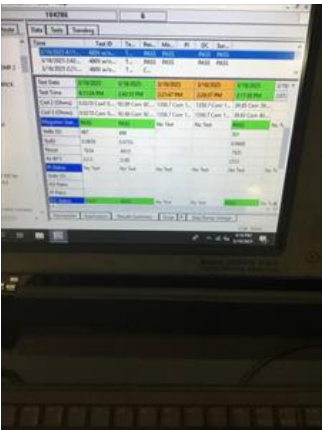
20.	Insulation Resistance/Megger	Megohms	P8

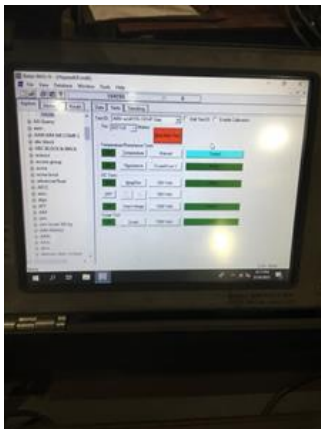
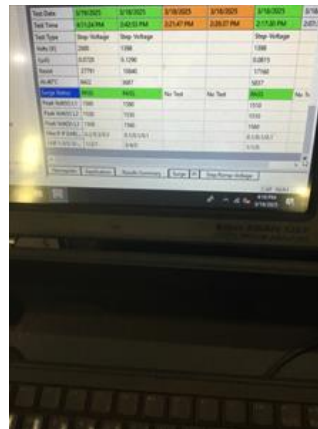
P57

22. Perform Surge Test

(P) Pass

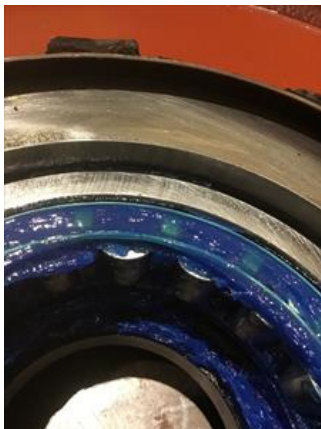
P12

27. Drive End Bearing Brand

FAG

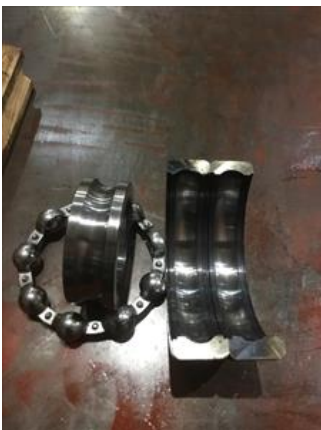
P92

29. Drive End Bearing Qty.	1
30. Drive End Bearing Type	(Roller) Roller Bearing
31. Drive End Lubrication Type	(Grease) Grease Lubricated
32. Drive End Bearing Insulation or Grounding Device?	none
33. Drive End Wavy Washer/Snap-Ring Other Retention Device?	
Snap ring	
34. Drive End Bearing Condition	good
35. Opposite Drive End Bearing Brand	FAG

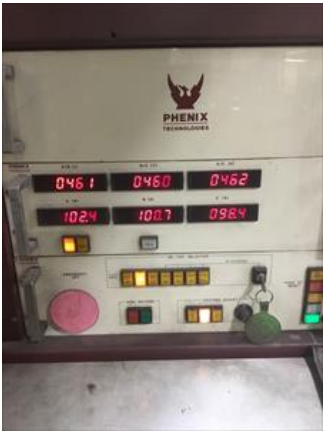
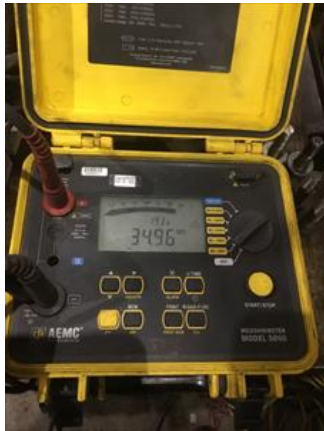
76. Final Insulation Resistance Test 34.96 Gigohms P31

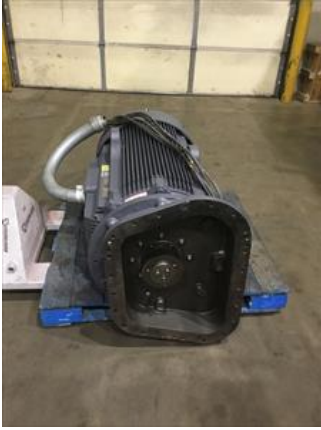
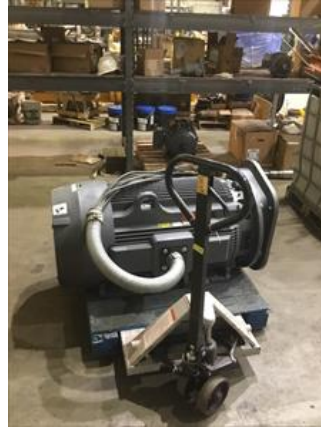
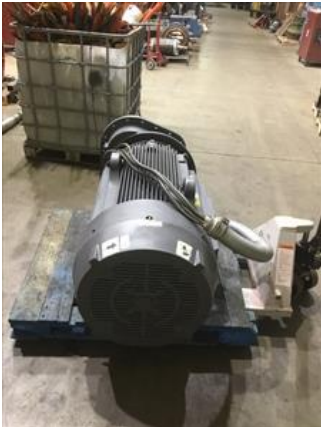
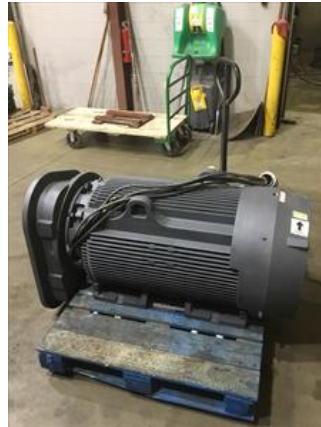
P132

86. Document Final Condition with Pictures after paint
