**AC Inspection as Found**  
**FUTURE FUEL CHEMICAL**  
2800 GAP RD HWY 394 SO  
BATESVILLE, AR 72501

**AC Inspection - Rev. 2**

Location: LR MOTOR SHOP

Description: 50 HP U.S ELECTRIC

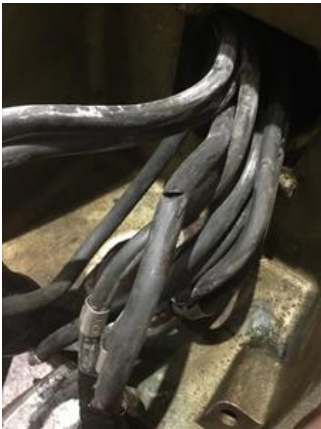
5. Does Shaft Turn Freely?	(Y) Yes	
6. Does the shaft require T.I.R in Lathe to identify additional repairs?	(No) No	
7. Does Shaft Have Visible Damage?	(No) No	
8. Assembled Shaft Runout	0.004 Inches	
9. Assembled Shaft End Play	0 inches	
10. Air Gap Variation <10%		
11. Lead Condition	(F) Fail	P69

*Insulation cut on lead #2*

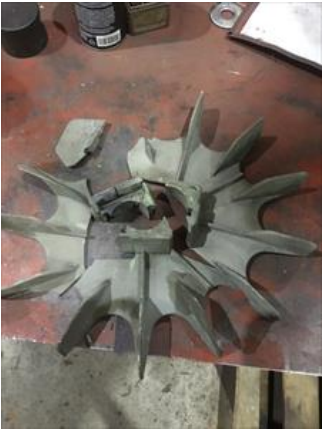
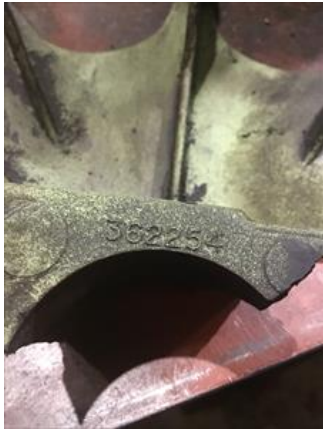
14.	Lead Numbers	1-9	
15.	Frame Condition	pass	
16.	Fan Condition	(F) Fail	P115
<div style="display: flex; justify-content: space-around;">

</div> <p>Destroyed. Sn: 362254</p>			
17.	Does motor have internal fan?	(No) No	
18.	Broken or Missing Components	Fan assembly	
Initial Electrical Inspection

*Bearings: (1) 6211 C3 (1) 6311 C3  
Fan assembly # 362254  
Sleeve ODE housing fit.  
Rewind stator / minor core repair*

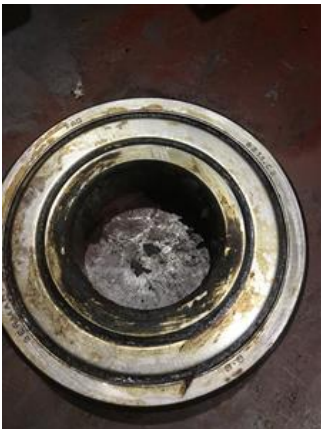
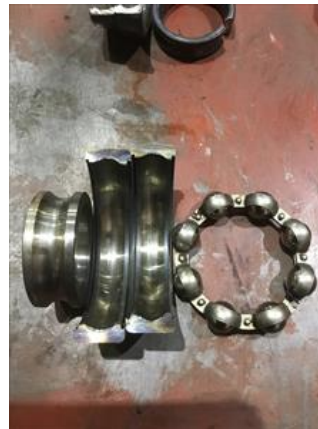
**6311 C3**

**worn**

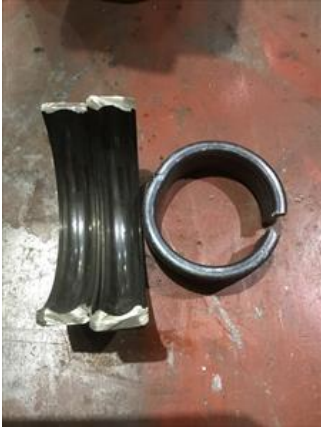
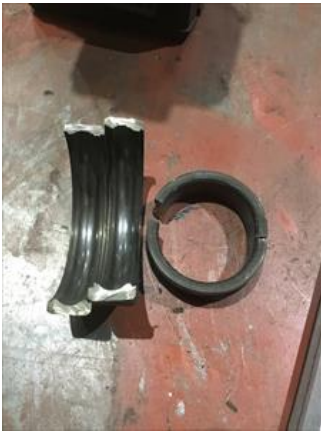
37. Opposite Drive End Bearing Type	<b>(Ball) Ball Bearing</b>
38. Opposite Drive End Lubrication Type	<b>(Grease) Grease Lubricated</b>
39. Opposite Drive End Bearing Insulation or Grounding Device?	<b>none</b>
40. Opposite Drive End Wavy Washer/Snap-Ring Other Retention Device?	<b>none</b>
41. Opposite Drive End Bearing Condition	<b>destroyed</b>
42. Drive End Seal	
43. Opposite Drive End Seal

Lip worn in.

(F) Fail

Sleeve ODE housing fit.

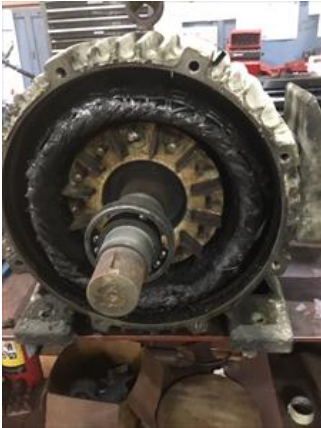
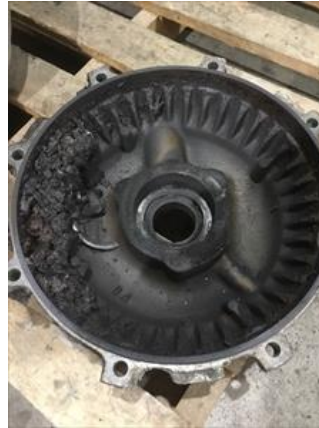
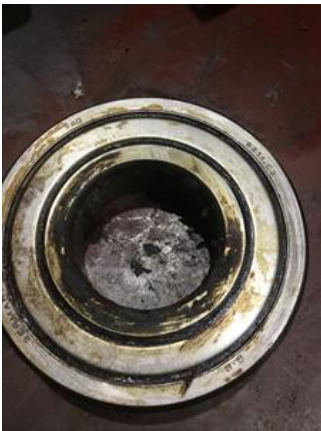
P18

*ODE housing fit, due to catastrophic bearing failure.*

*Poorly lubricated bearings on both ends caused the ODE bearing to fail .*
