**AC Inspection as Found**  
**APPLIED INDUSTRIAL TECHNOLOGY**  
P.O. BOX 93018  
CLEVELAND, OH 44101

**AC Inspection - Rev. 2**

**Serial Number:** CZ412111

**Description:** 60 HP BALDOR

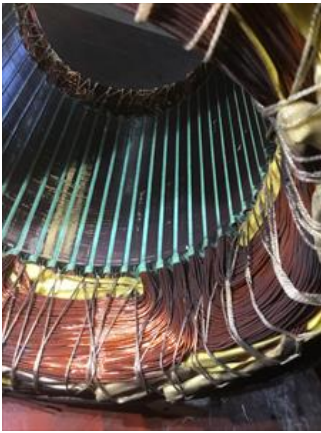
*Drive end*

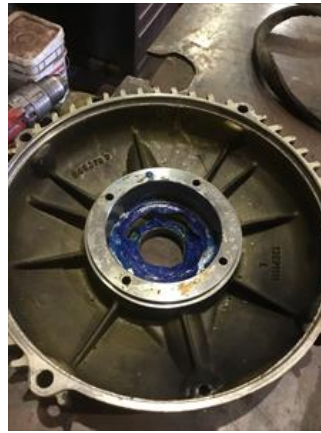
Opposite drive end

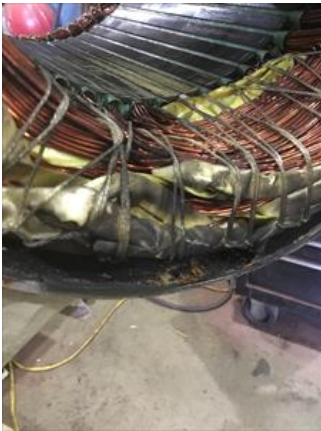
Opposite drive end

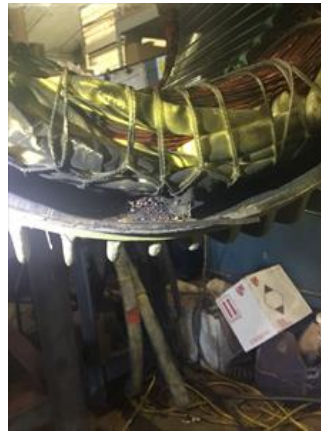
Rust on opposite drive end.

Co sign :	
<b>Root Cause of Failure</b>		
67.	Failure locations <i>ODE windings shorted to ground. ODE housing measures too tight.</i>	
68.	Root cause of failure <i>Water seeped inside the stator windings on the ODE side causing them to short to ground. See pics below.</i>

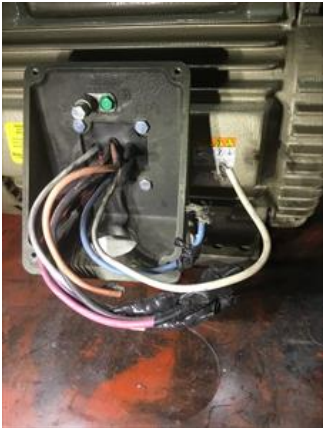
4. Describe the Overall Condition of the Equipment as Received		
Serviceable		
Initial Mechanical/Electrical		
5. Does Shaft Turn Freely?	(N) No	
6. Does the shaft require T.I.R in Lathe to identify additional repairs?	(No) No	
7. Does Shaft Have Visible Damage?	(No) No	
8. Assembled Shaft Runout	Inches	
Unable to perform due to locked up shaft.		
9. Assembled Shaft End Play	0 inches	
10. Air Gap Variation <10%

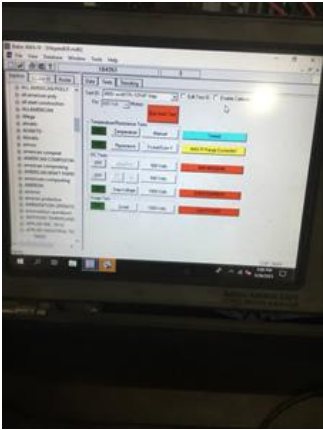
See item 22.		
20.	Winding Resistance		
1-2	1-3	2-3	
 	See item 22

22. Number of Stator Slots	48
23. Stator Condition	rewind
24. Stator Thermistors/Ohms	
25. Stator Overloads/Ohms

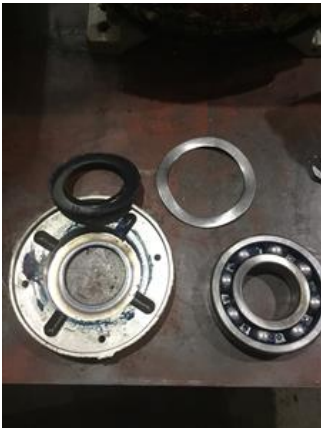
41. Opposite Drive End Bearing Condition

**replace**
