## AC Inspection as Found

### FUTURE FUEL CHEMICAL

#### AC Inspection - Rev. 2

Description: 75 HP BALDOR

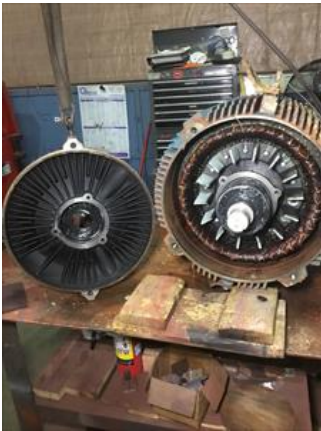
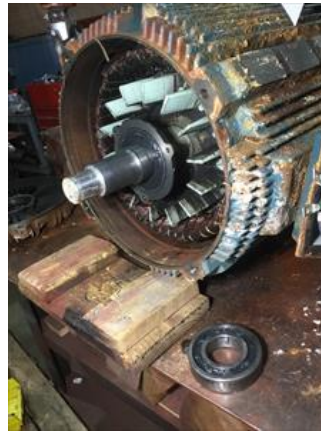
*Broken bolt*

*Part Broken off in housing.*

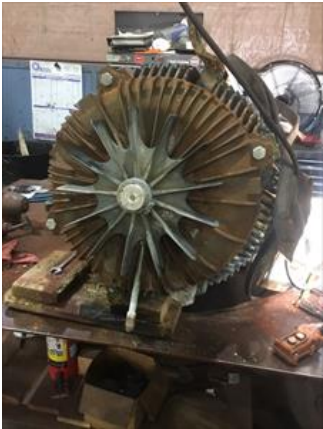
17. Does motor have internal fan?	(No) No	
18. Broken or Missing Components	p	P124
<div>Broken of fan cover mount bolt on ODE.</div>

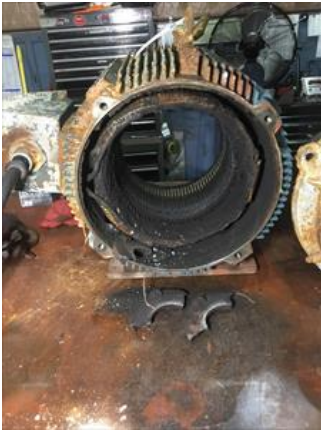
## 21. Perform Surge Test

(F) Fail

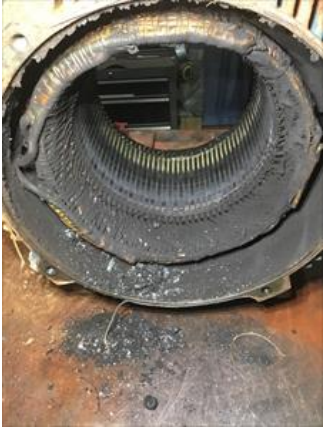
33. Drive End Bearing Condition	<b>destroyed</b>	P82

DE bearing suffered catastrophic cage failure due to contaminated lubrication. This caused the rotor to drop onto the stator core and particles from the failed bearing, and broken bearing cap impacted the windings causing a short circuit.

| 48. List the Parts needed for the Repair Below<br><i>New shaft. Rewind stator &amp; major core repair.<br/> Replace broken DE bearing<br/> Sleeve for 7219 housing fit.<br/> 6313 and 7219 bearings.</i> | |

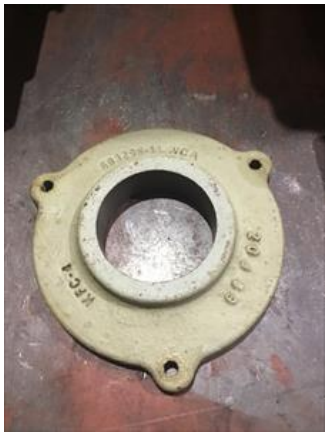
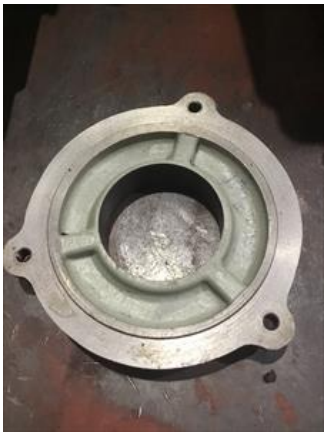
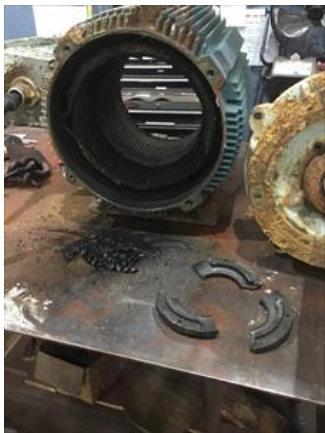
Fit bad because of both bearings suffering catastrophic failure!			
60.	Drive End - Endbell Bearing Fit Condition			(F) Fail

63. Bearing Cap Condition

Drive End Bearing Cap  
destroyed

Replace shaft  
Machine DE housing bearing it and repair shaft air seal
